May 29, 2024

Re: DOC North Central Correctional Facility – IPI Sally Port Vehicle Gate Review
DAS Project No.: 9366.00

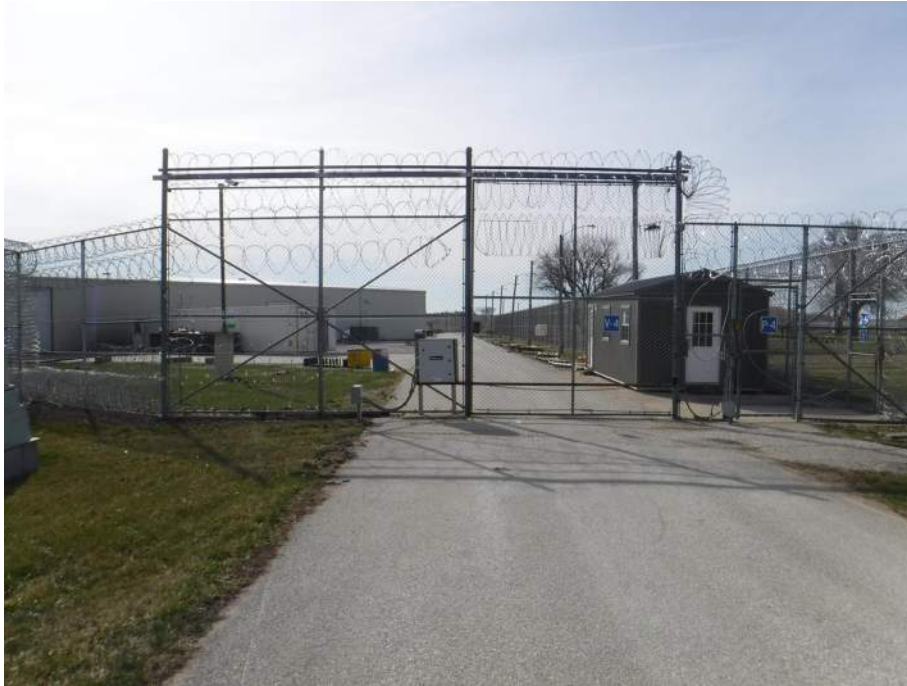
PHOTO NUMBER 1-1

DESCRIPTION: South gates, looking Southerly

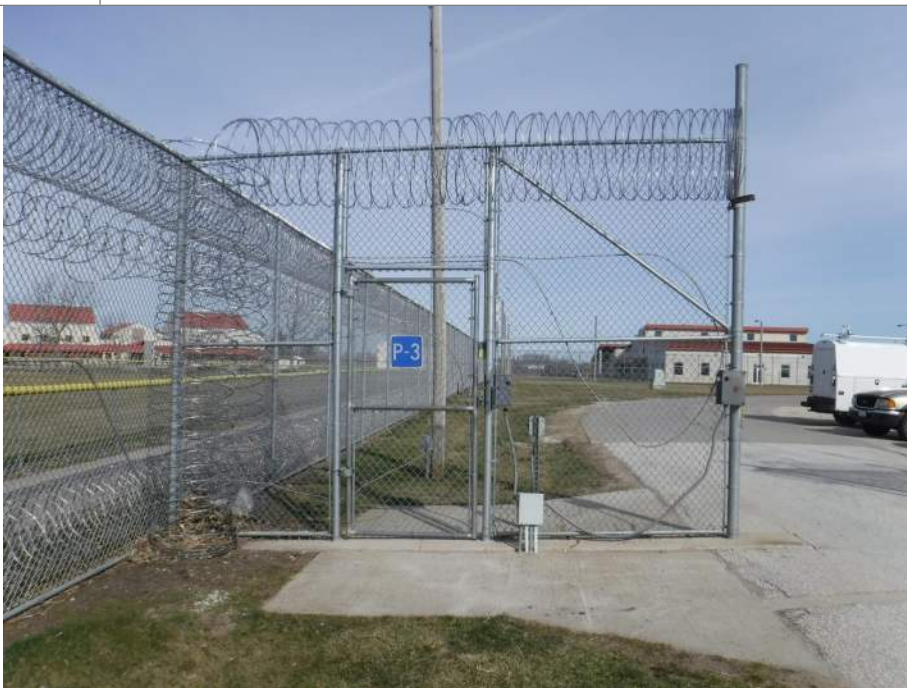
PHOTO NUMBER 1-2

DESCRIPTION: North gates, looking Northerly

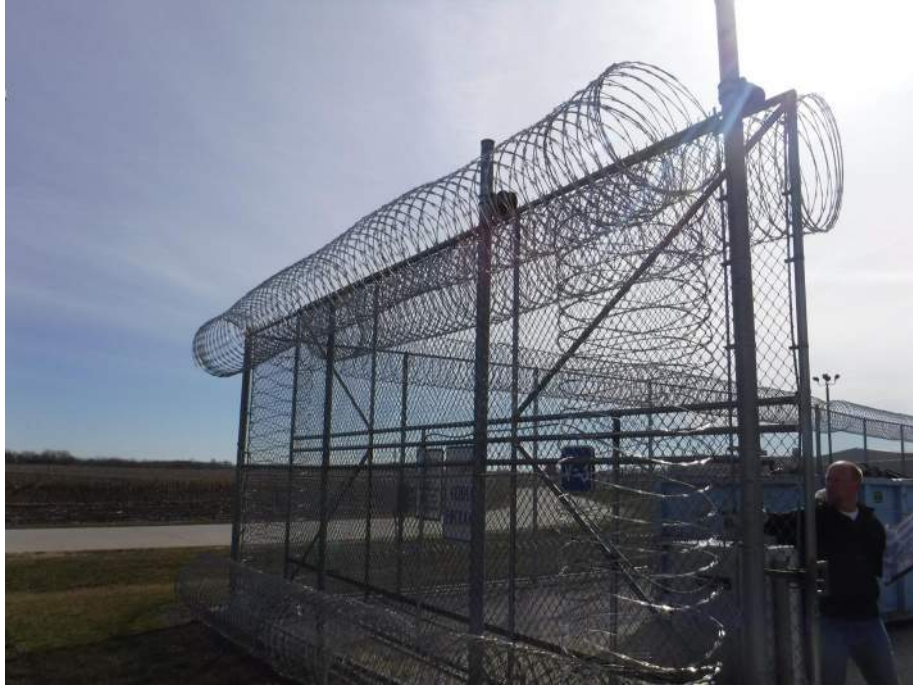
PHOTO NUMBER 1-3

DESCRIPTION: North Gates, looking Southerly

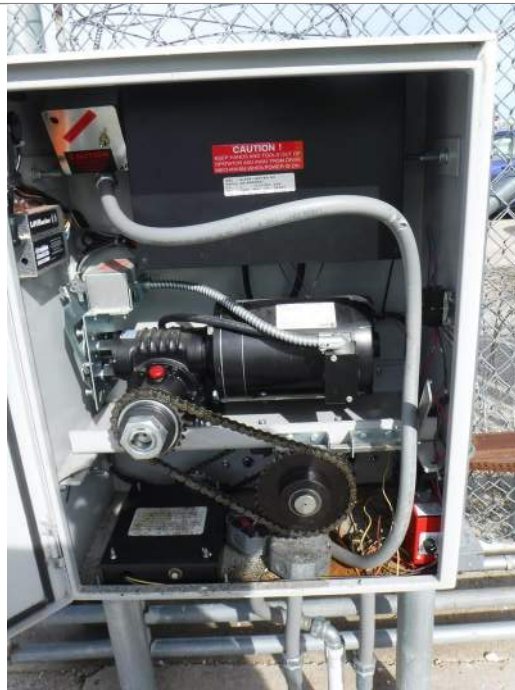
PHOTO NUMBER 1-4

DESCRIPTION: Gate operator control box

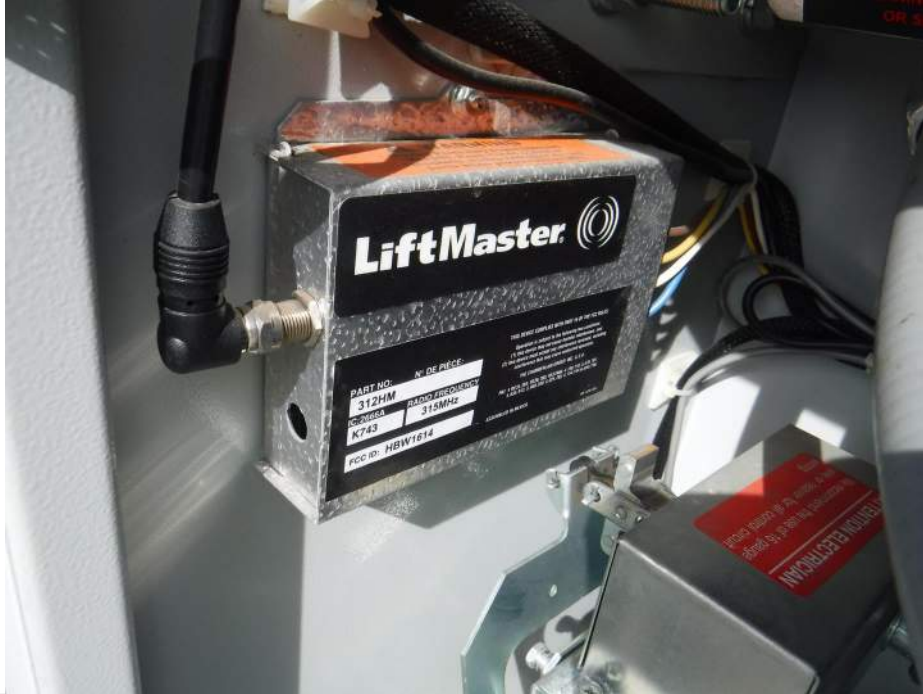
PHOTO NUMBER 1-5

DESCRIPTION: Gate operator controls

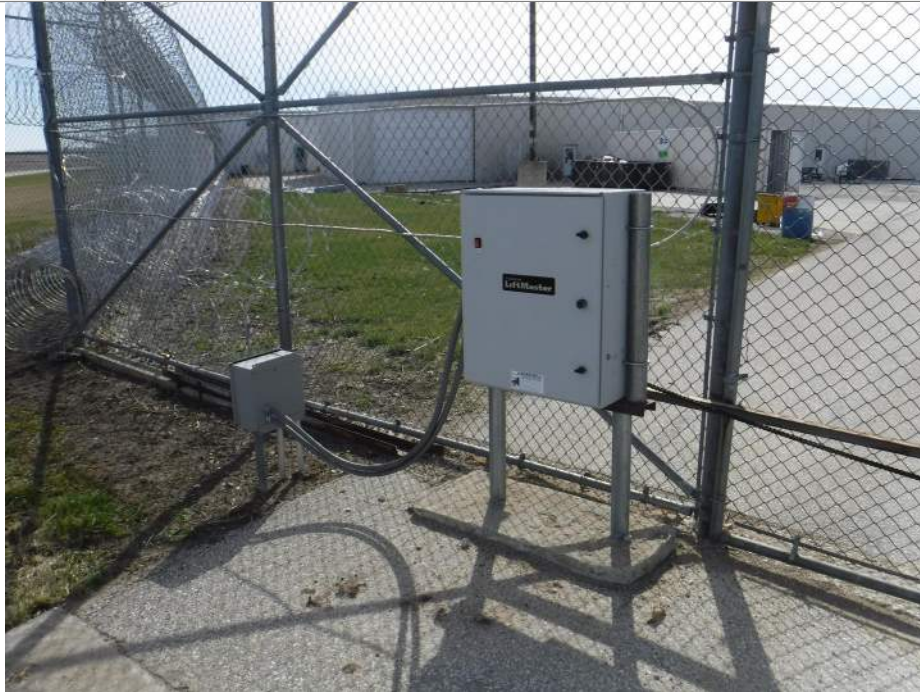
PHOTO NUMBER 1-6

DESCRIPTION: South gate operator control box

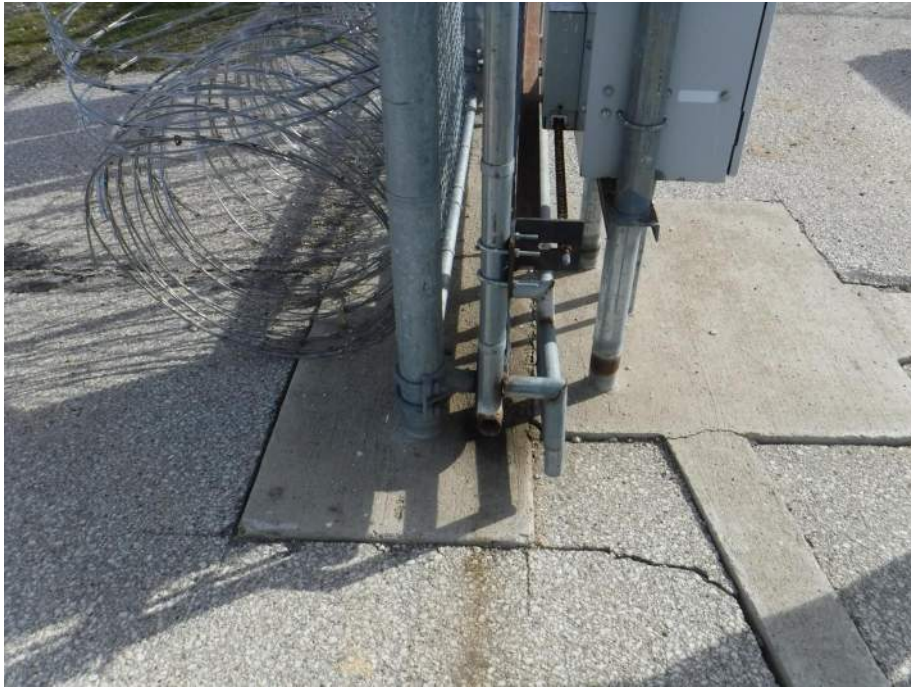
PHOTO NUMBER 1-7

DESCRIPTION: North gate

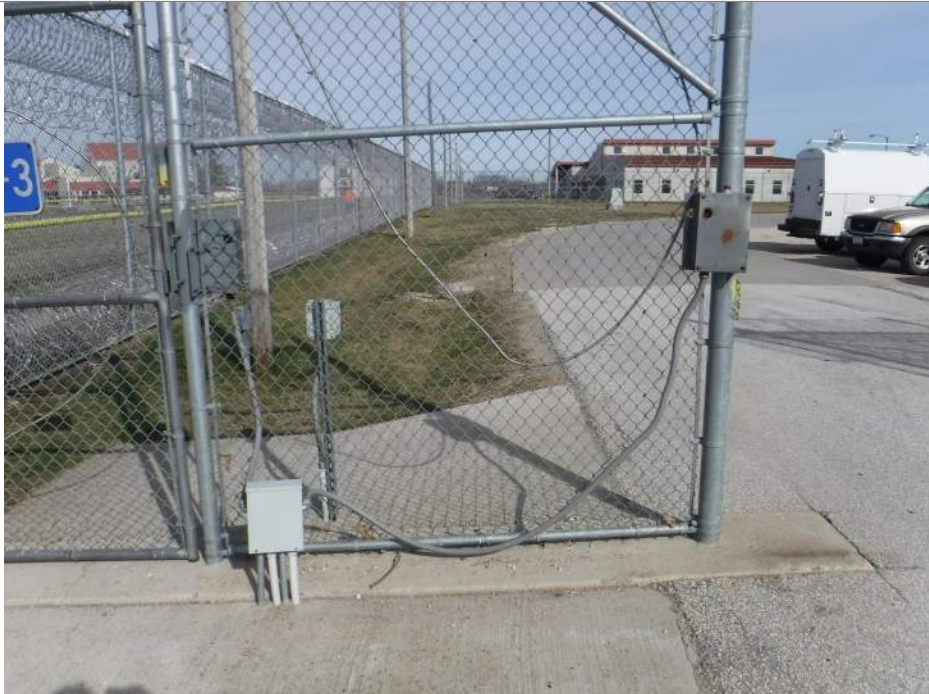
PHOTO NUMBER 1-8

DESCRIPTION: North gate locking mechanism and wiring connection

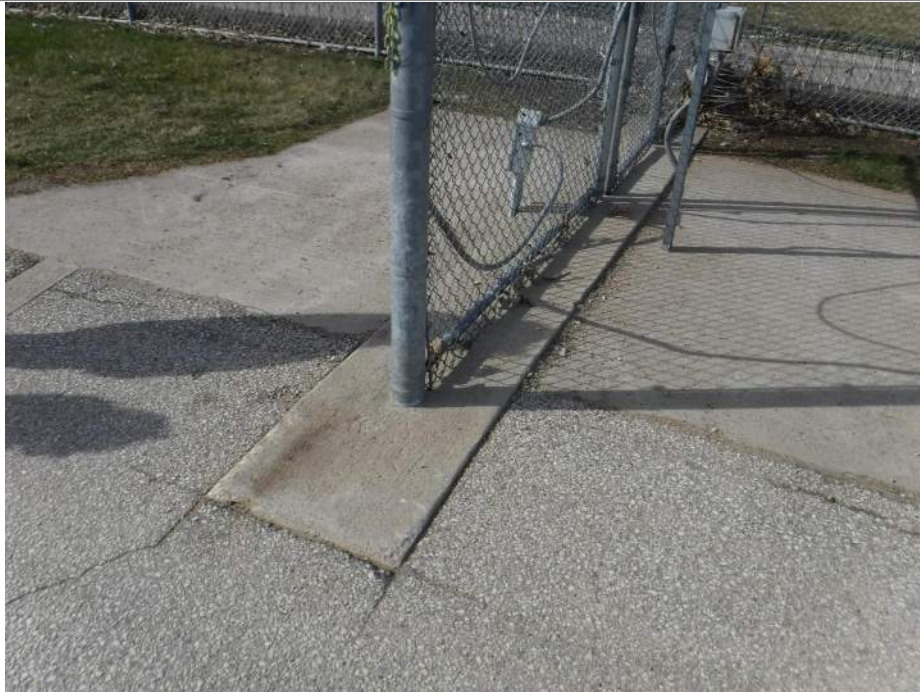
PHOTO NUMBER 1-9

Under the perimeter fencing and surrounding the gate posts of the sallyport, an approximate 2' wide by 4" thick concrete maintenance strip is installed. This concrete maintenance strip continues across the drive under the gate and is not believed to be frost protected or isolated from the fence and gate posts. There is evidence that this maintenance strip may be adversely moving/heaving the fence and gate posts leading to some of the continuous alignment issues the automated gate and locking system has been experiencing. The rest of the drive is asphalt paving.

DESCRIPTION: North gate receiving post and concrete maintenance pad

4. Removal and replacement of the 2' wide concrete maintenance strip under the adjacent fencing and gates. Replacement of the maintenance strip should be isolated from the fence posts to provide independent movement.

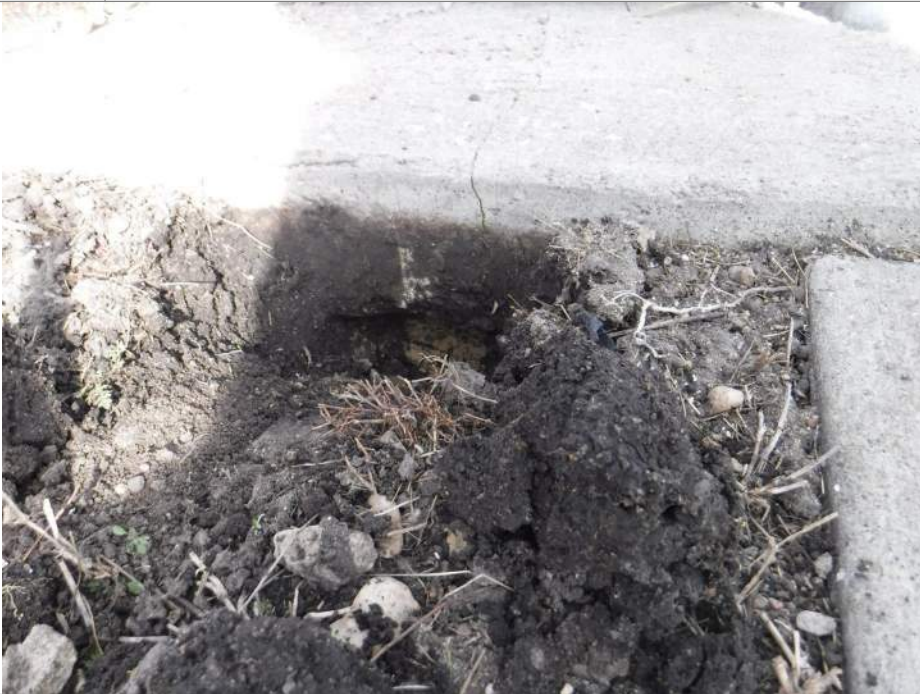
PHOTO NUMBER 1-10

DESCRIPTION: Excavation along maintenance pad showing approximate depth concrete slab depth of 4"

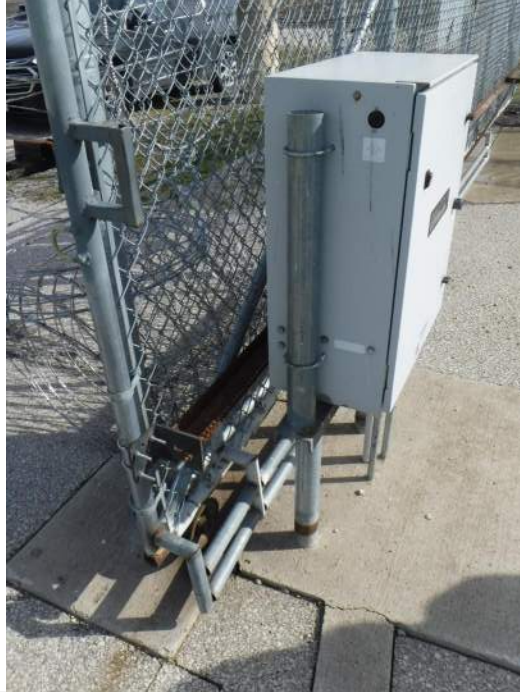
PHOTO NUMBER 1-11

DESCRIPTION: North gate operator control box

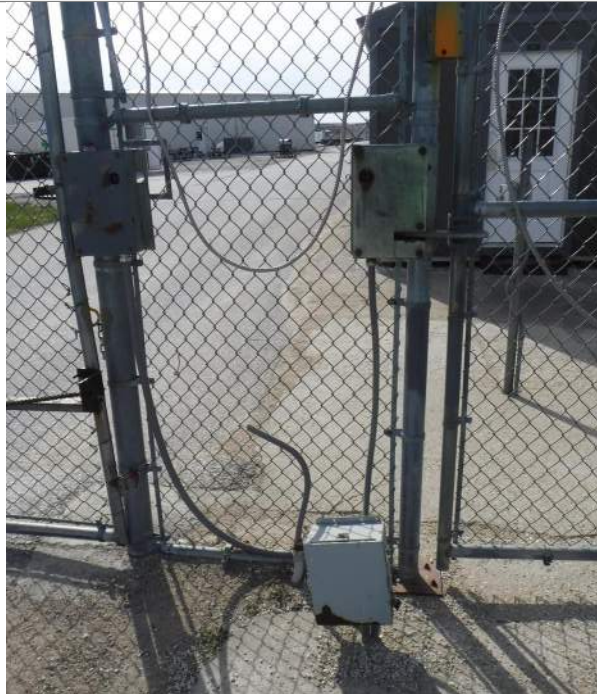
PHOTO NUMBER 1-12

DESCRIPTION: South gate locking mechanisms and wiring connections

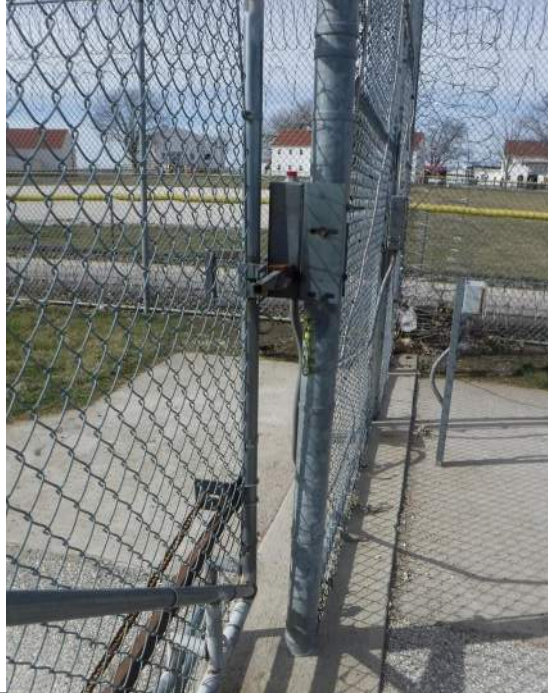
PHOTO NUMBER 1-13

DESCRIPTION: Typical gate gap when closed

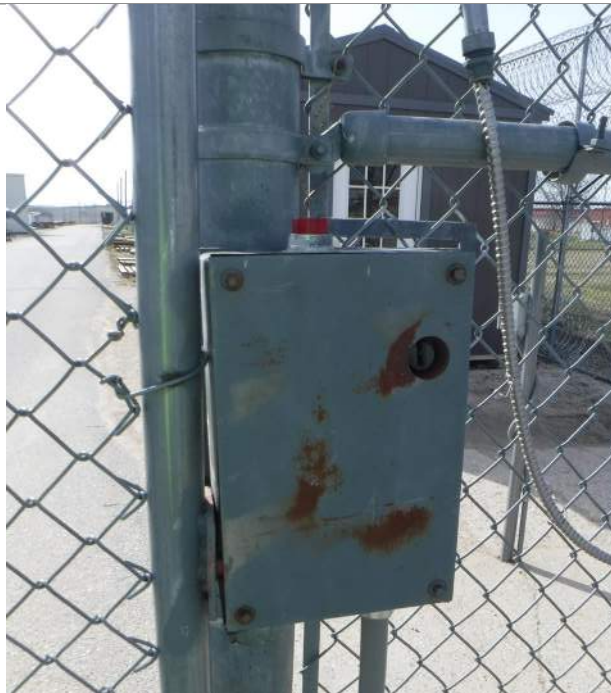
PHOTO NUMBER 1-14

DESCRIPTION: Typical gate locking mechanism enclosure
