Existing Conditions Report and Treatment Recommendations

Abbie Gardner Sharp Cabin Historic Site

RDG Project Number: 3004.995.00

Report Date: September 15, 2022

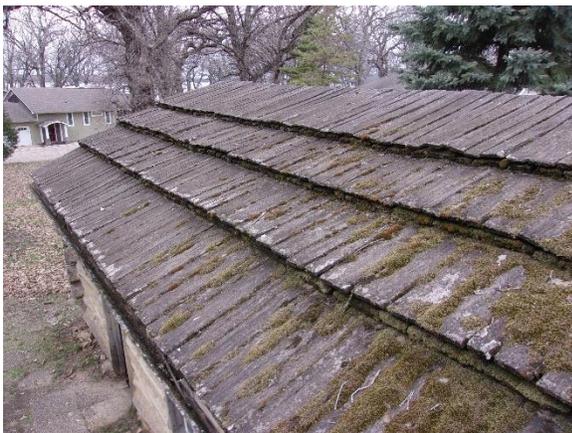
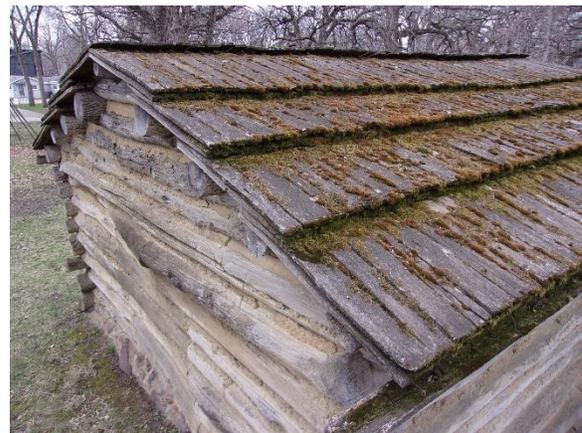
Figure 15 – cabin roof

Existing wood shingles, double layer. Each shingle is approximately 24" to 36" in length; with 18" to 24" exposure. These likely date from the 1974 era restoration. There is some moss or other biological growth over much of the roof, but severe growth is located on the north half of the roof, which likely receives less sunshine than the south half. The shingles are in fair condition, although generally no leaks were reported.

A v-shaped wood gutter is located along both the north and south roof lower edges. These may date to the 1974 era restoration. These are in poor condition. There are no downspouts; the water likely simply runs out the ends onto the ground. Gutters and other water management is needed, but challenging to provide if the 1856 cabin never had them to begin with.

1. Make repairs to roof and water management systems. Replace wood shingle roof that is at the end of its life cycle. Include sheathing repairs and modern underlayment products not visible to the public, using methods and materials as appropriate to promote necessary air flow beneath the shingle roof.

- b. Consider vegetation management adjacent and over the roof that might be contributing to moss or mold growth on shingles.
 - c. Consider repairs to roof rafter system and roof structure, as appropriate.

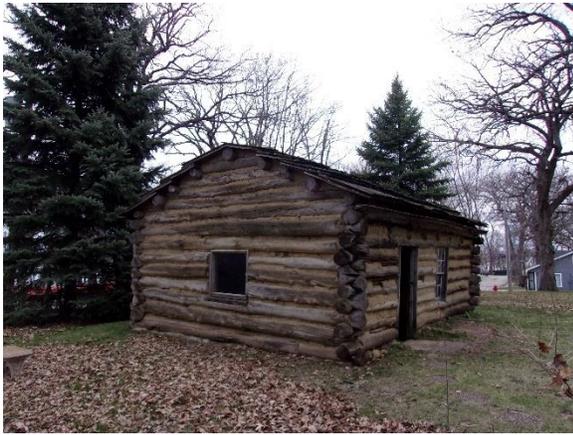
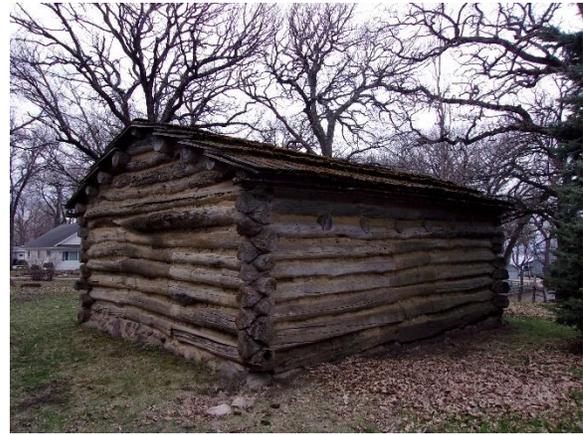
Figure 17 – cabin west and south walls

Logs. The logs are in generally fair condition, considering their age. Several show conditions of rot and worm holes. The south wall appears to be bowing out from the plane of the wall. Note: this report does not identify wood species and specific age of the logs.

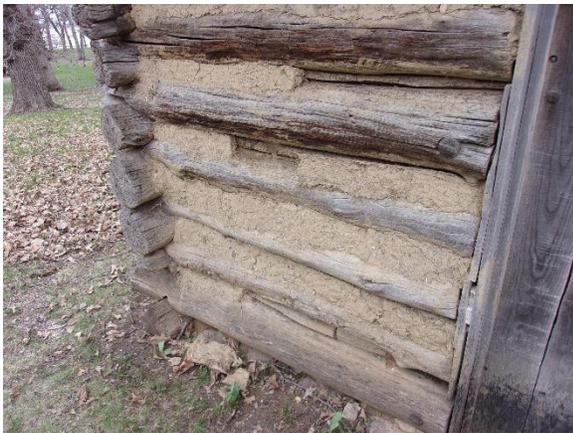
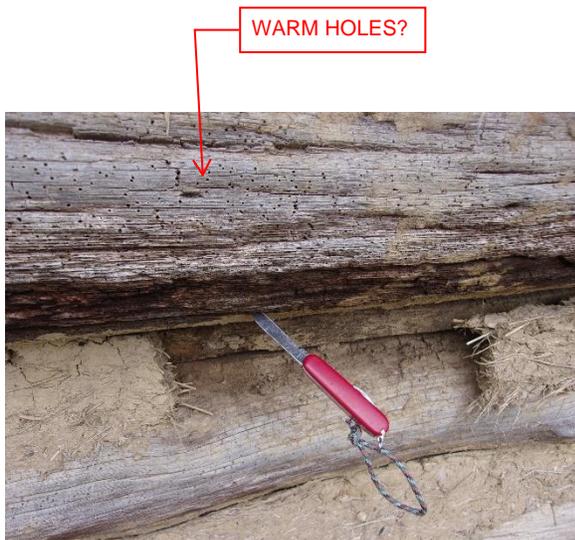
Figure 19 – cabin chinking

Chinking. Much of this material likely dates to 1974 restoration or later repairs. It appears to generally consist of dried mud and grass, with some pebble aggregate. Due to the very temporary nature of this material, this requires constant maintenance; much of what is in place today is likely repairs and has fallen out in many places. The chinking is typically about 3” wide, except at the south face, where it is about 6” wide.

- c. Remove failed daubing and chinking. Provide new materials to match period appropriate solutions. Recognize the temporary nature of this building material.

3. Make repairs to the daubing and chinking between the logs. Recognize this is an ongoing maintenance item. Repairs might be incorporated into the visitor experience, or as an annual event.

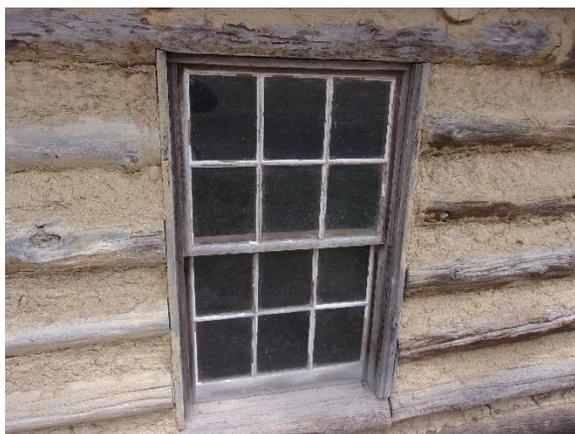
Figure 23 – cabin south window

South wall has a simple 6 over 6 double wood window. Both sashes are fixed into place. This style of window appears in early photographs of the cabin, near this location, and in other locations. It's not known if this window dates to 1857, but was likely retained or reused from the existing windows in place during the 1974 restoration. **The glazing putty is in poor condition, missing in locations.** There is no window hardware, or counterweight for the sashes. The sashes and frame are unpainted.

2. Consider removal and infill of west window if this opening is considered not to date to period of significance (1857).
 3. Make repairs to existing window adjacent to the door.

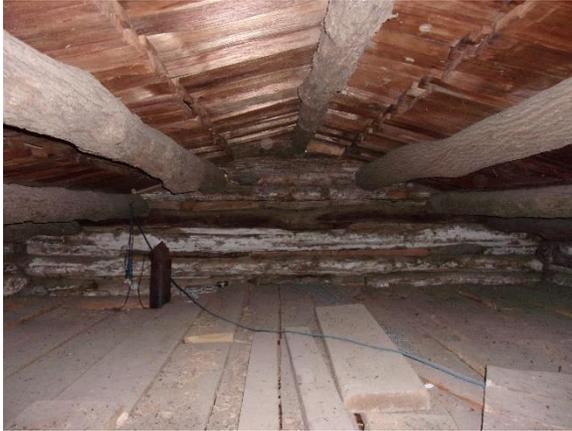
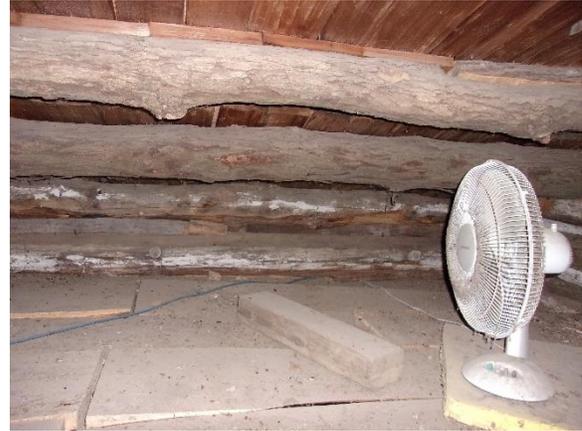
Figure 25 – cabin attic

The ceiling is made of exposed log joists at about 2'-6" on center, some with exposed bark; these date from the 1974 restoration. A layer of log planks, with exposed bark on the bottom, lies on top of the joists. The top half of the log planks, visible in the attic space, are generally flat and smooth. The planks are omitted at the west end to allow access to the attic space.

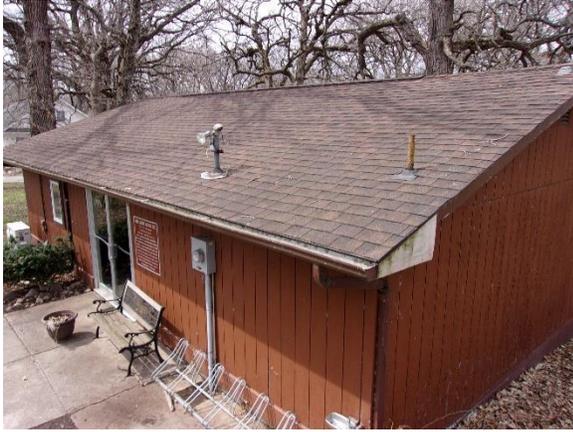
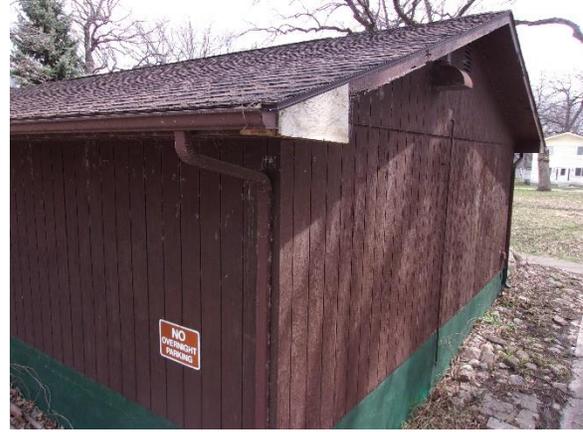
Figure 14 – museum roof

Existing asphalt shingle, architectural (laminated or dimensional shingles) style roofing. This is in fair to good condition, it appears to be likely 7 to 10 years old.

There is an abandoned power supply pole with a security light. (The existing power supply is underground.) There appears to be 2 vent stacks penetrating the roof.

The roof overhangs the exterior walls by about 2 feet. The slope appears to be 4:12 pitch.

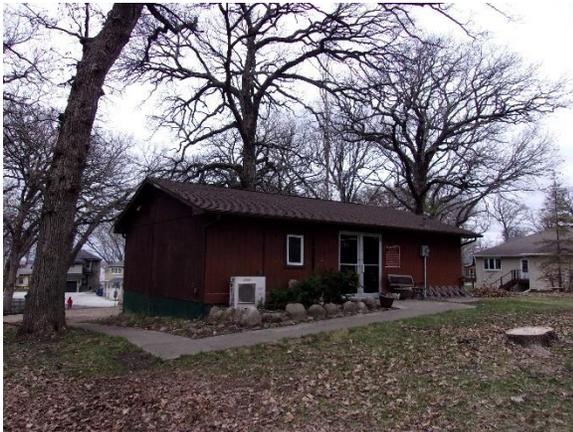
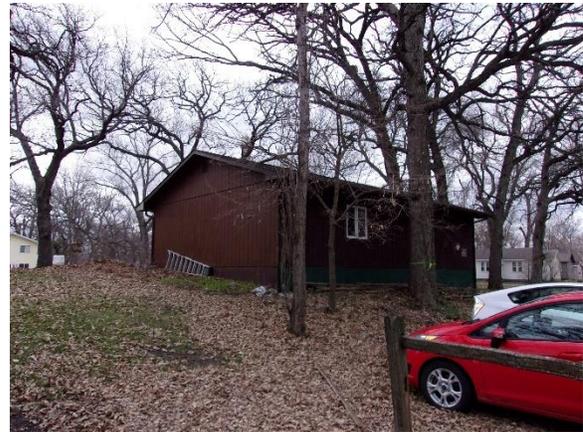
Figure 29 – museum south and east walls

Vertical wood sheathing siding, painted or stained, generally in fair condition. The planks are 8" wide but are likely part of 4' wide sheets of siding. The wall is 8' tall.

Likely poured in place concrete perimeter footing and floor, likely slab on grade with frost depth footings. The exposed footing faces at the north, west, and south walls appears to have a painted or stained mortar or cementitious parge coat applied, swirl pattern. The parge coat was likely used to mask the surface left by the concrete formwork.

A thin horizontal crack appears along the concrete footing, about 8" below the siding. This is likely near the point where the concrete floor transitions to the concrete footing.

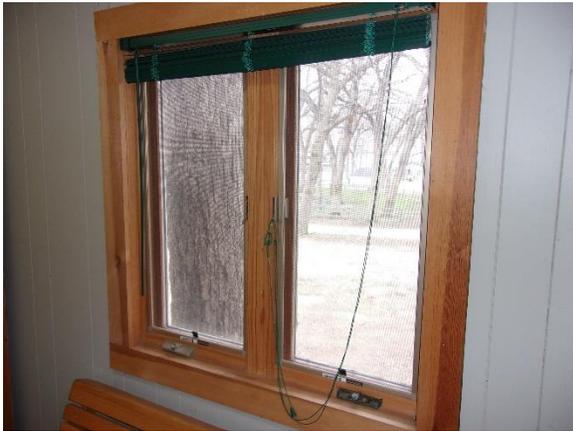
Figure 31 – window

There are only 2 windows. A single window on the east wall, and a double window on the west wall. These are hand crank operating casement windows, and appear to be metal clad wood windows, with insulating glass. They appear to be in fair condition and likely at the end of their useful life.

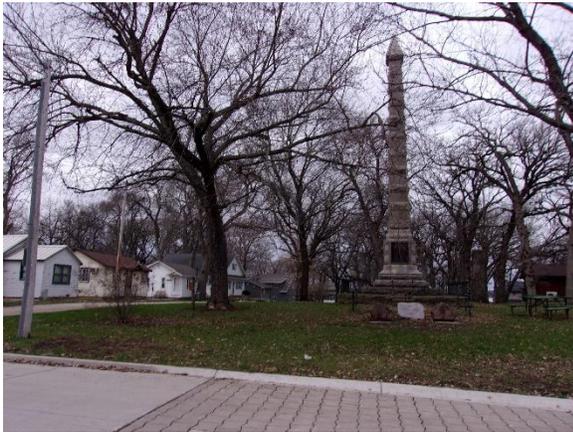
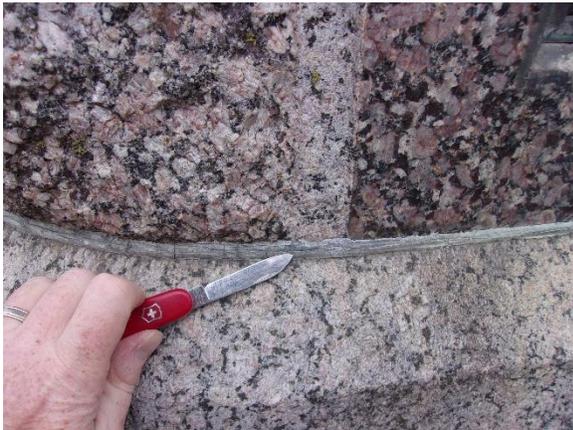
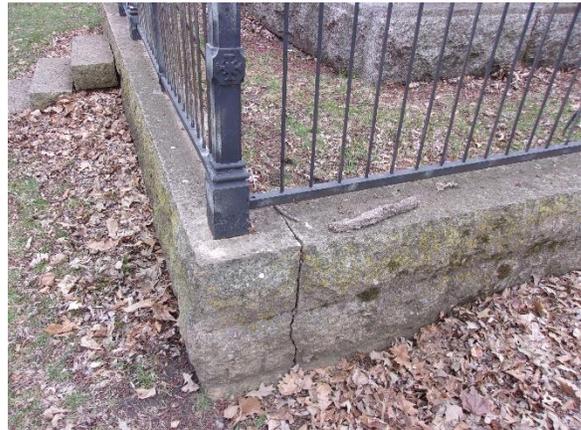
Figure 37 – obelisk

The monument appears to be in good condition.

A base is constructed of a limestone wall and painted steel railing. This is in fair to good condition with some stone spalling. Stone joints could be repointed, and metal could be repainted.

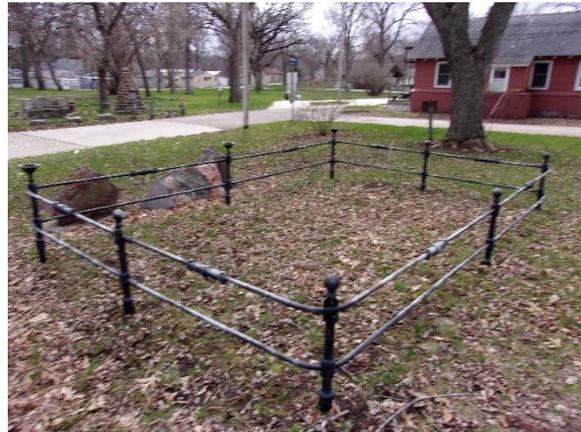
Figure 38 – mass grave

The painted steel railing is in fair to good shape. Parts of the railing have broken off over time. The design is very similar to the fence at the base of the obelisk, and likely date to the same time period. A more modern “in memory of” stone is located here.

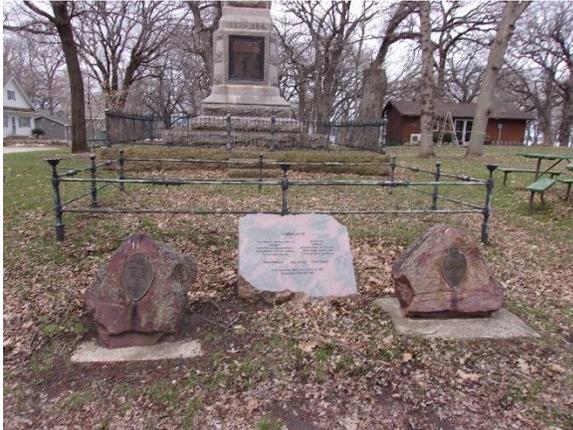
Figure 41 – DAR monuments

Two quartzite boulders on concrete pads, with bronze plaques. These are in good condition.

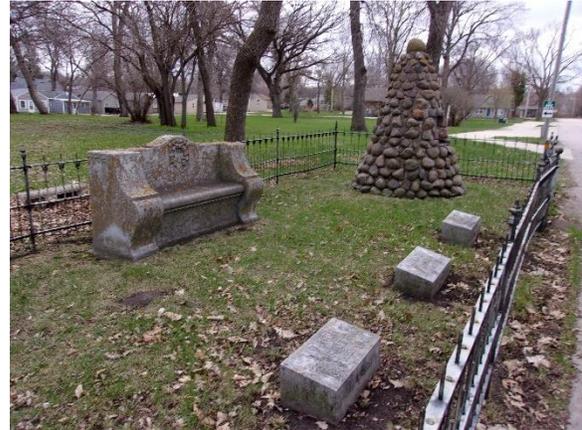
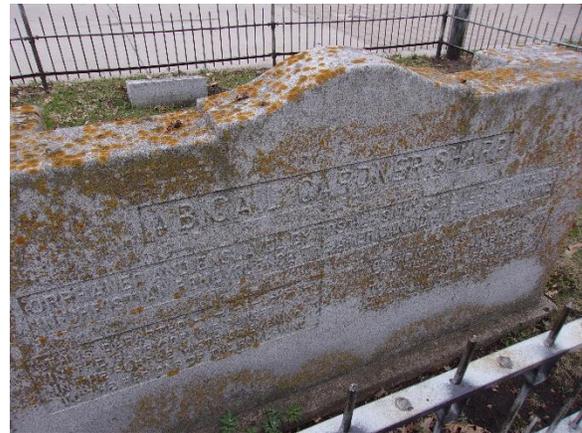
Figure 42 – Family cemetery

These are in good condition, with significant lichen in some locations, making the inscriptions hard to read.

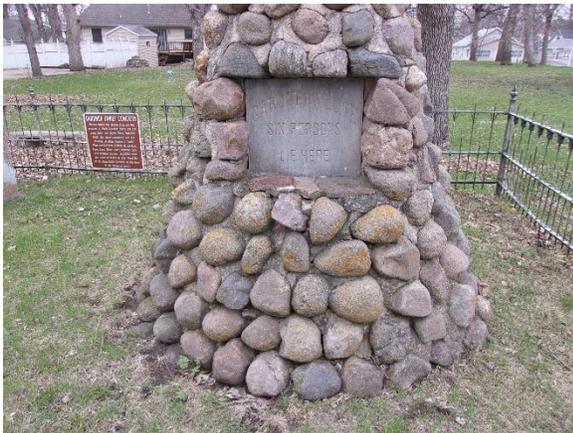
Figure 43 – cairn detail

The cairn appears to have high strength mortar with exposed aggregate. Some of the mortar is missing, near the base.
