Limited Asbestos & Lead-Based Paint Inspection Report

Clarinda Correctional Facility

Phase 1 – Main Building

June 11, 2020

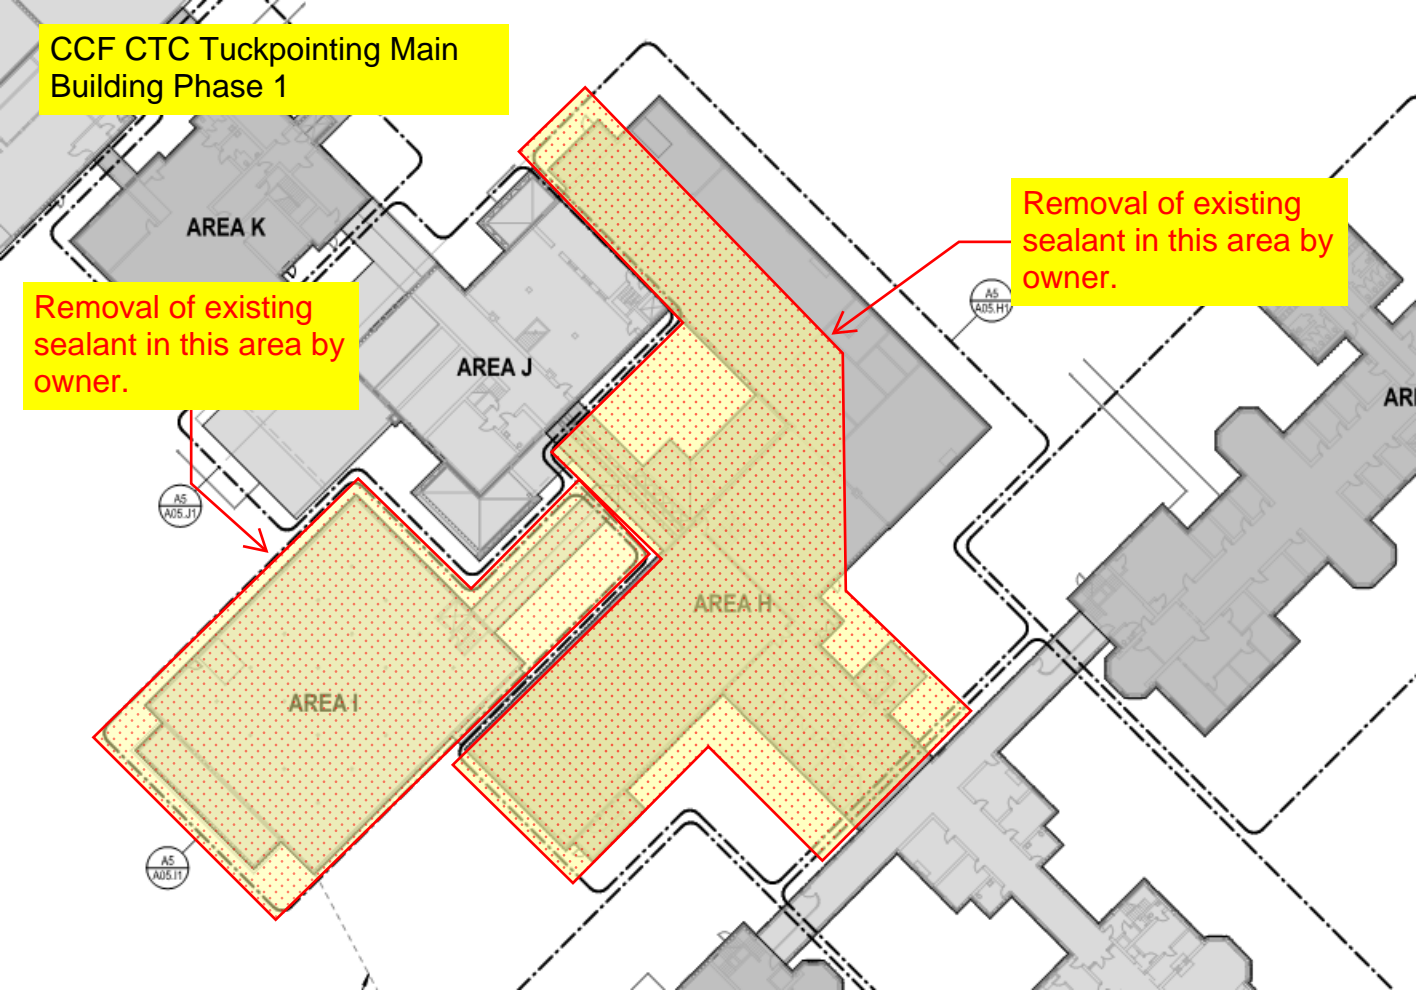
Removal of existing sealant in this area by owner.

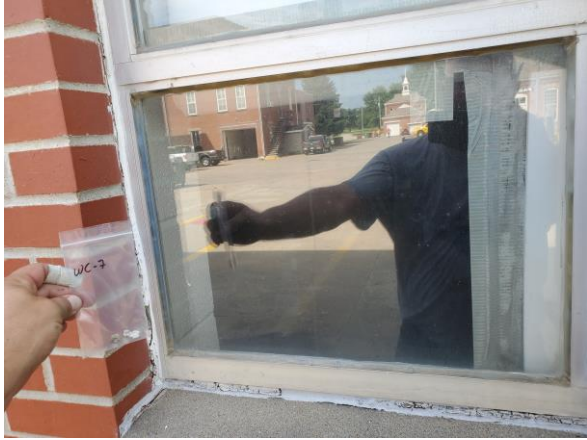
Sample Number	Material Description	Material Location	Asbestos Content
WC-7	Window Caulk (white/tan)	Area I (receiving) – Around Windows throughout the Building	2.4% Chrysotile
WC-8	Window Caulk (white)	Area H – Around Windows throughout the Building	4.9% Chrysotile

Photo #1 Sample WC-7. Asbestos Containing White/Tan Window Caulk Around Windows of Area I Building (receiving).

- A. Existing sealant at area H and area I shall be removed/abated by the owner. See attached plan view for area of sealant removal by owner.
- B. Lead paint is noted to be present throughout the building on window components. Contractors shall minimize disturbing the lead paint and follow OSHA regulations while working around window areas.

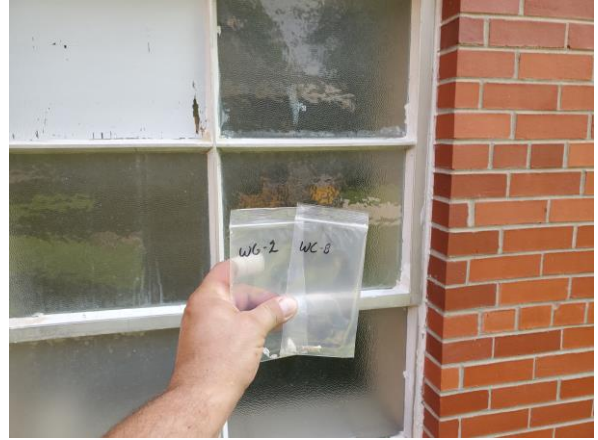
Lab No.: 7018126(L2) **Analyst Observation:** Tan Caulk **Location:** Area M-South Side
Client No.: WC-8 **Client Description:** Window Caulk (White) **Facility:**
Percent Asbestos: **Percent Non-Asbestos Fibrous Material:** **Percent Non-Fibrous Material:**
PC 4.9 Chrysotile None Detected 95.1

Photo #2 Sample WC-8. Asbestos Containing White Window Caulk Around Window of Area H Building.
