HAZARDOUS BUILDING MATERIALS SURVEY REPORT

Elmcrest Building
1251 334th Street
Woodward, Iowa 50276

Atlas Project ID: 204BS06333

Re: Hazardous Building Materials Survey Report
Elmcrest Building
1251 334th Street
Woodward, Iowa 50276
Atlas Project Number: 204BS06333

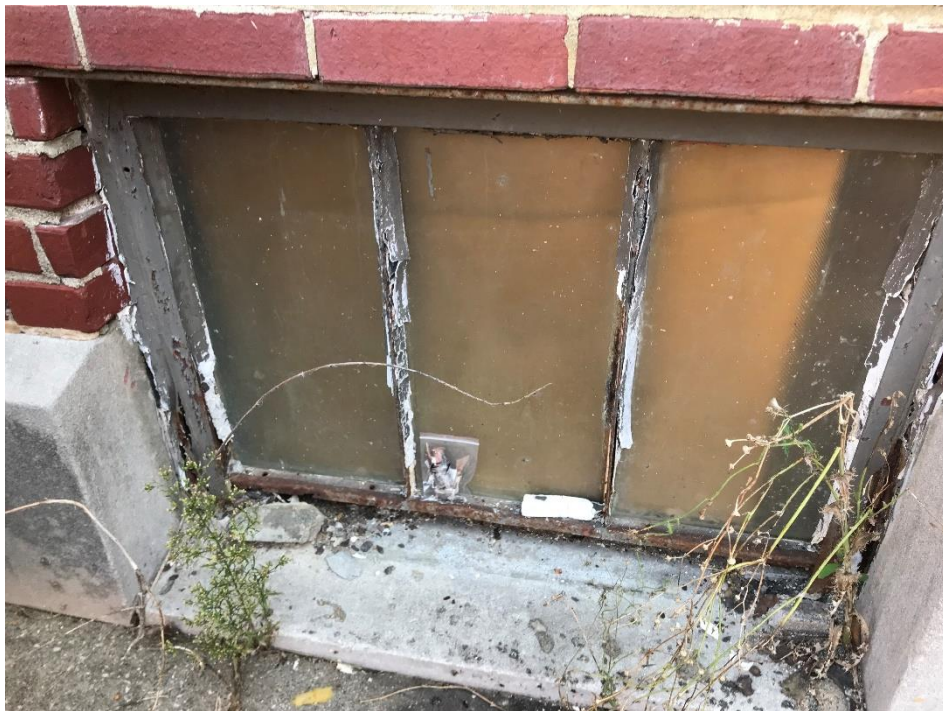
2

View of the Asbestos Containing Window Glazing. (E 1, 3% Chrysotile)

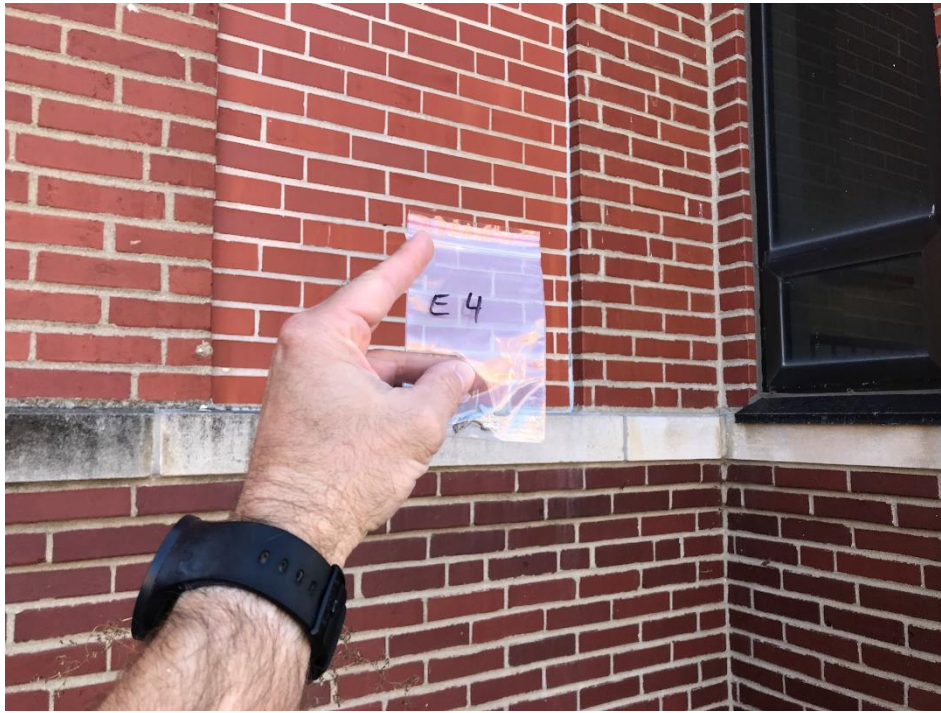
3

View of the Asbestos Containing Gray Caulk. (E 4, 4% Chrysotile)

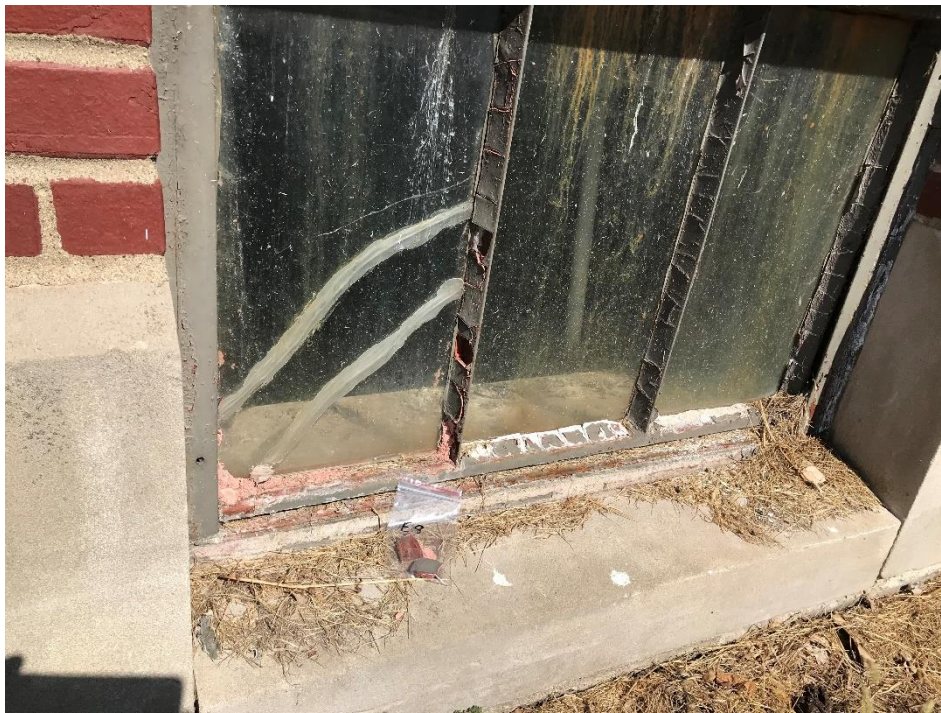
4

View of the Asbestos Containing Red Window Glazing. (E 8, 2% Chrysotile)

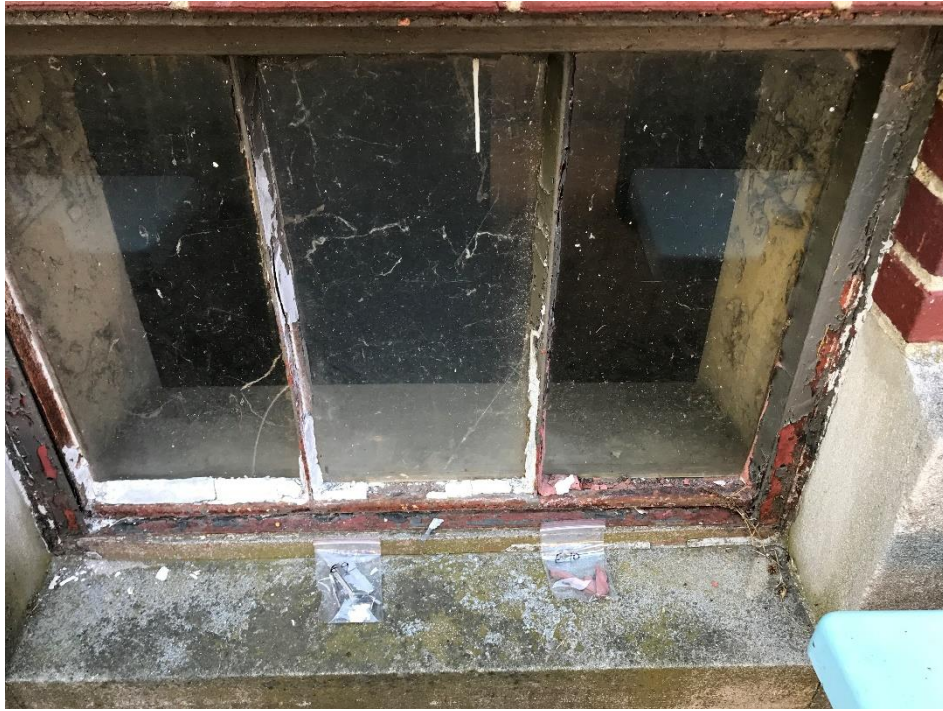
5

View of the Asbestos Containing Window Glazing. (E 9, 4% Chrysotile)

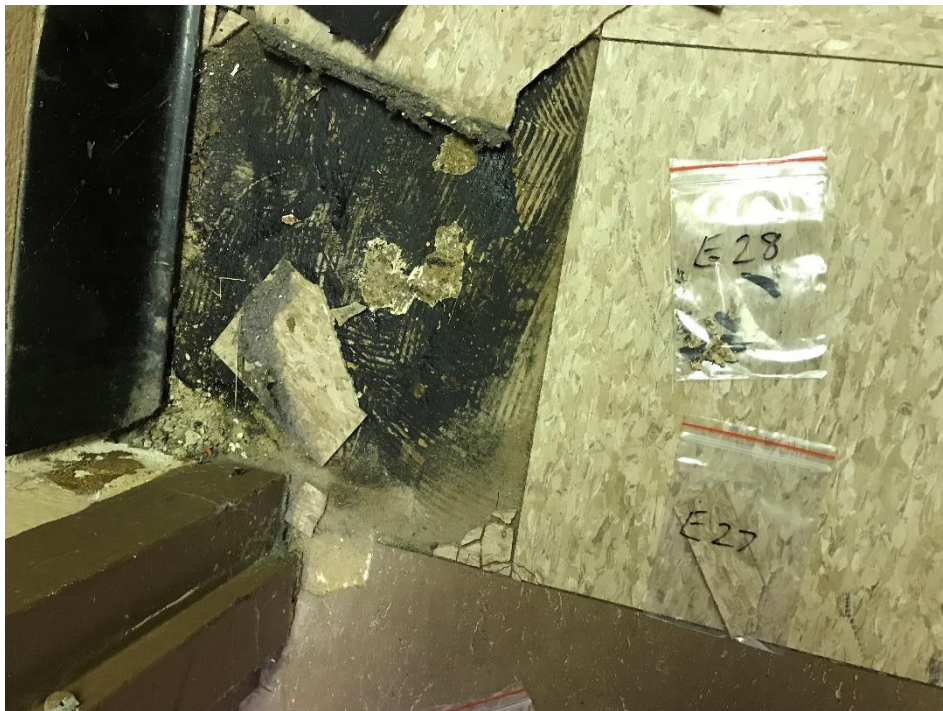
6

View of the Asbestos Containing Black Mastic and Gray Backing.
(E 28, 3% & 25% Chrysotile)

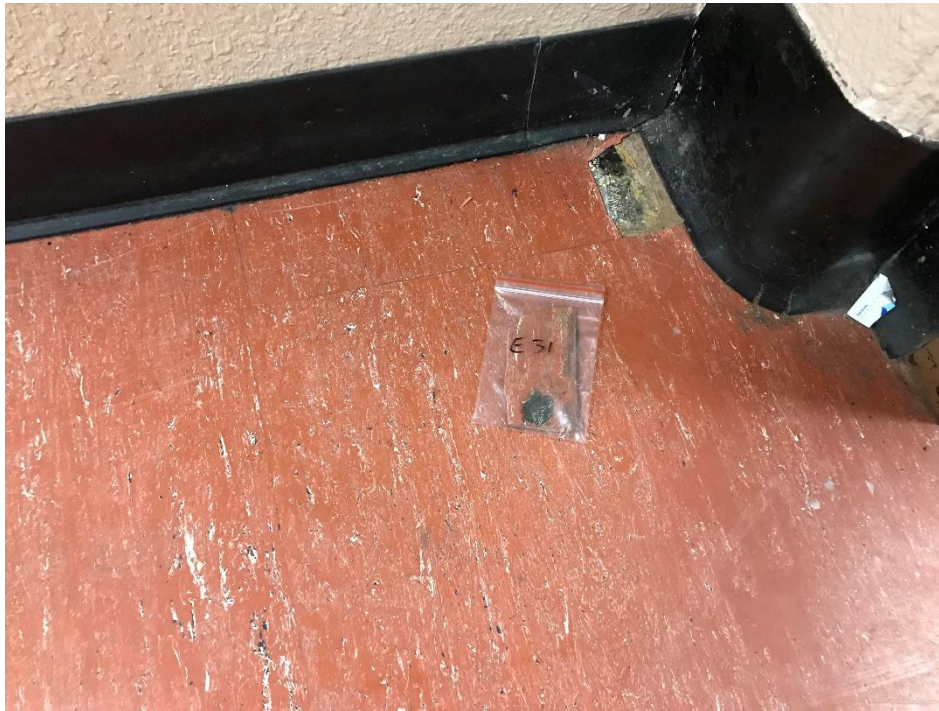
7

View of the Asbestos Containing Black/Yellow Mastic. (E 31, <1% Chrysotile)

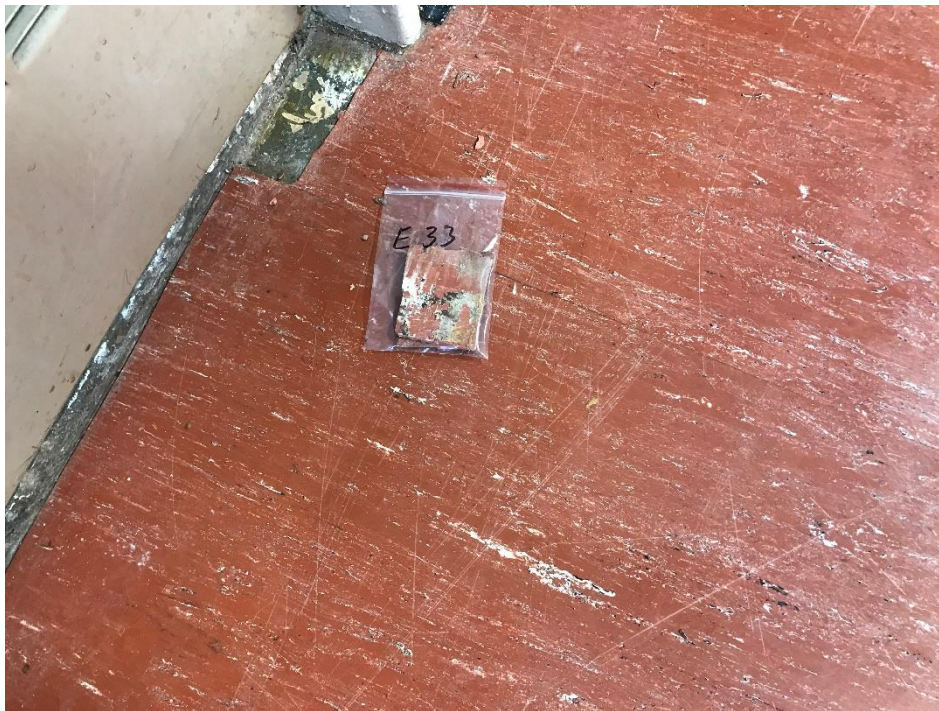
8

View of the Asbestos Containing Yellow/Black Mastic. (E 33, <1% Chrysotile)

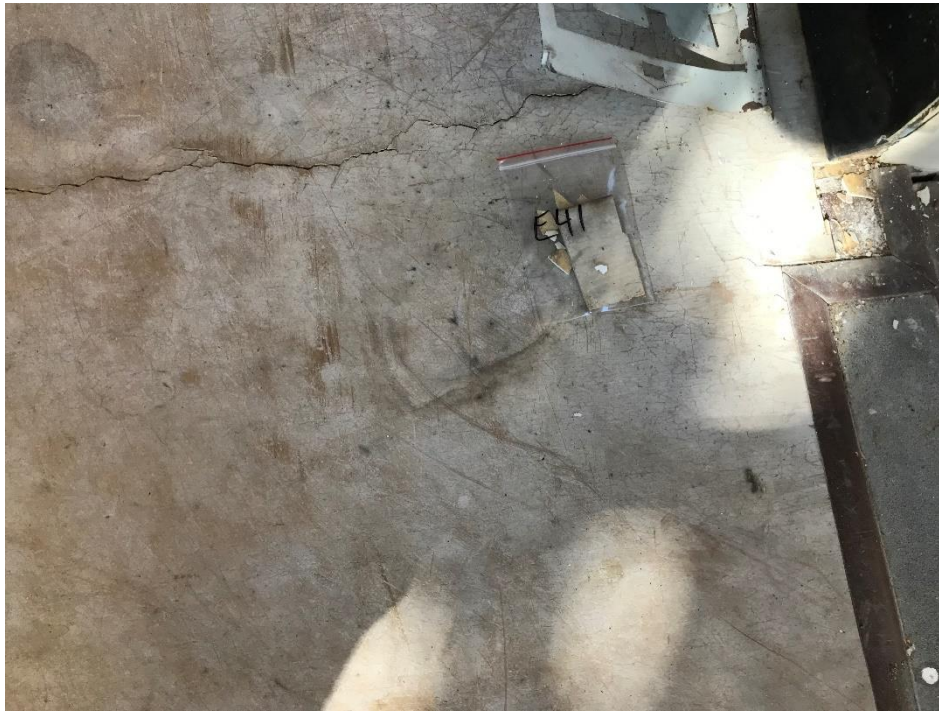
9

View of the Asbestos Containing Gray Backing (Under Lt Brown Flooring).
(E 41, 20% Chrysotile)

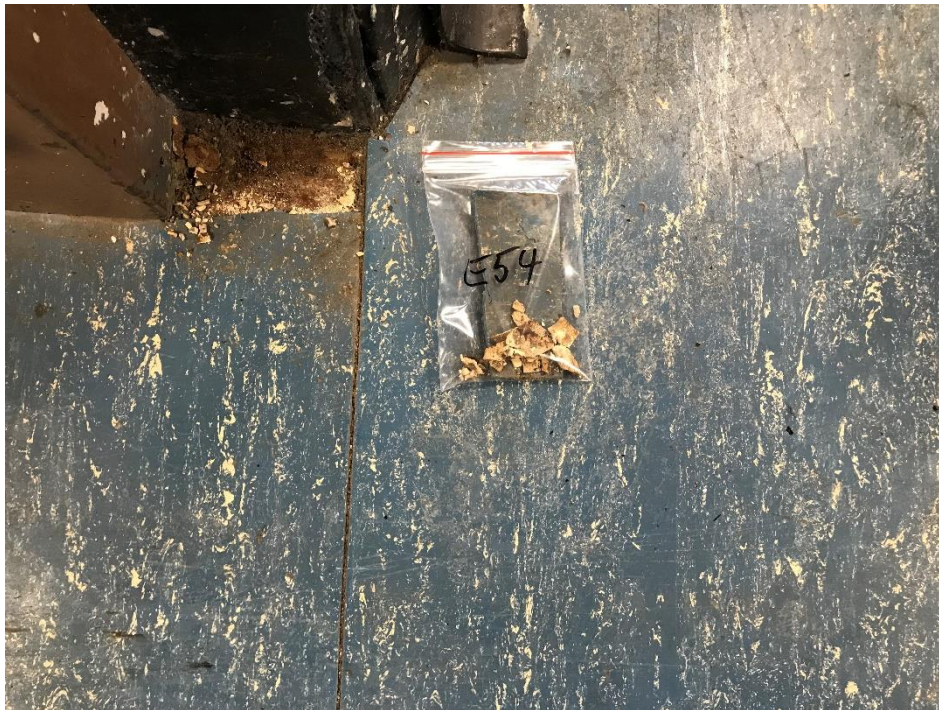
10

View of the Asbestos Containing Gray Backing. (Under Blue Flooring)
(E 54, 15% Chrysotile)

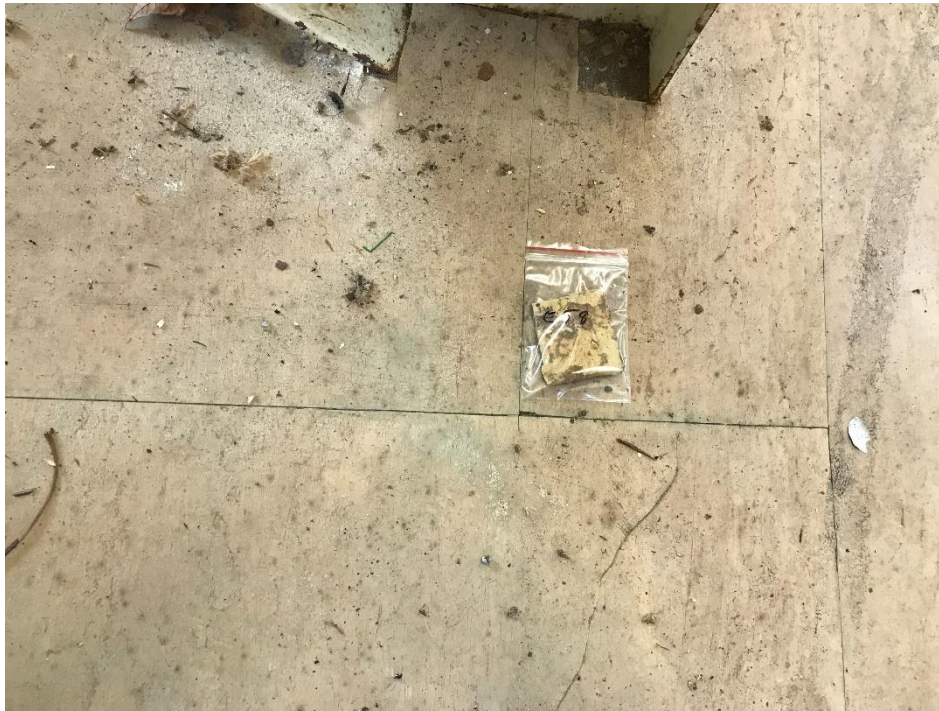
11

View of the Asbestos Containing Yellow/Brown Mastic & Gray Backing.
(Under Lt Brown Flooring) (E 58, 1% & 25% Chrysotile)

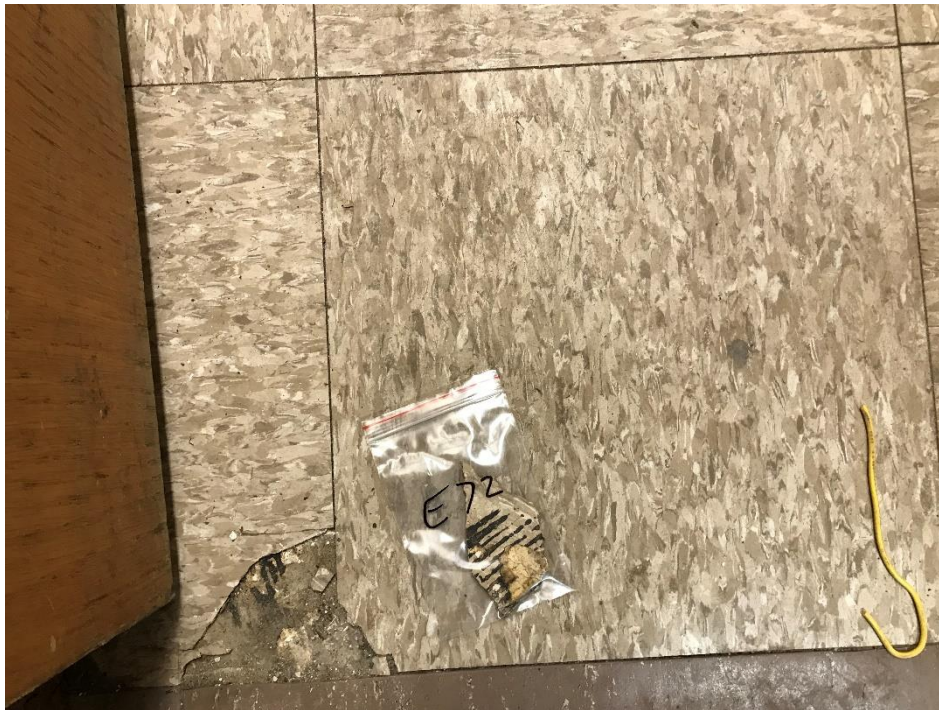
12

Black Mastic	1 st Floor Janitor Closet Under 12"x12" Brown VFT	E 72	60 SQFT	4% Chrysotile

View of the Asbestos Containing Black Mastic. (E 72, 4% Chrysotile)

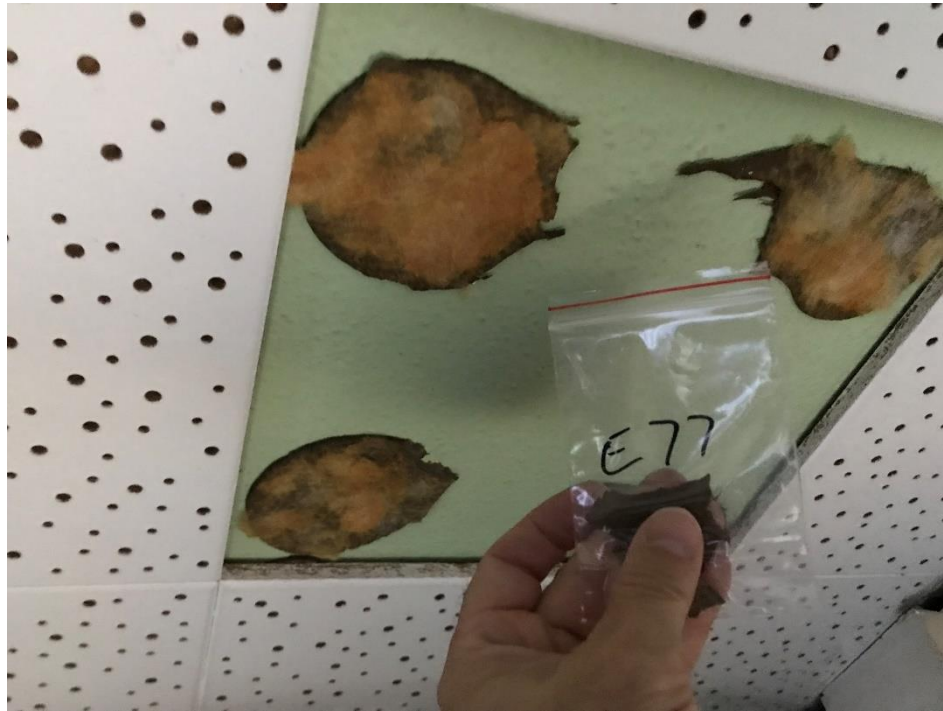
13

View of the Asbestos Containing Brown Pucks. (E 77, 4% Chrysotile)

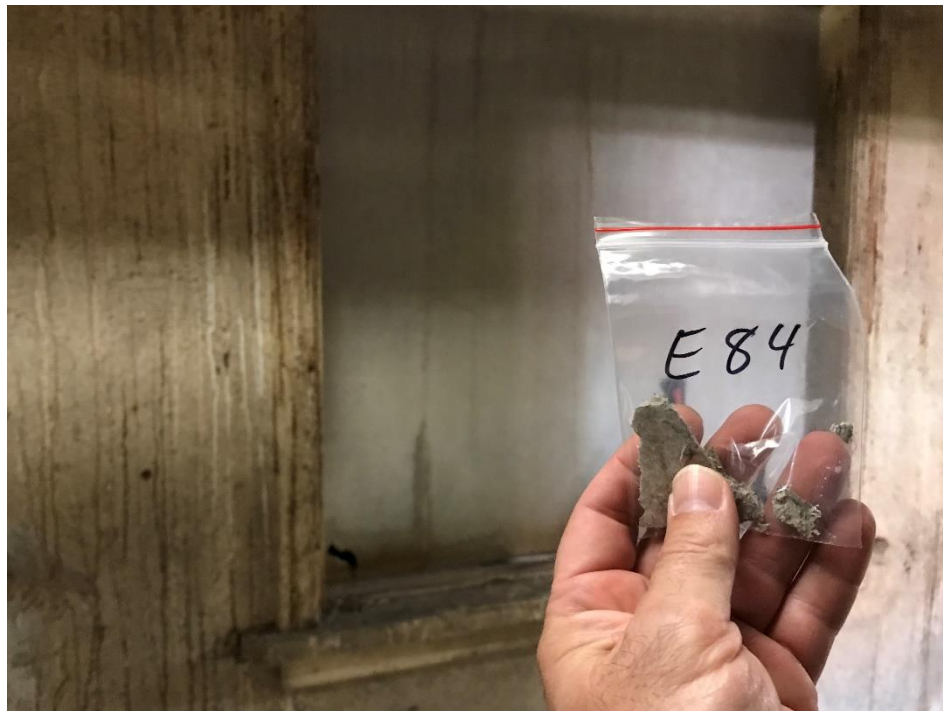
14

View of the Asbestos Containing Transite Panes. (E 84, 20% Chrysotile)

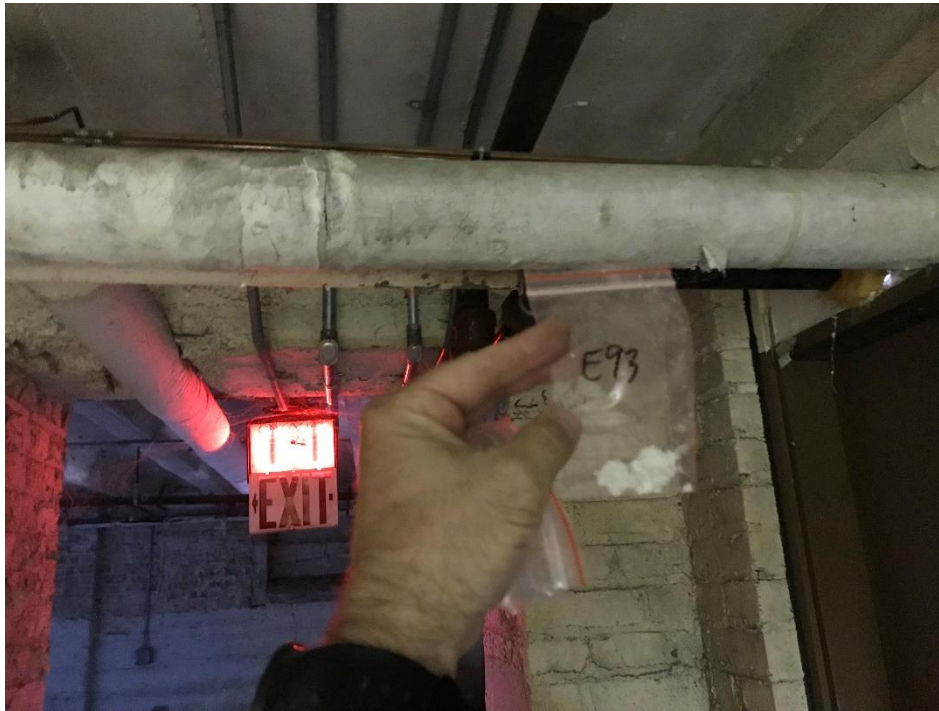
15

View of the Asbestos Containing TSI Run. (E 93, 15% Amosite & 20% Crocidolite)

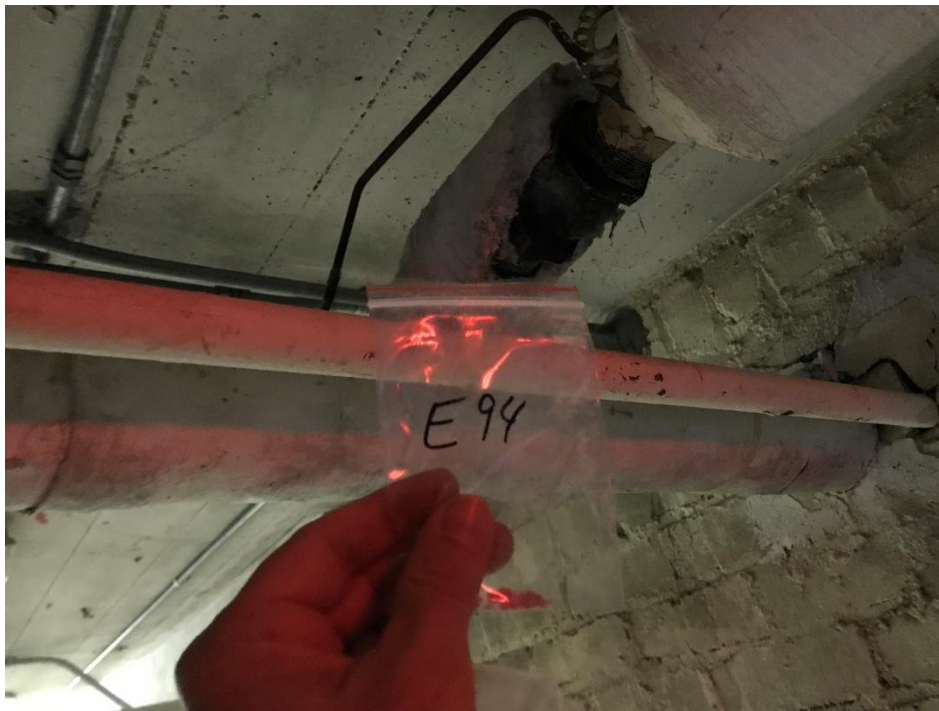
16

View of the Asbestos Containing TSI Elbow. (E 94, 20% Chrysotile)

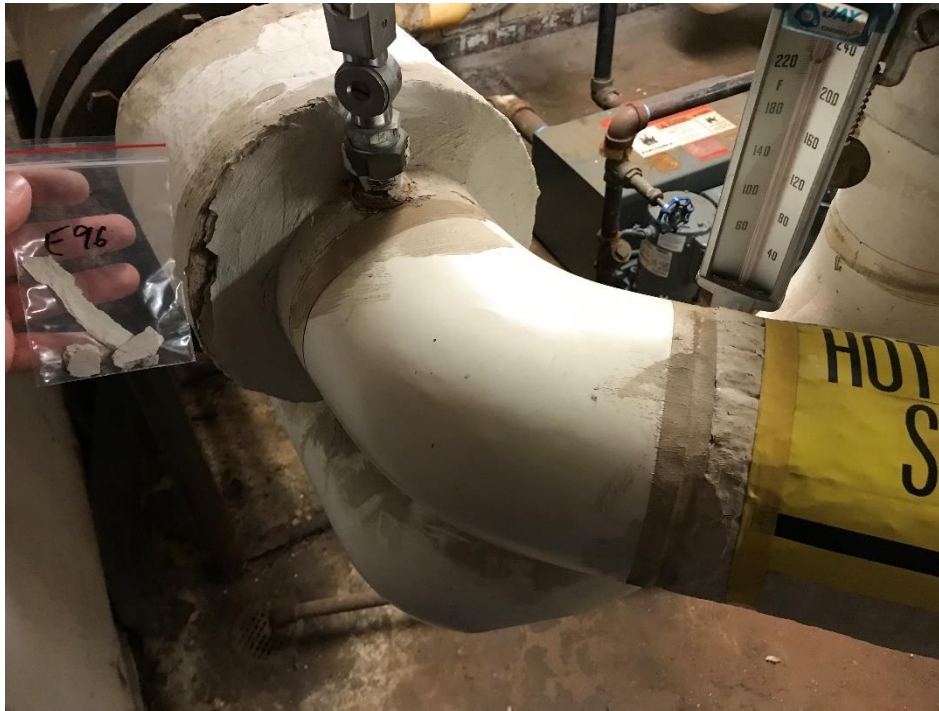
17

View of the Asbestos Containing Caulk. (E 96, 3% Chrysotile)

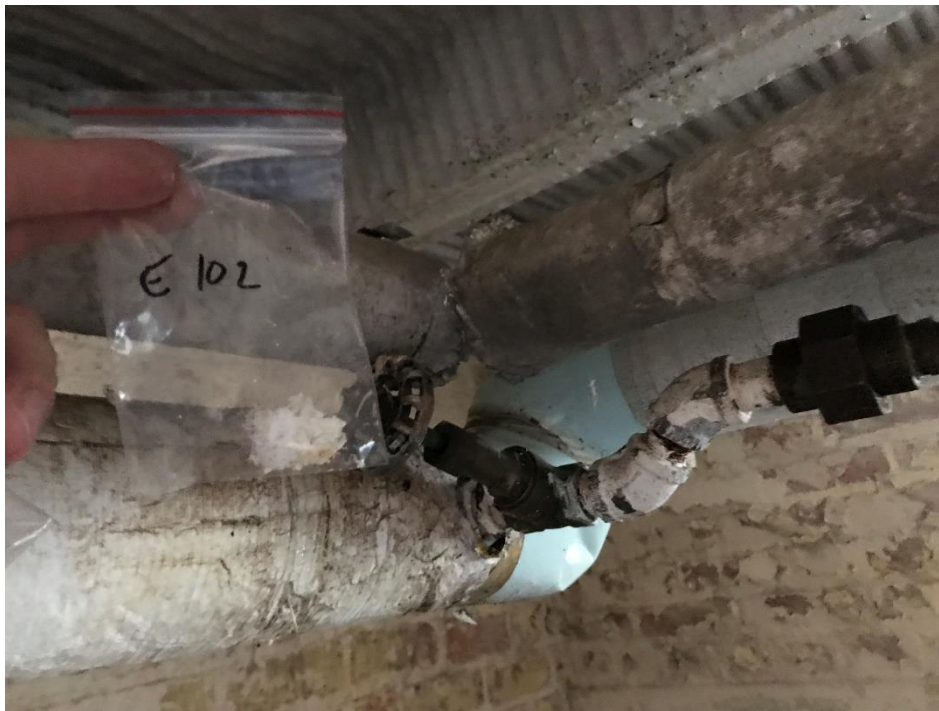
18

View of the Asbestos Containing TSI Elbow. (E 102, 15% Amosite & 20% Chrysotile)

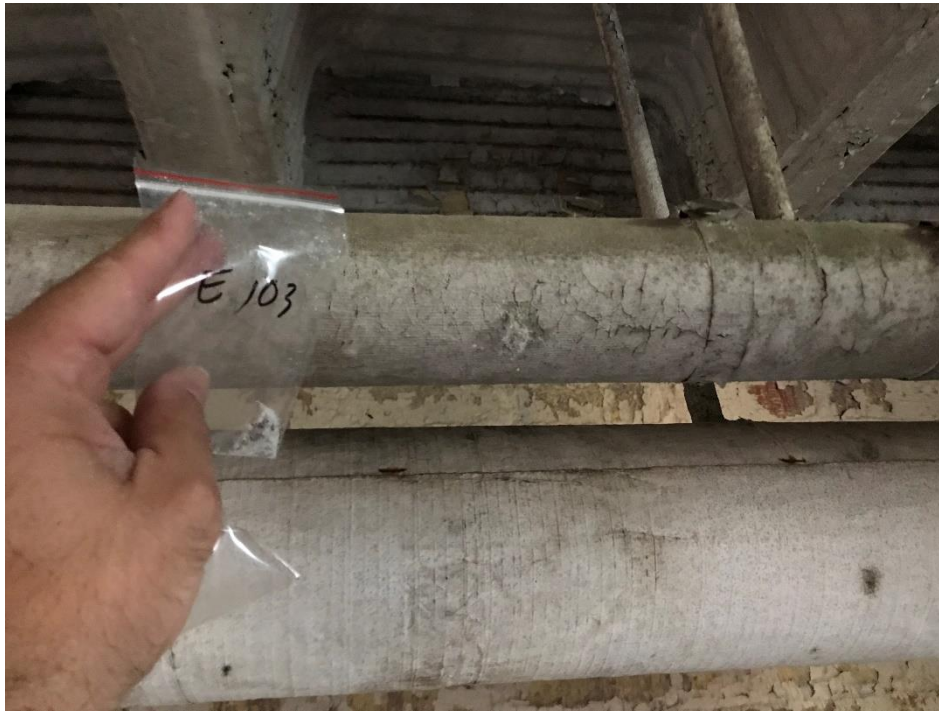
View of the Asbestos Containing TSI Run. (E 103, 10% Amosite & 10% Chrysotile)

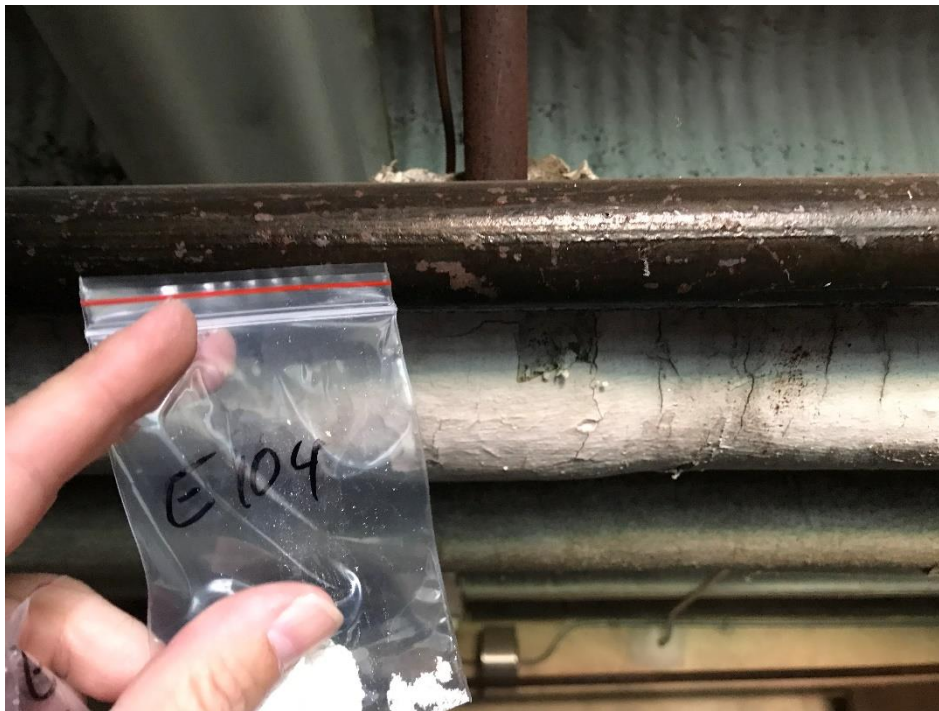
View of the Asbestos Containing TSI Elbow. (E 104, 85% Chrysotile)

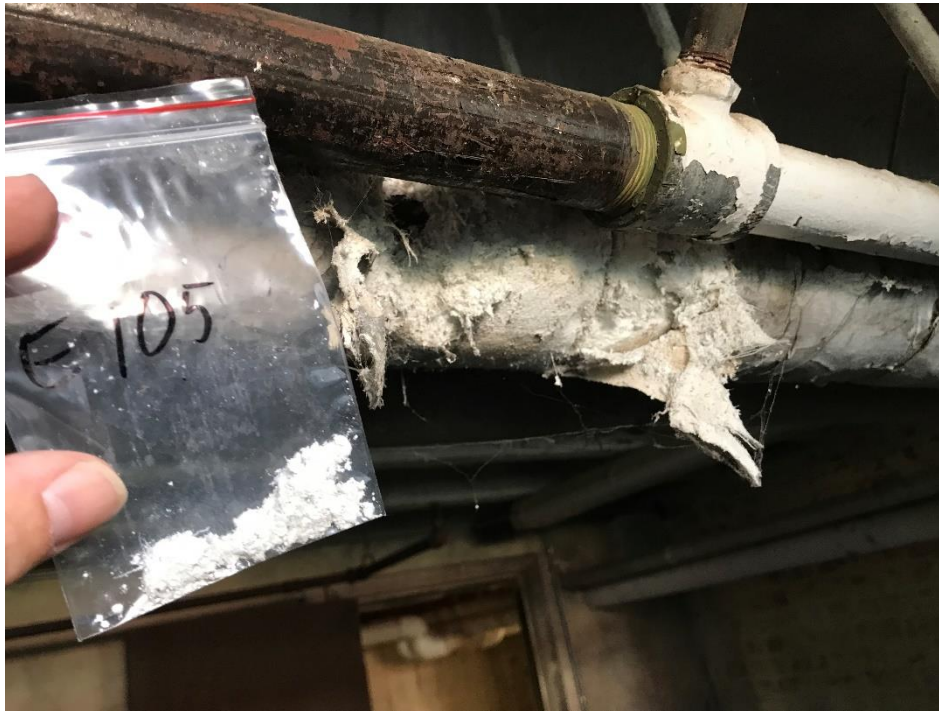
View of the Asbestos Containing TSI Run. (E 105, 35% Amosite & 15% Crocidolite)

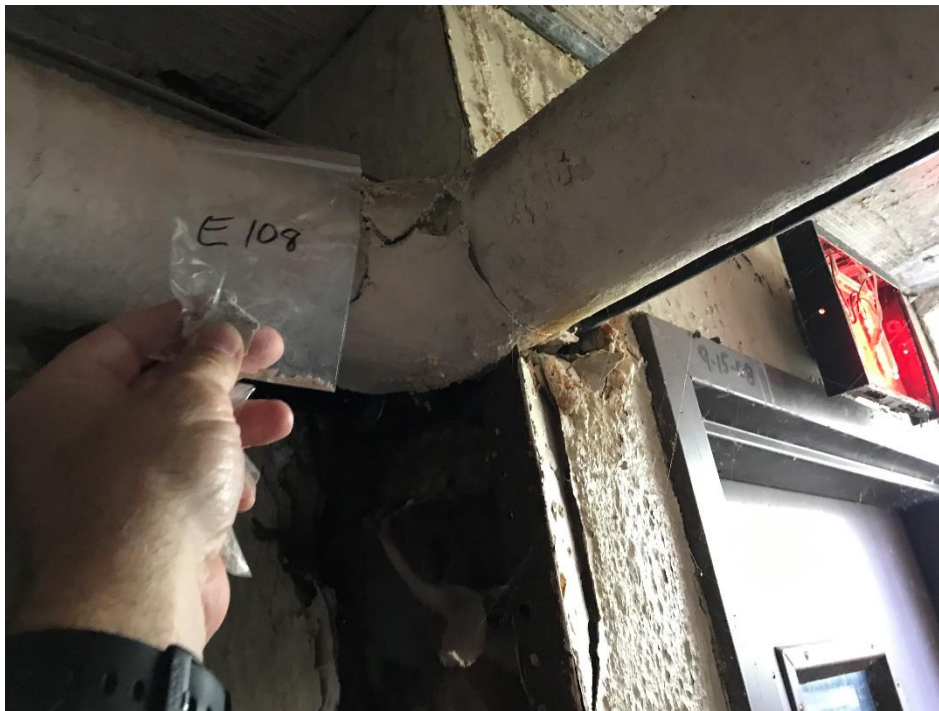
View of the Asbestos Containing TSI Elbow & Texture. (E 108, 55% & 2% Chrysotile)

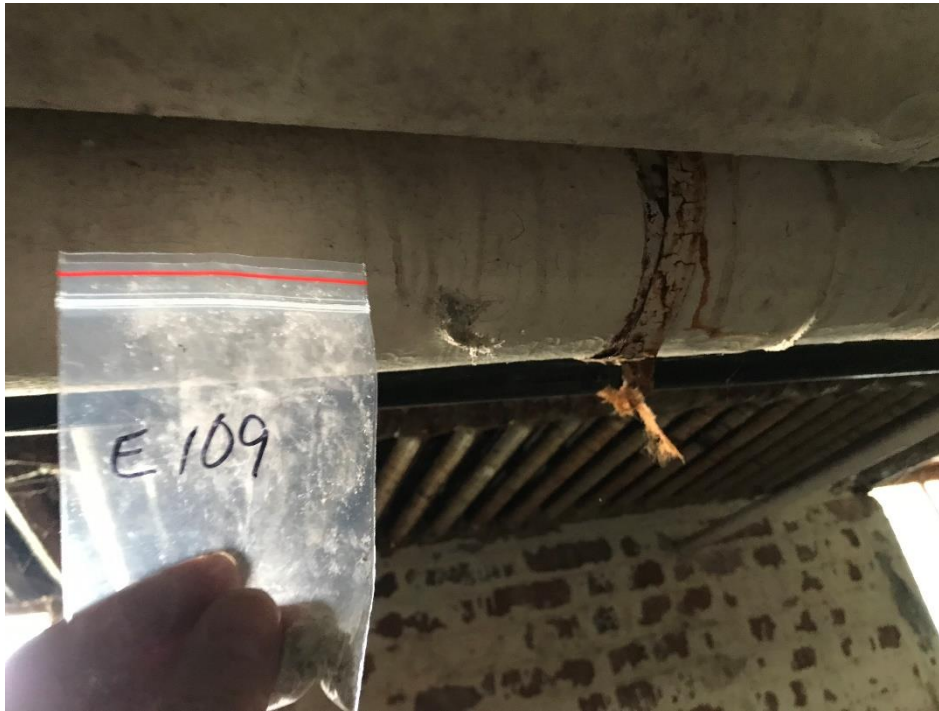
View of the Asbestos Containing TSI Run. (E 109, 30% Amosite & 15% Crocidolite)

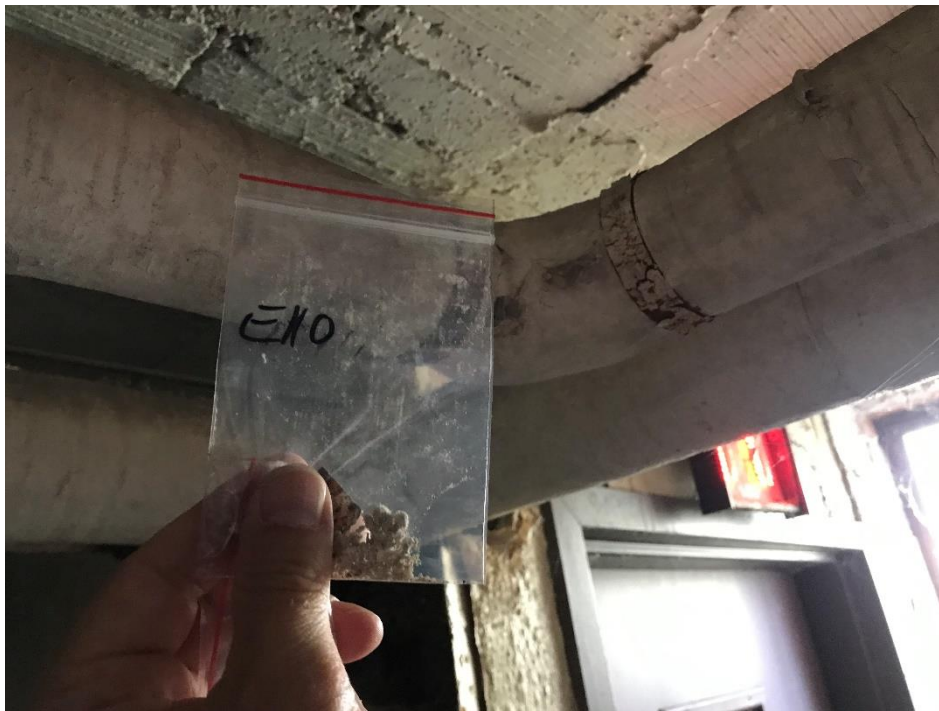
TSI Elbow Sm Insulation & Texture	Basement N Wing N Room	E 110	10 Elbows	60% Chrysotile
TSI Run Sm	Basement N Wing N Room	E 111	150 LF	5% Amosite 35% Crocidolite
TSI Elbow Sm Insulation & Texture	Basement W Wing	E 112	14 Elbows	15% Amosite 25% Chrysotile 30% Crocidolite & 2% Amosite 4% Crocidolite
TSI Run Sm	Basement W Wing	E 113	160 LF	15% Amosite 30% Crocidolite

View of the Asbestos Containing TSI Elbow & Texture. (E 110, 60% & ,1% Chrysotile)

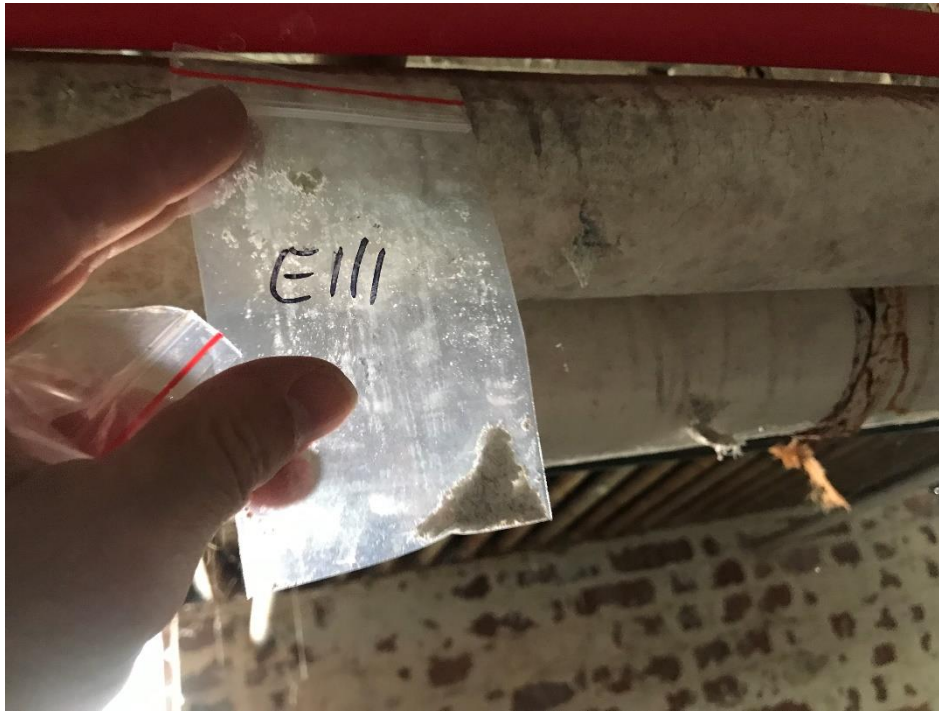
View of the Asbestos Containing TSI Run. (E111, 5% Amosite & 35% Crocidolite)

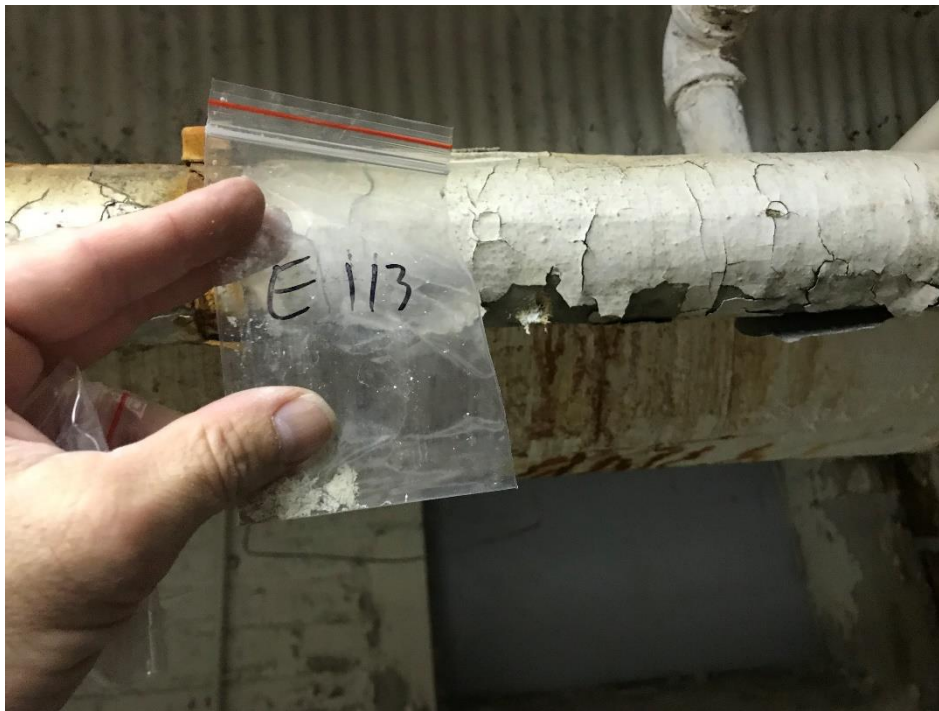
View of the Asbestos Containing TSI Run. (E 113, 15% Amosite 30% Crocidolite)

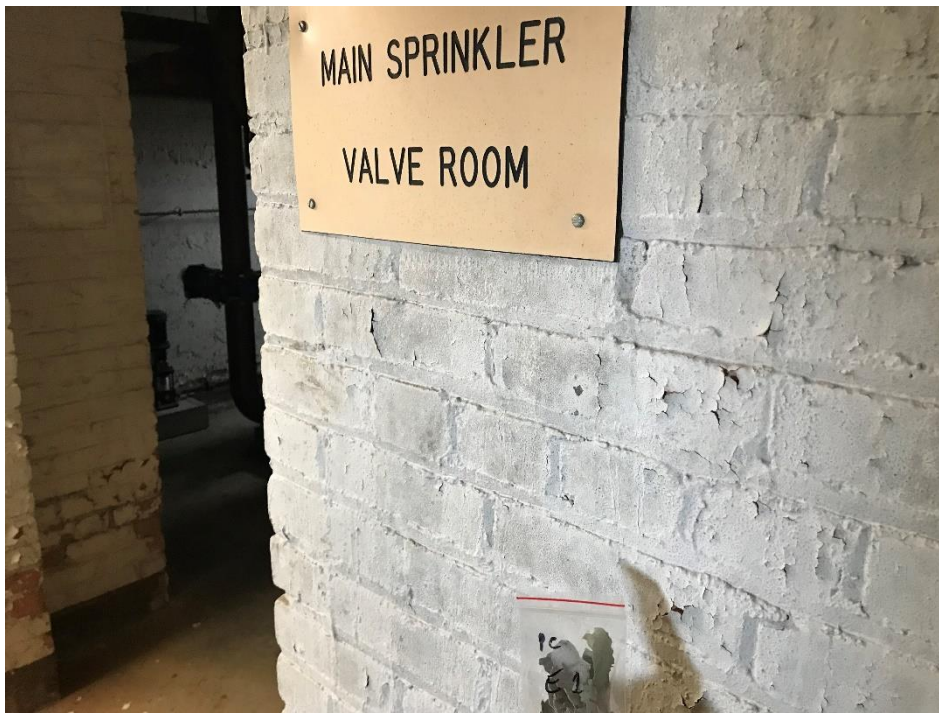
2

View of the White Lead Containing Paint. (PC E 1, 0.48% Pb)

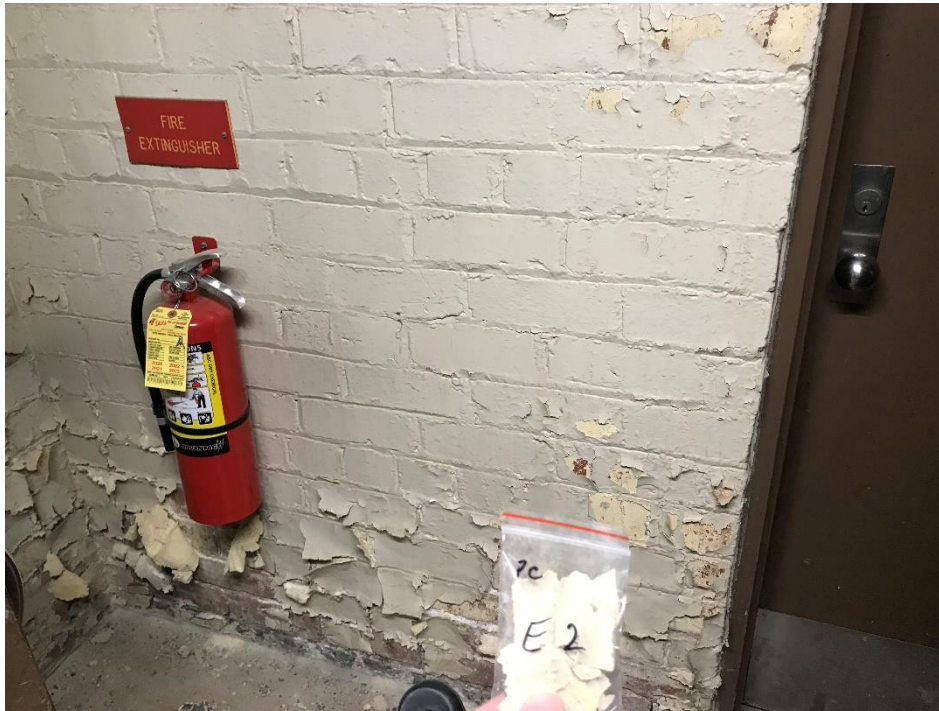
3

View of the Dull Green Lead Containing Paint. (PC E 2, 0.15% Pb)

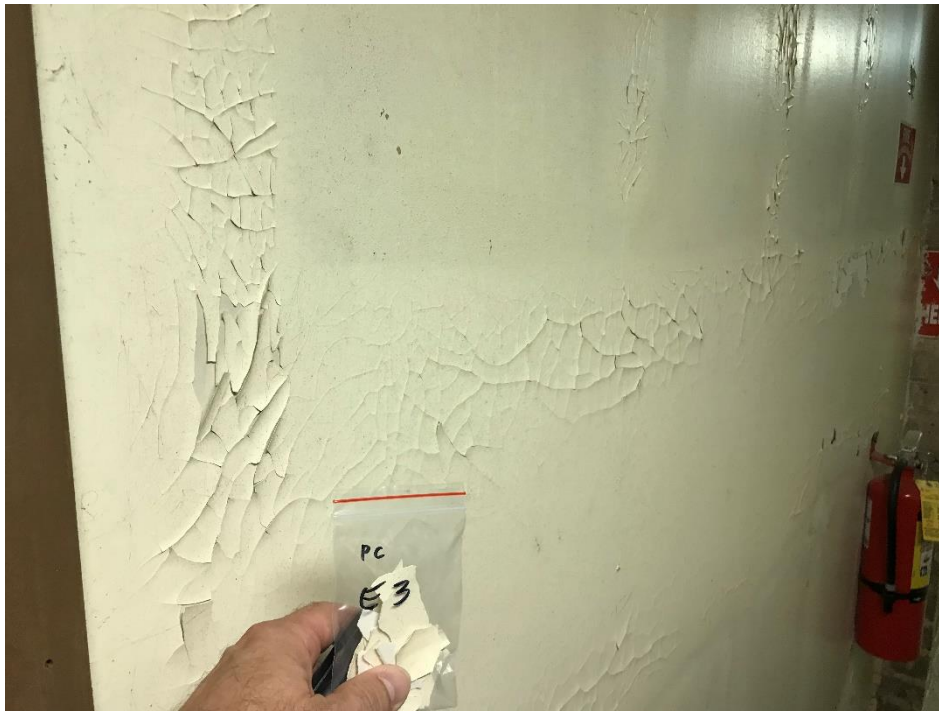
4

View of the Dull Pale Yellowish White Lead Containing Paint. (PC E 3, 0.027% Pb)

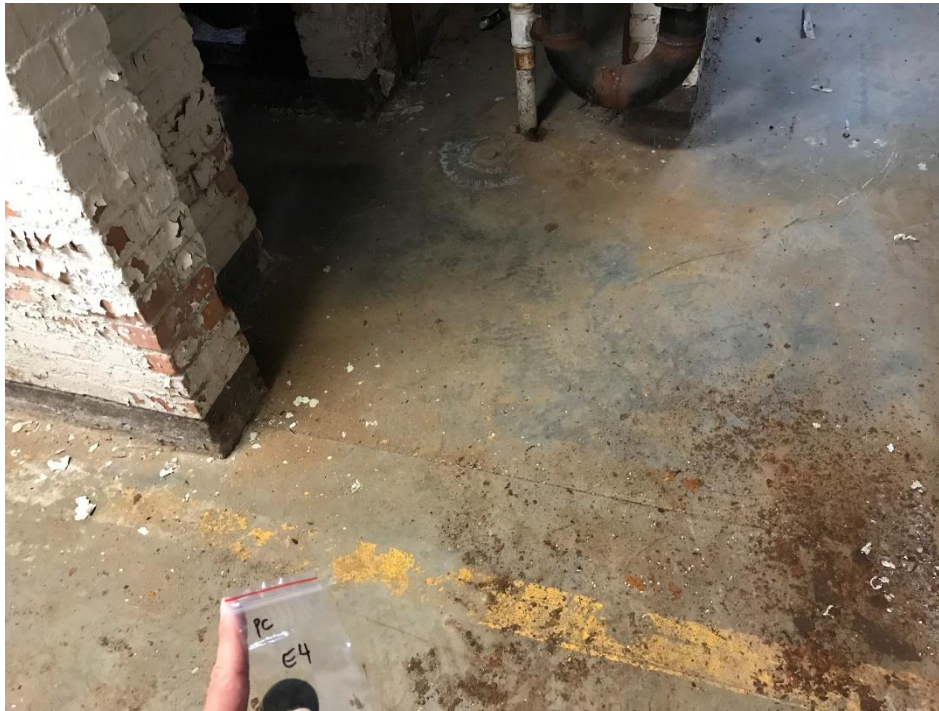
5

View of the Yellow Lead Based Paint. (PC E 4, 18% Pb)

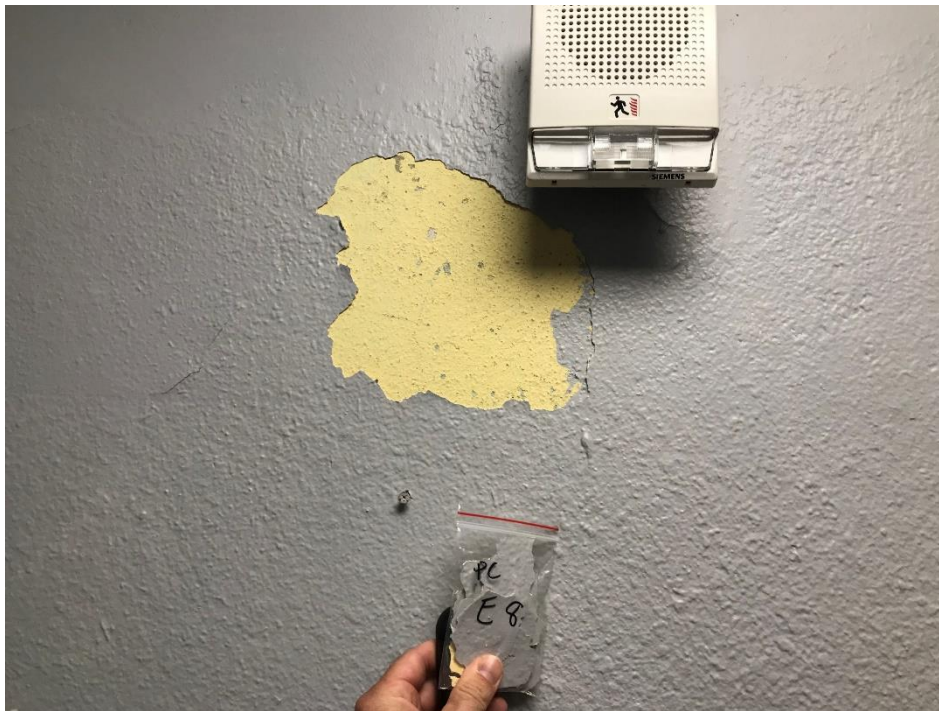
6

View of the Light Gray Lead Containing Paint. (PC E 8, 0.012% Pb)

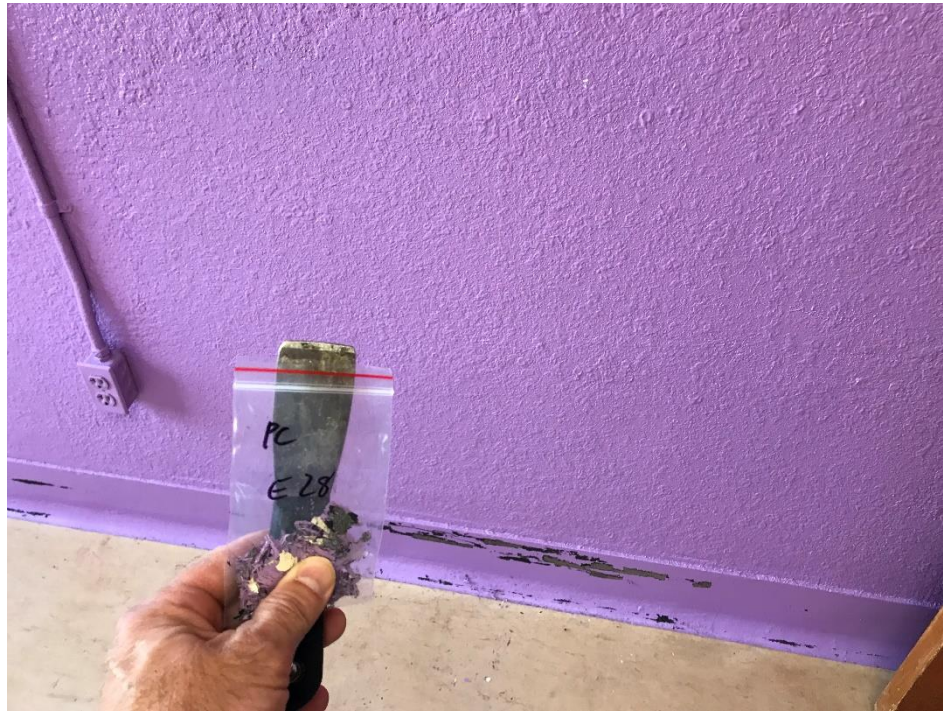
7

View of the Lavender Lead Containing Paint. (PC E 28, 0.059% Pb)

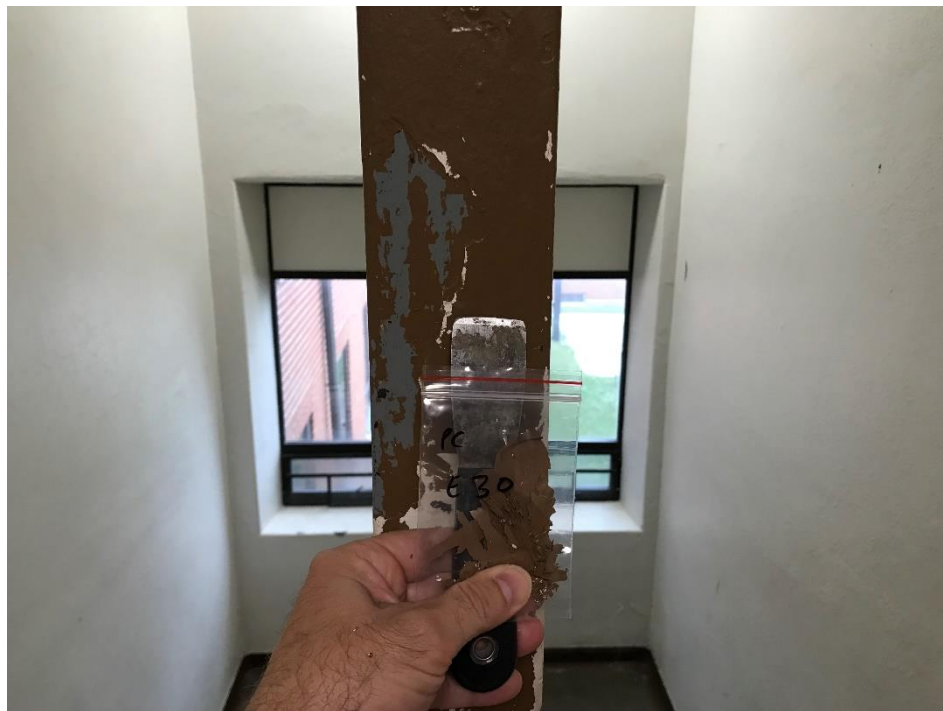
8

View of the Brown Lead Containing Paint. (PC E 30, 0.11% Pb)

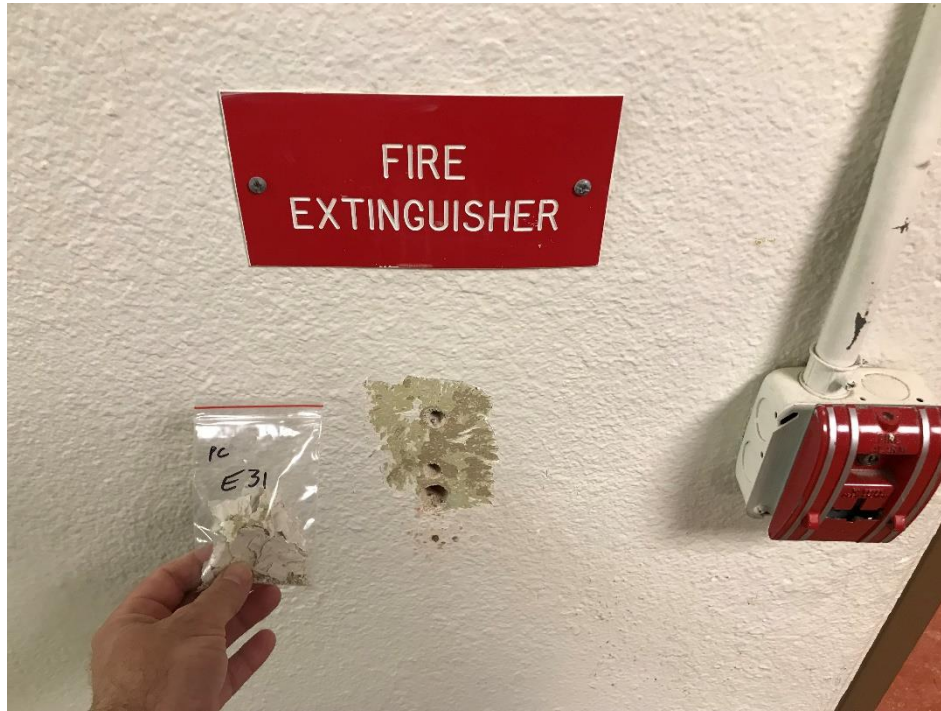
9

View of the White Lead Based Paint. (PC E 31, 1.7% Pb)
