HAZARDOUS BUILDING MATERIALS SURVEY REPORT

Elmcrest Building
1251 334th Street
Woodward, Iowa 50276

Atlas Project ID: 204BS06333

Re: Hazardous Building Materials Survey Report
Elmcrest Building
1251 334th Street
Woodward, Iowa 50276
Atlas Project Number: 204BS06333

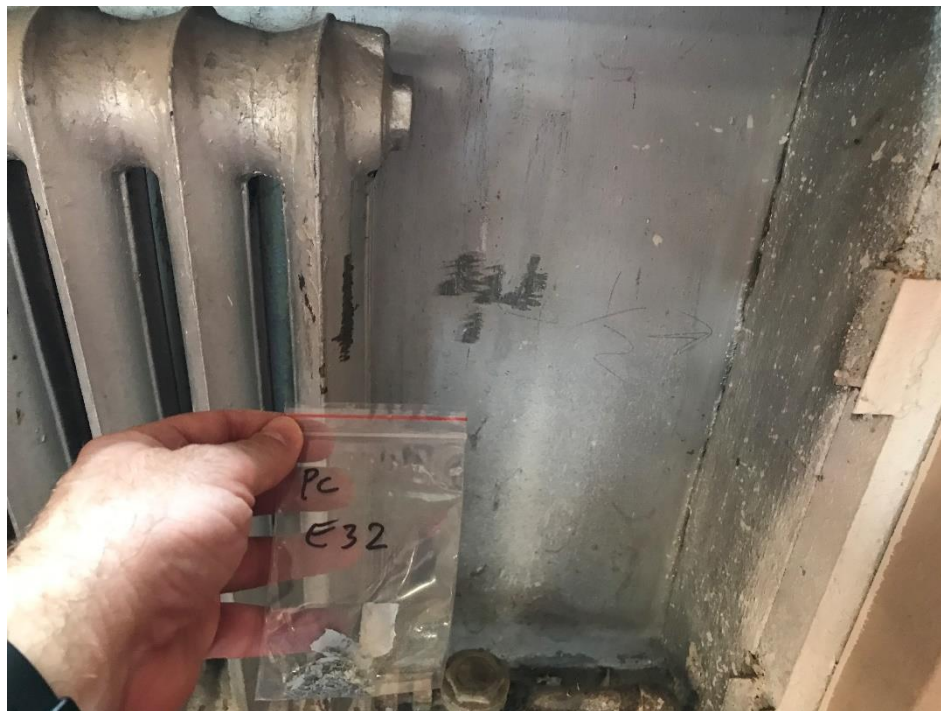
10

View of the Silver Lead Containing Paint. (PC E 32, 0.22% Pb)

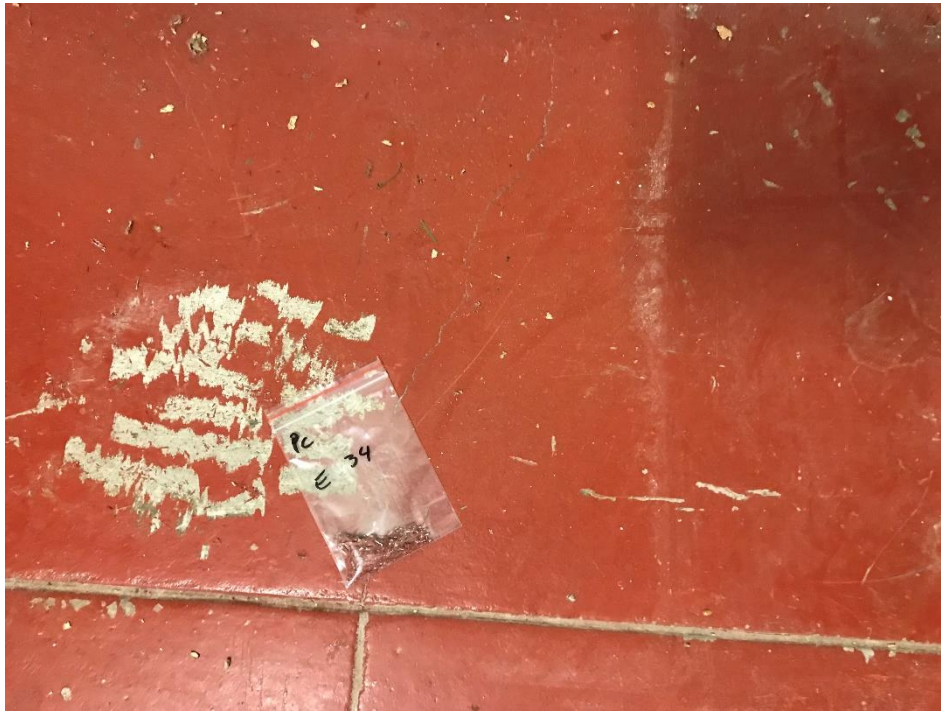
11

View of the Red Lead Based Paint. (PC E 34, 0.79% Pb)

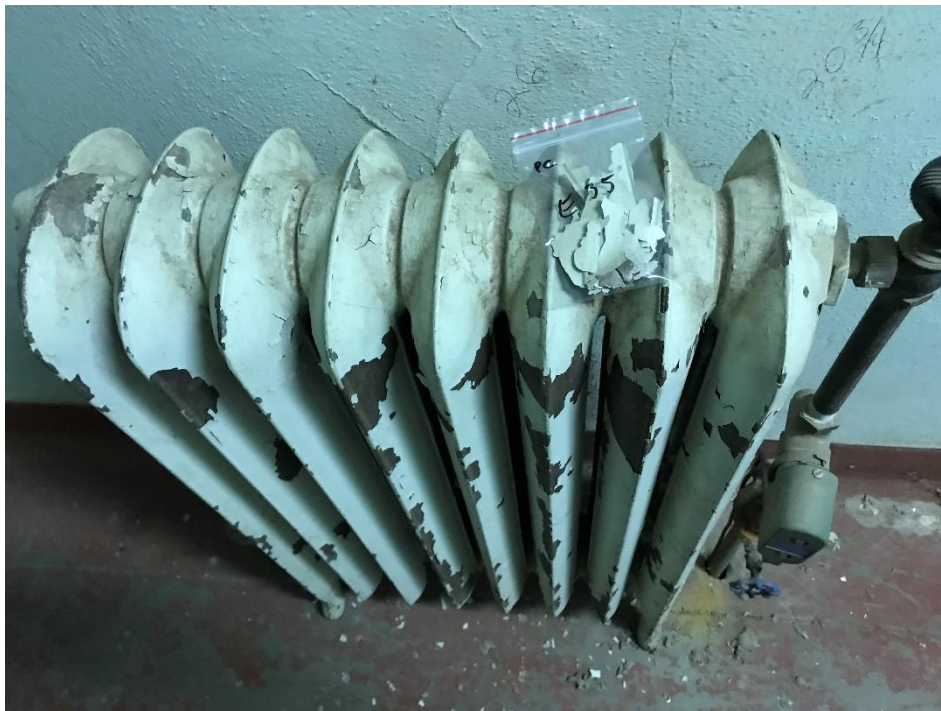
12

View of the Light Green Lead Containing Paint. (PC E 35, 0.36% Pb)

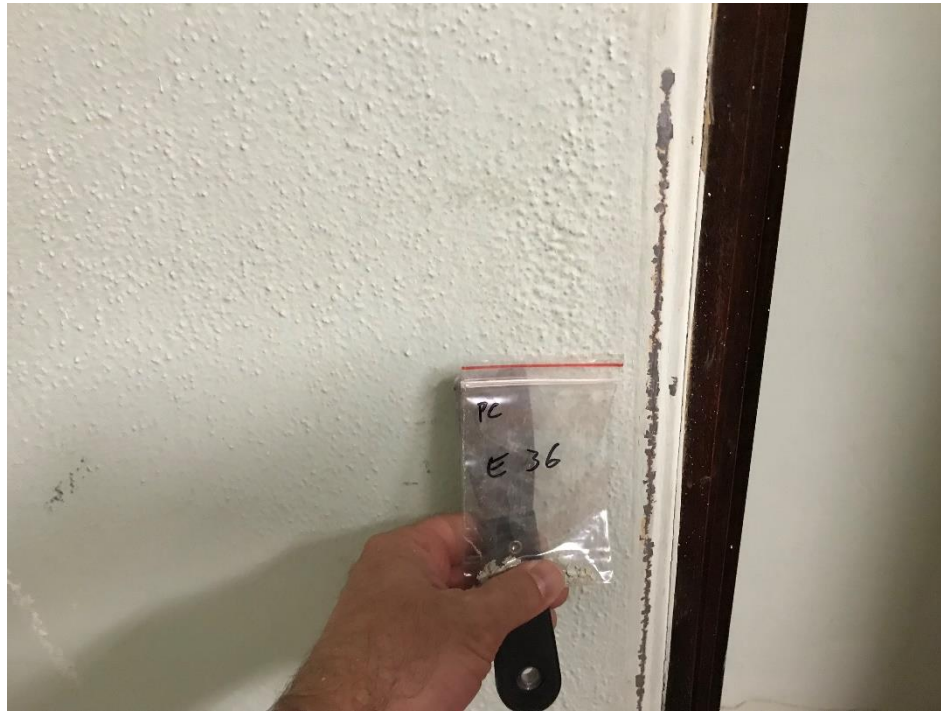
13

View of the Light Green Lead Based Paint. (PC E 36, 16% Pb)

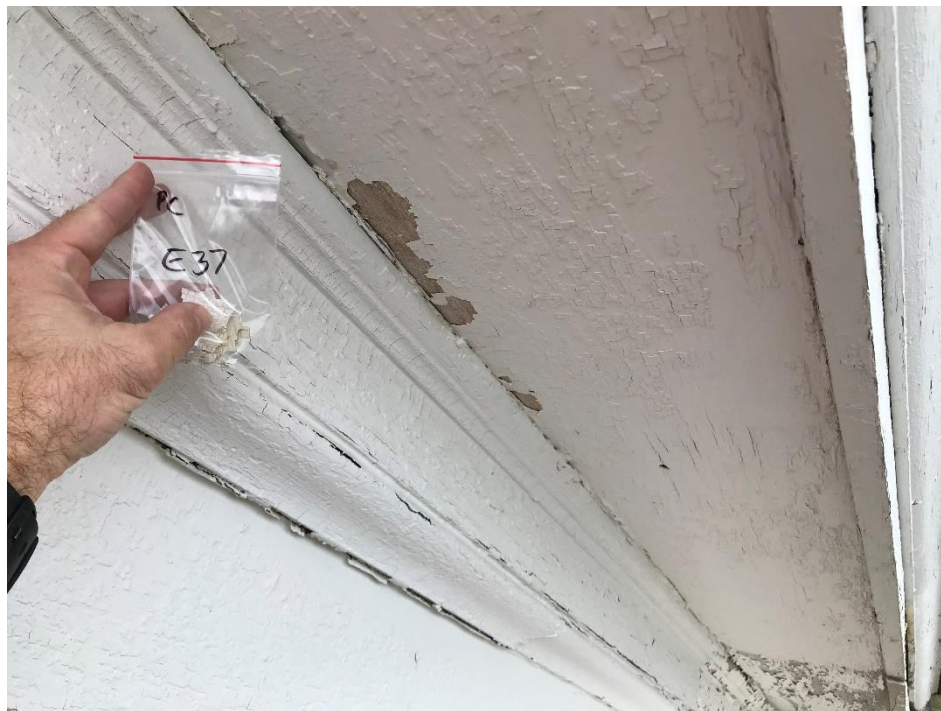
14

View of the White Lead Based Paint. (PC E 37, 28% Pb)
