HAZARDOUS BUILDING MATERIALS SURVEY REPORT

Medical Center
1251 334th Street
Woodward, Iowa 50276

Report Date: November 9, 2023

Atlas Project ID: 204BS06333

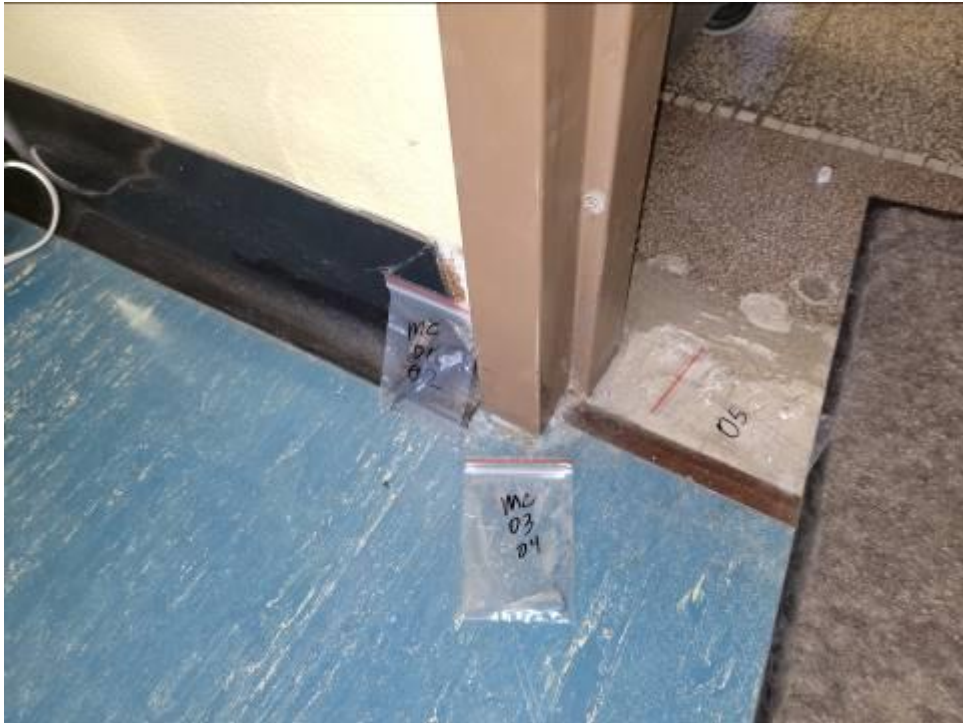
2

View of Blue Laminate Flooring (3% Chrysotile)

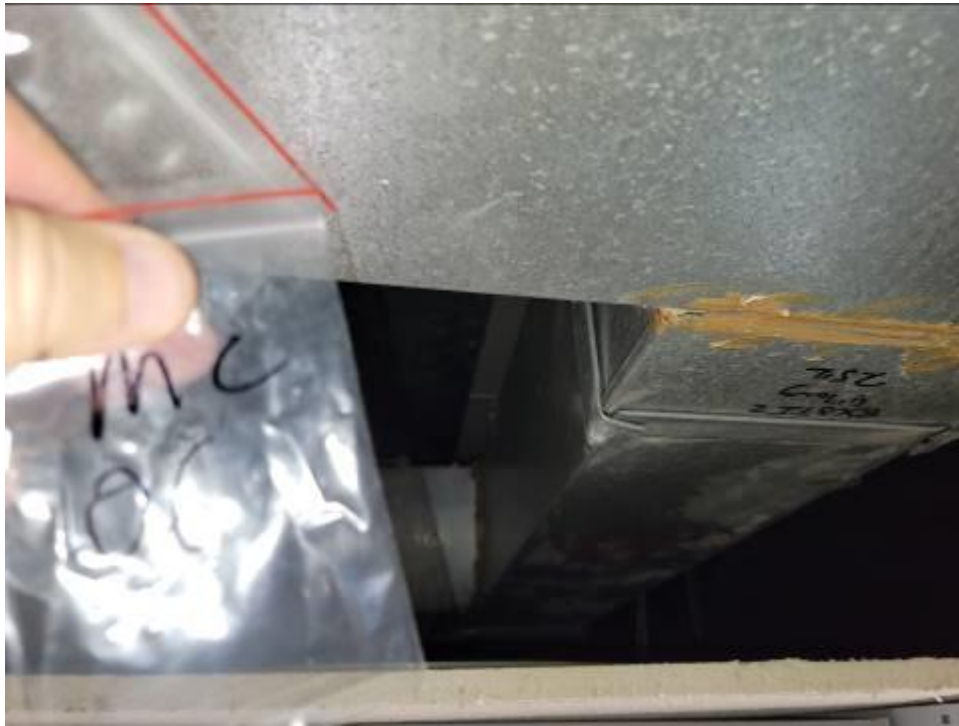
3

View of Tan Duct Sealant (2% Chrysotile)

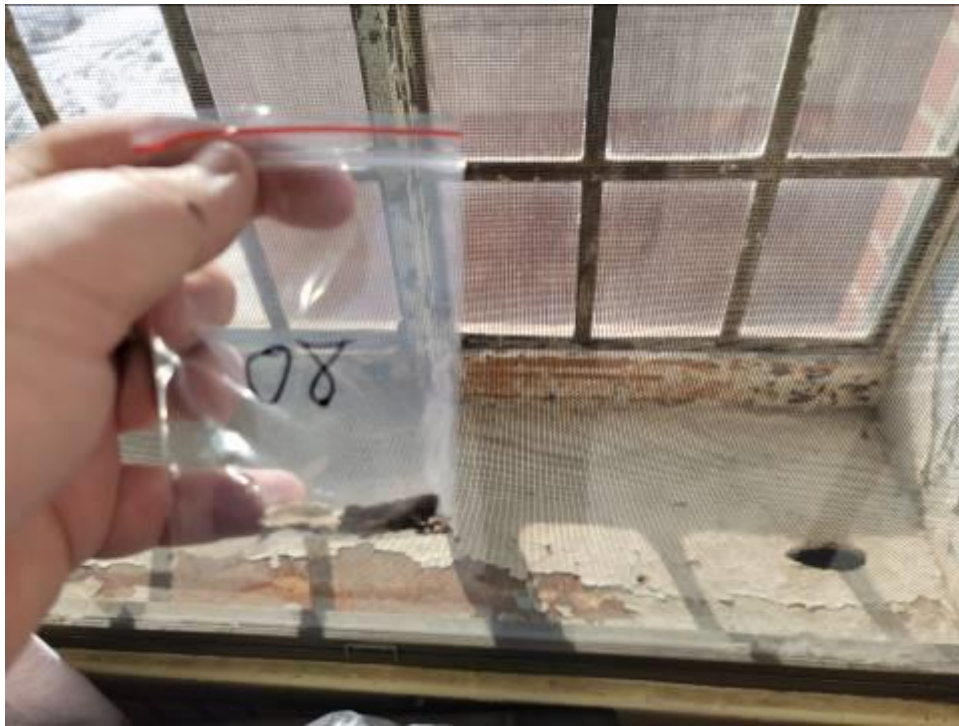
4

View of White Window Glazing
(2% Anthophyllite 2-3% Chrysotile)

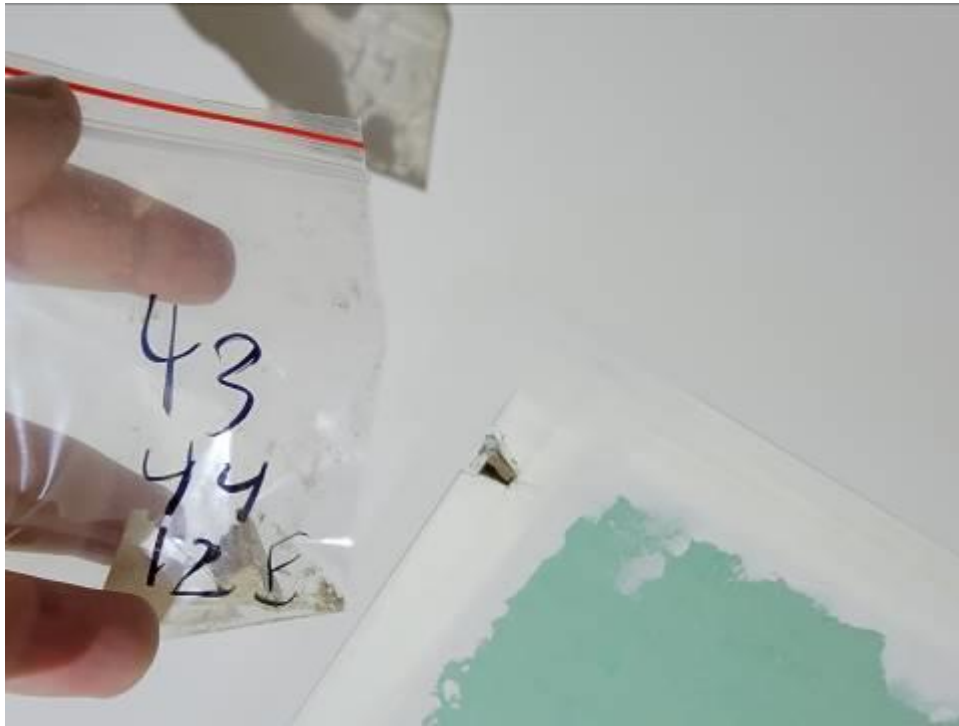
5

View of Drywall Mud (2% Chrysotile)

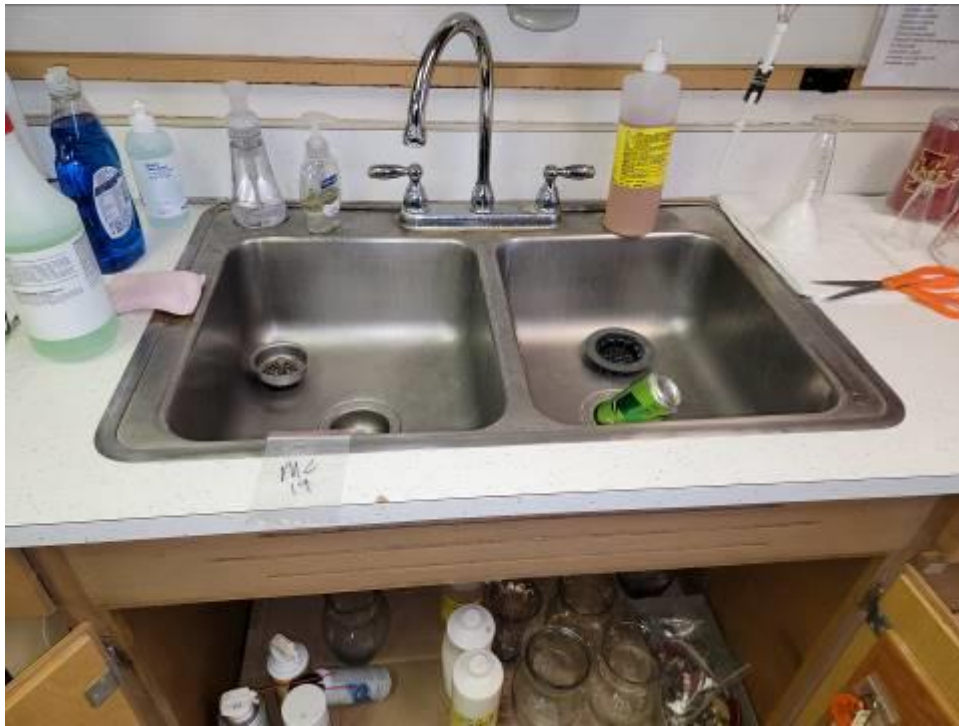
6

View of Gray Sink Insulation (5% Chrysotile)

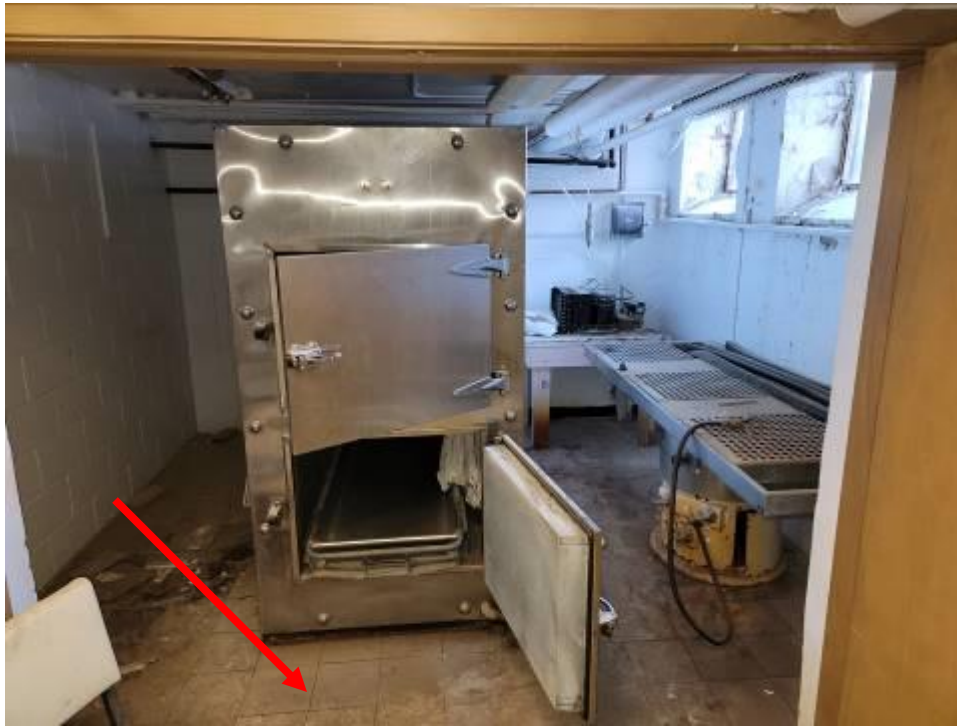
7

View of 9" x 9" Brown and gray/beige with pink, white, blue, brown VFT (3-5% Chrysotile)

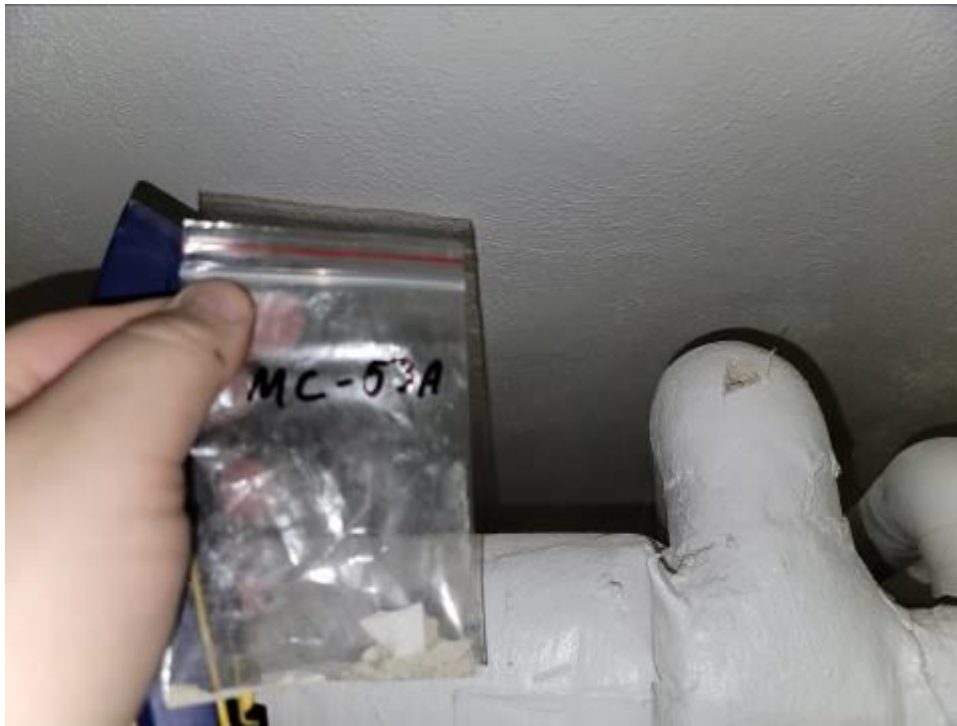
8

View of TSI 1" Elbow (2% Chrysotile)

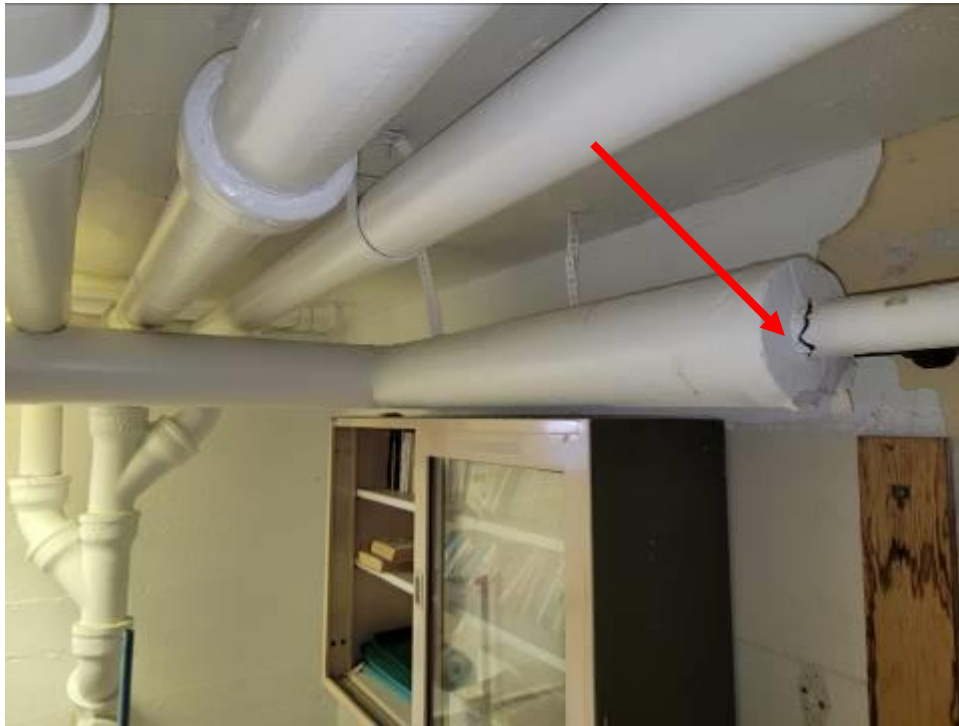
9

View of TSI 2" Pipe (10-20% Amosite 5% Chrysotile)

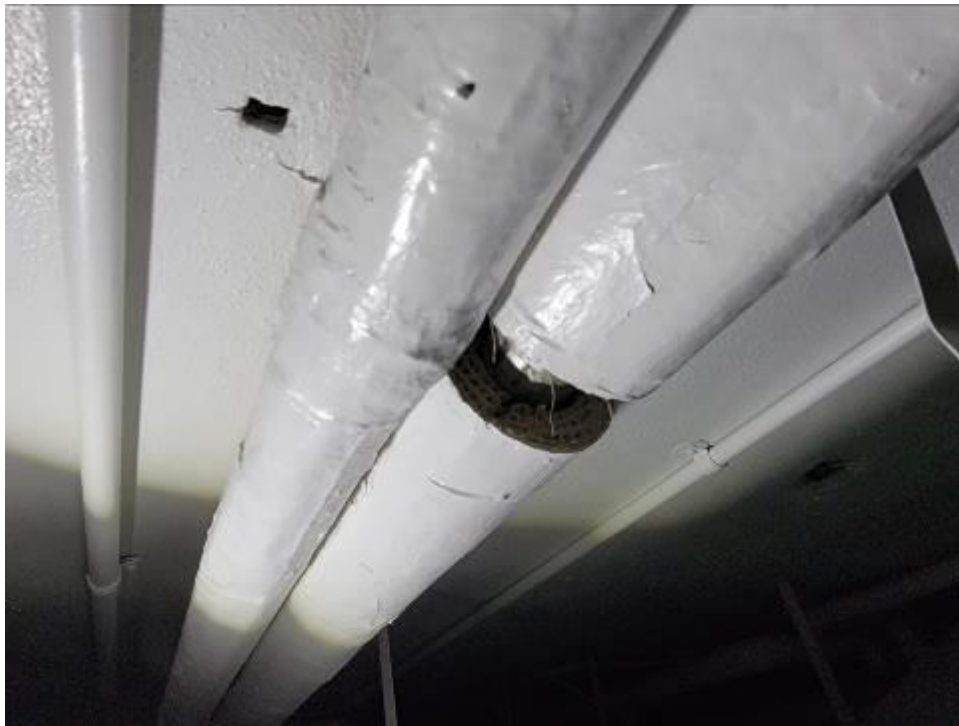
10

View of TSI Aerocell (40-65% Chrysotile)

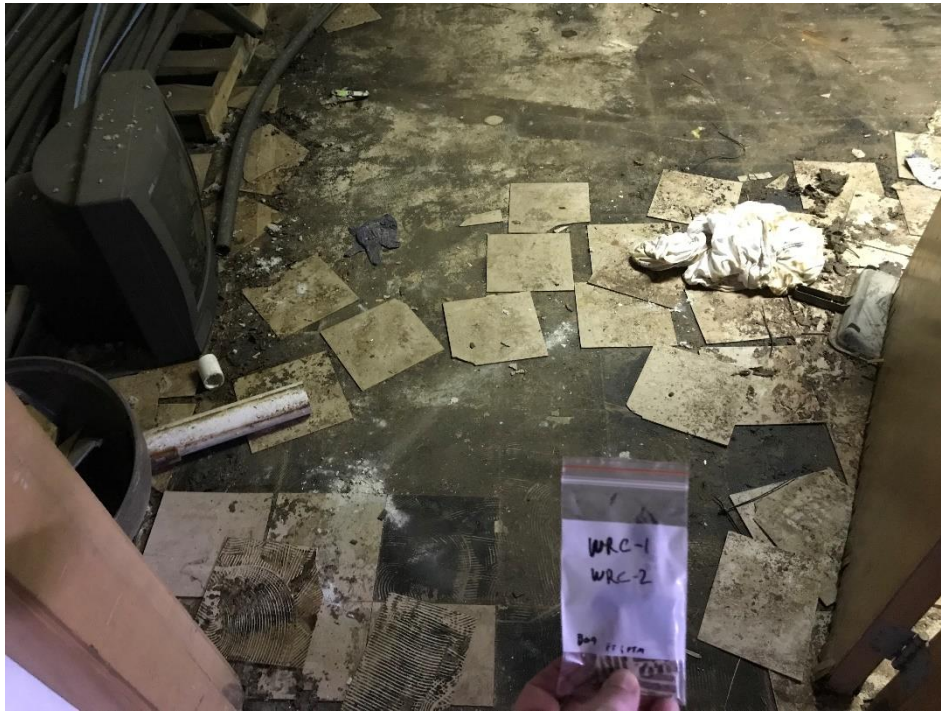
11

View of Beige 9" x 9" Vinyl Floor Tile in Basement (WRC-1, 5% Chrysotile)

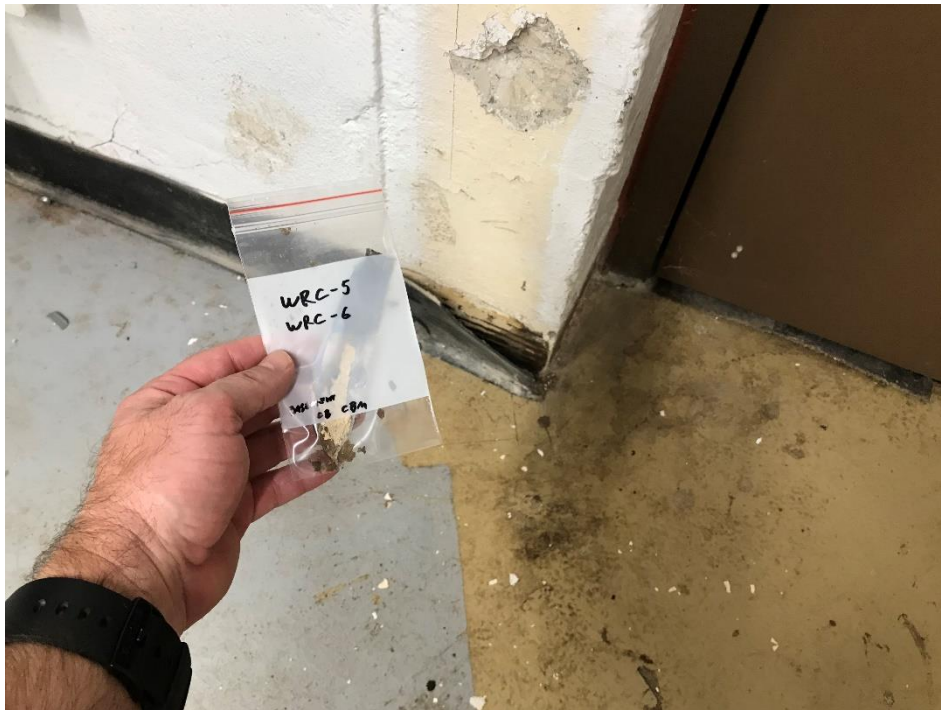
12

View of Brown Cove Base Mastic in Basement (WRC-6, 3% Chrysotile)

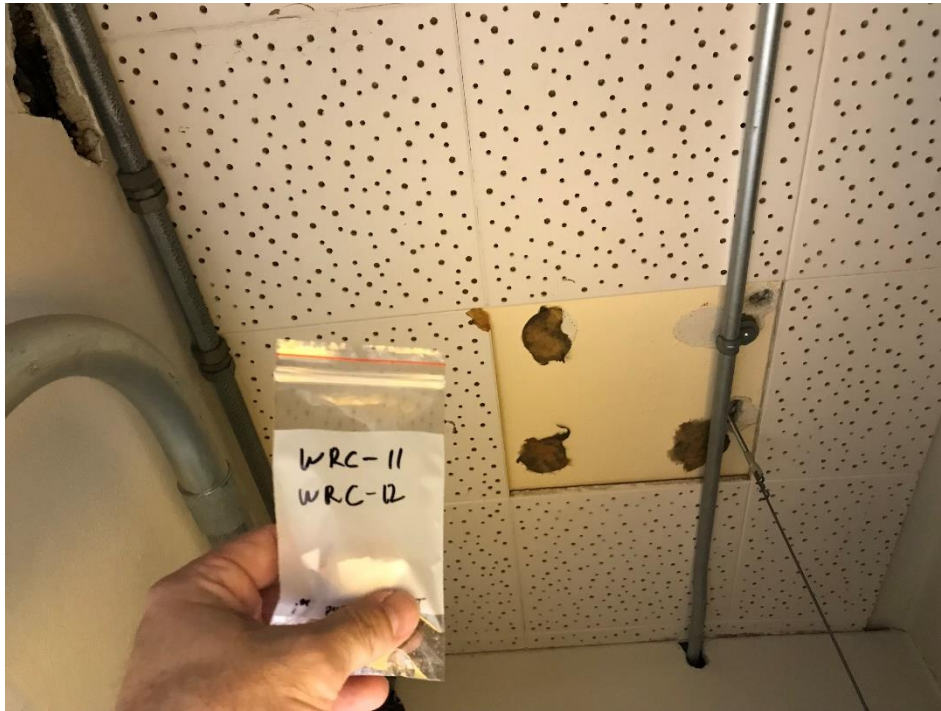
13

View of Brown Ceiling Pucks on 1st Floor (WRC-12, 3% Chrysotile)

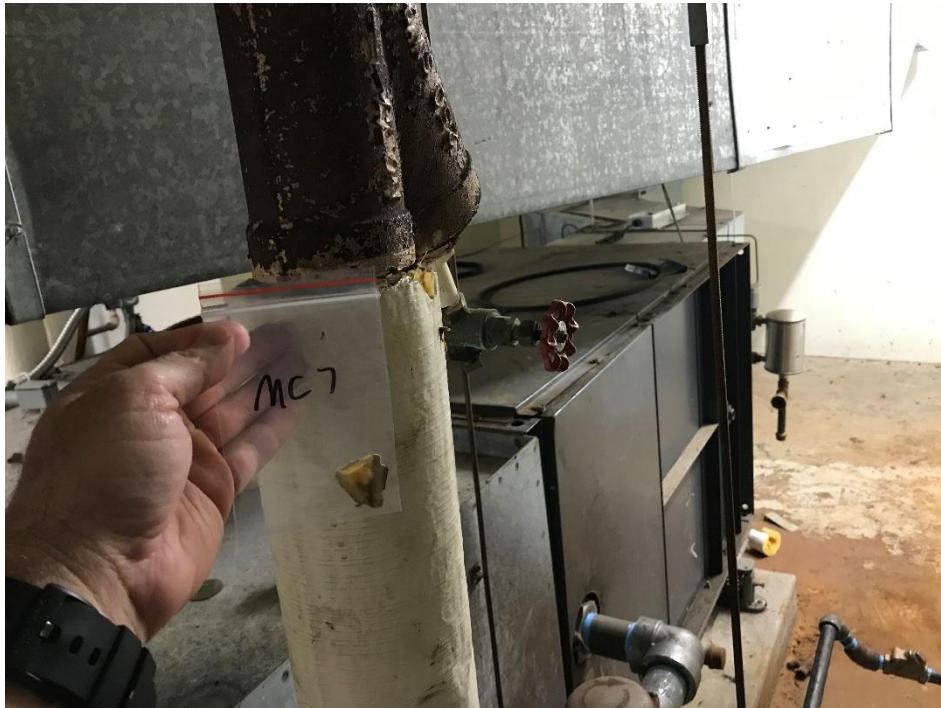
14

View of the Asbestos Containing TSI Run (Mastic/Sealant).
(South Wing, MC 7, 4% Chrysotile)

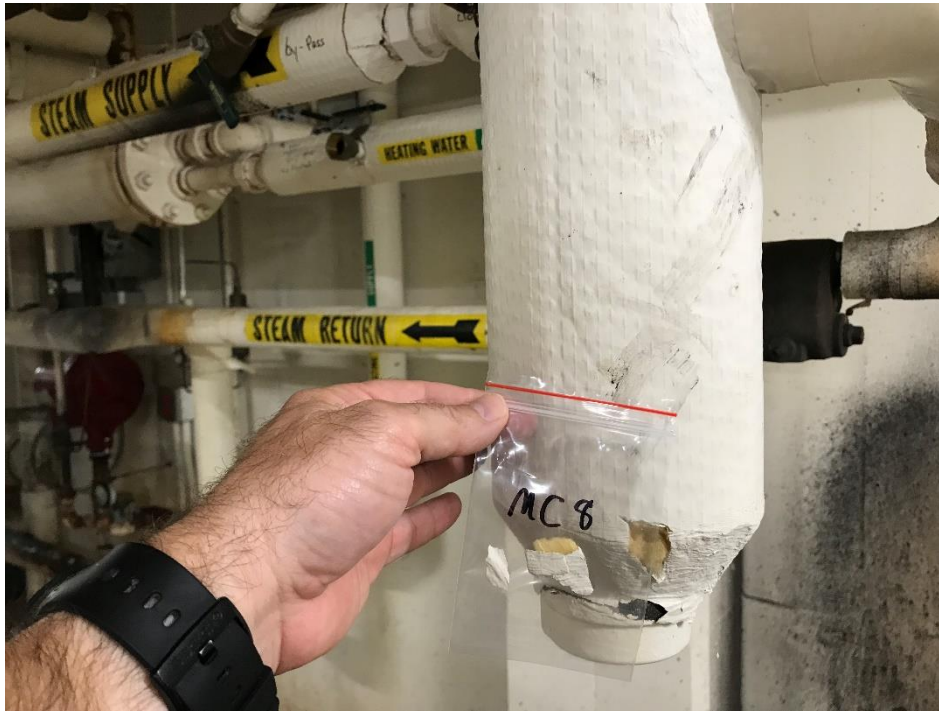
15

View of the Asbestos Containing TSI Run (Mastic/Sealant).
(South Wing, MC 8, 4% Chrysotile)

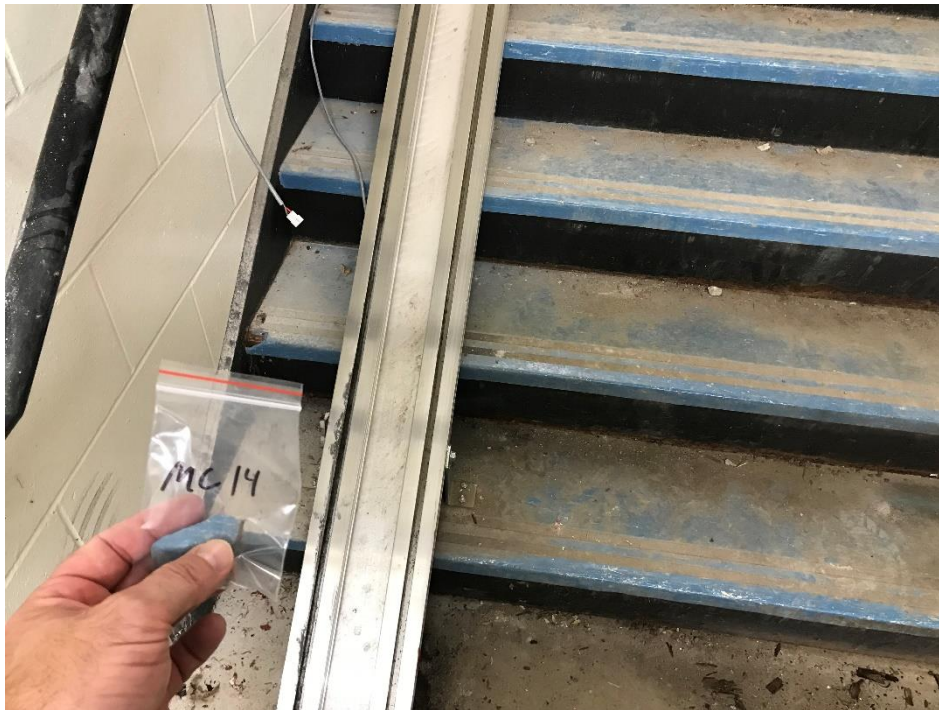
16

View of the Asbestos Containing Blue Vinyl Flooring on Stairs.
(South Wing, MC 14, 3% Chrysotile)

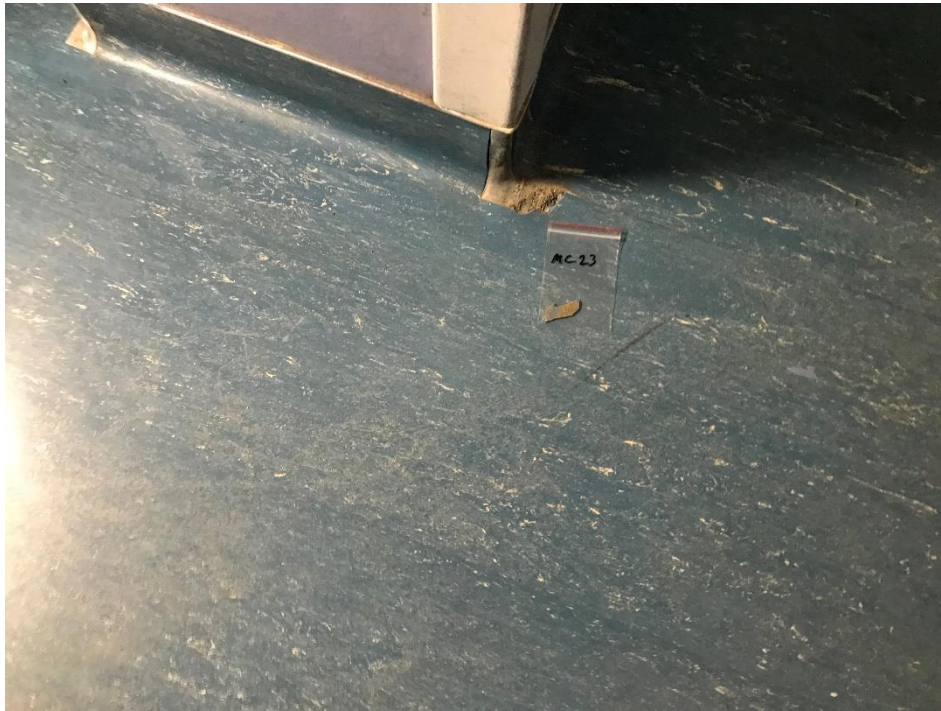
17

View of the Asbestos Containing Blue Vinyl Flooring.
(South Wing, MC 23, 3% Chrysotile)

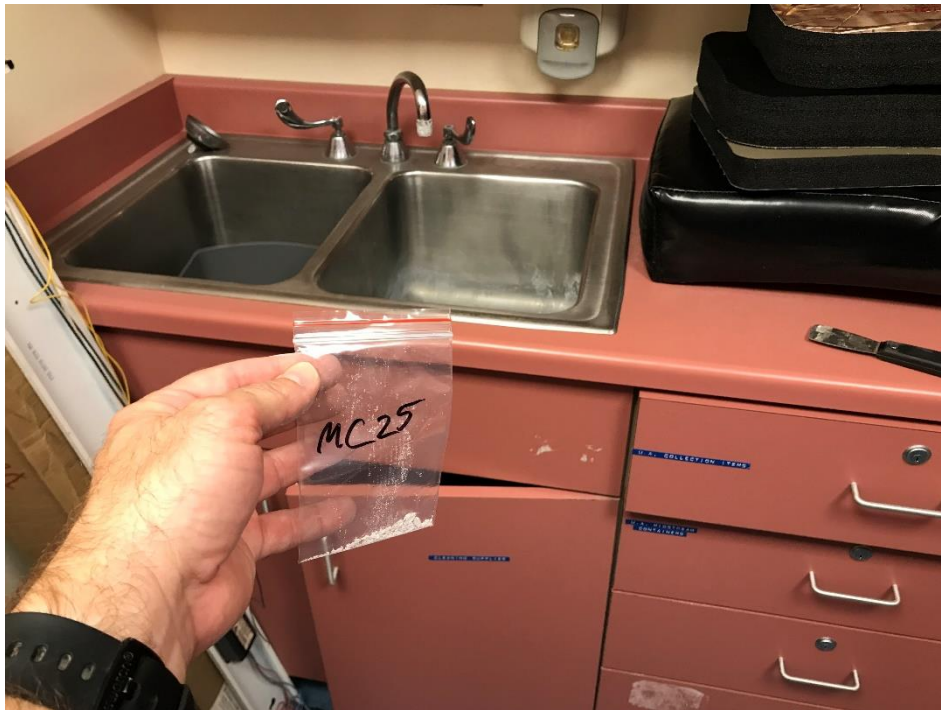
18

View of the Asbestos Containing White Sink Insulation.
(South Wing, MC 25, 15% Chrysotile)

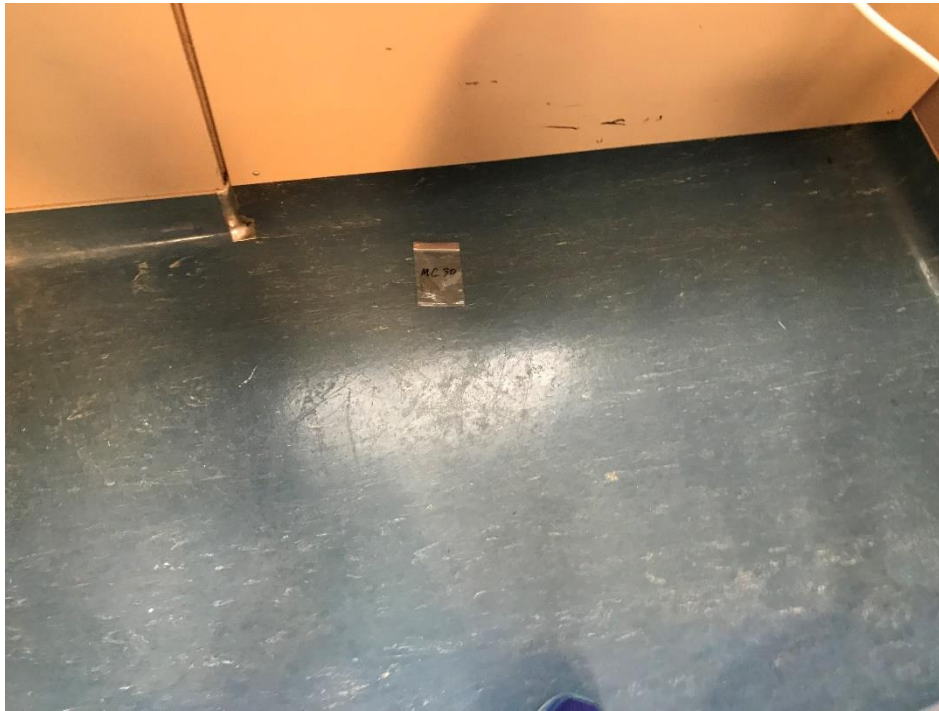
19

View of the Asbestos Containing Blue Vinyl Flooring.
(South Wing, MC 30, 2% Chrysotile)

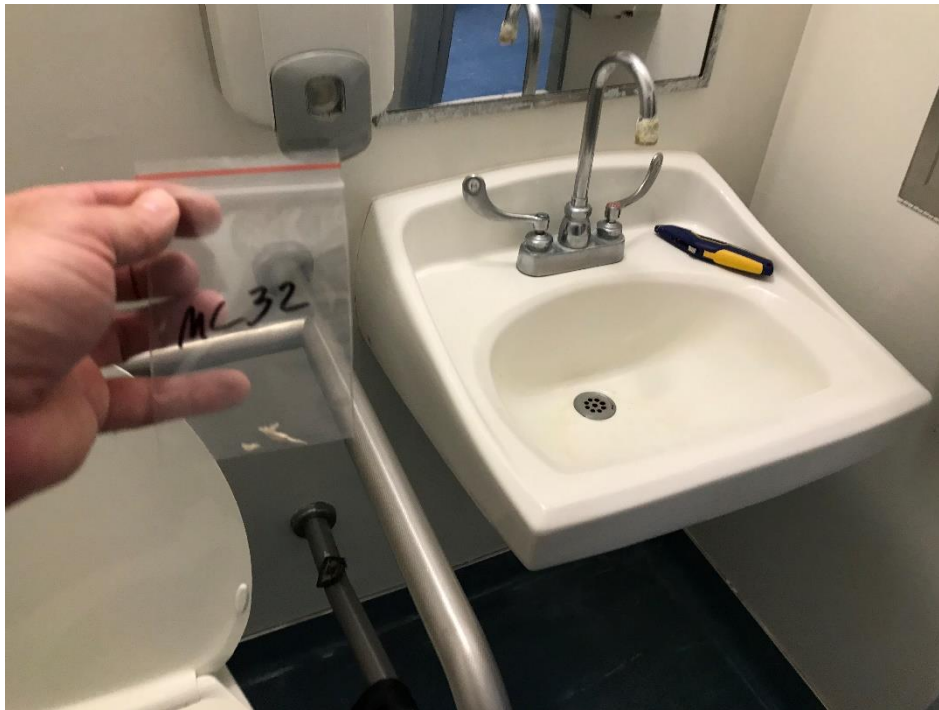
20

View of the Asbestos Containing White Caulk. (South Wing, MC 32, <1% Chrysotile)

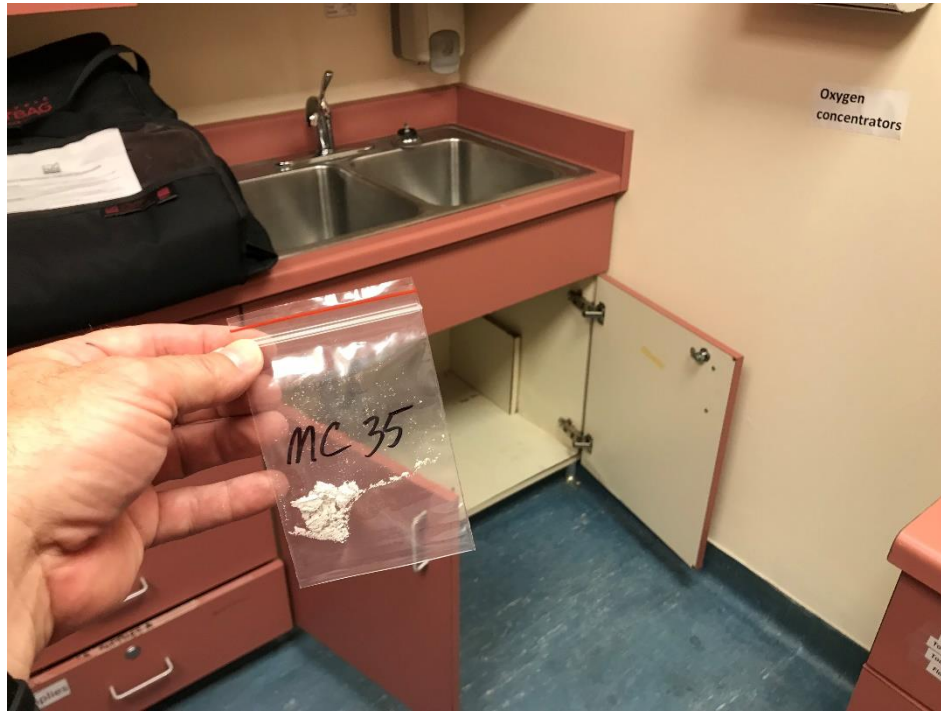
View of the Asbestos Containing White Sink Insulation.
(South Wing, MC 35, 8% Chrysotile)

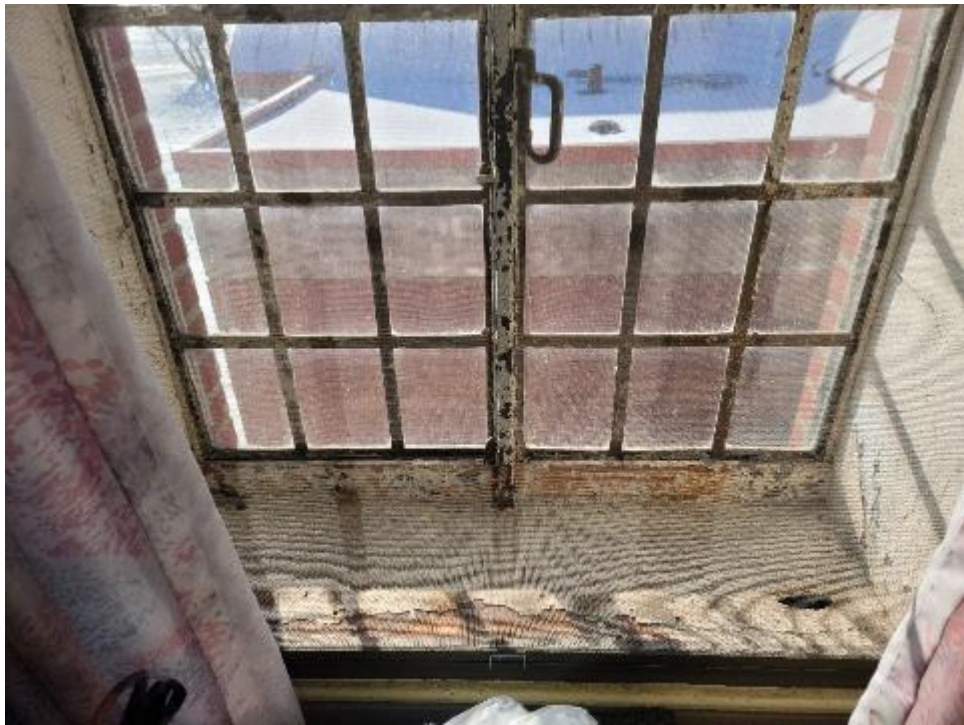
2

- Windows: An XRF sample reading found the white and light tan paint on the window sills, trough, and frame to contain 1.9 - 5.9 mg/cm². Based on the sample analysis, the paint on the windows is considered lead-based paint.

View of white paint on window frame and trough. (2.0 and 5.9 mg/cm²)

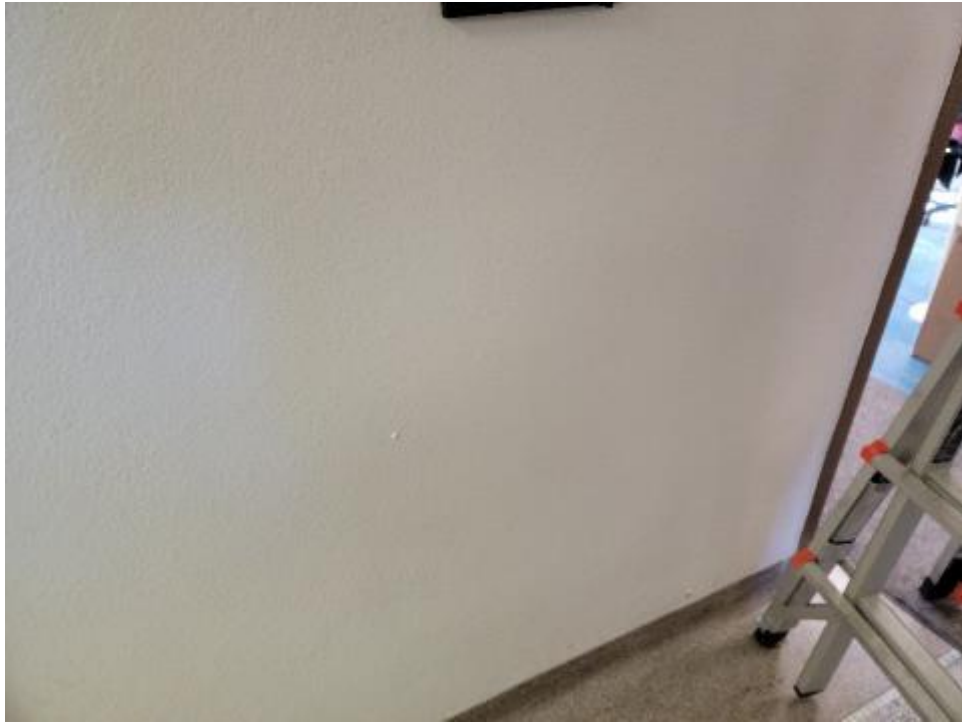
3

- Walls: An XRF sample reading found the gray, off-white, light yellow, pink over orange, and white paint on the walls to contain 0.8 – 17.9 mg/cm². Based on the sample analysis, the paint on the walls are considered lead-based paint.

View of gray paint on plaster walls. (0.8 mg/cm²)

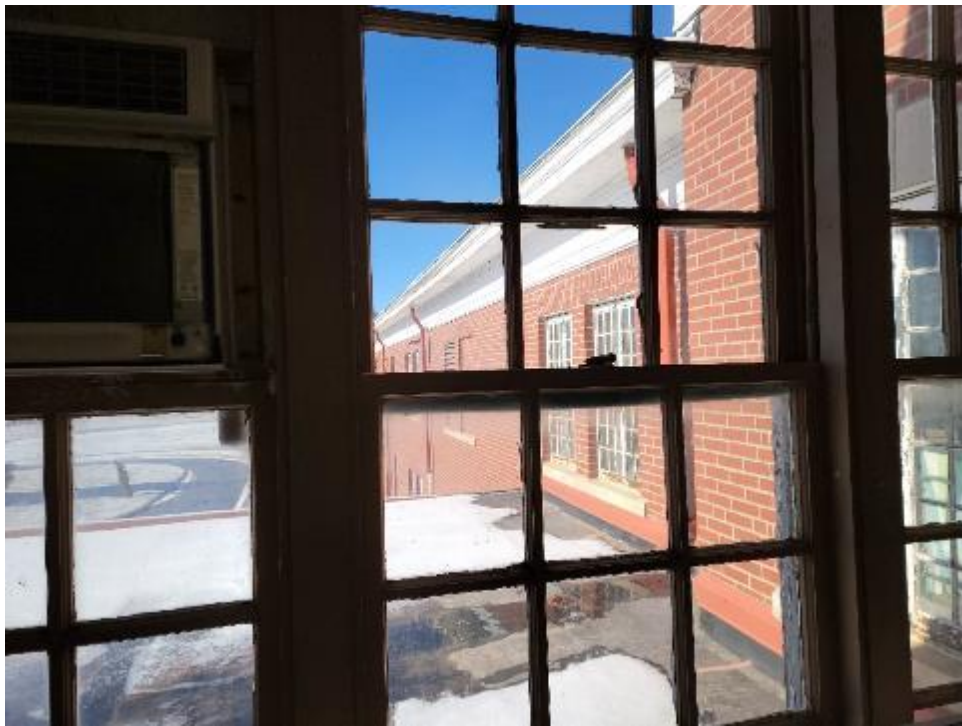
4

View of very light tan paint on the window frames (1.9 mg/cm²)

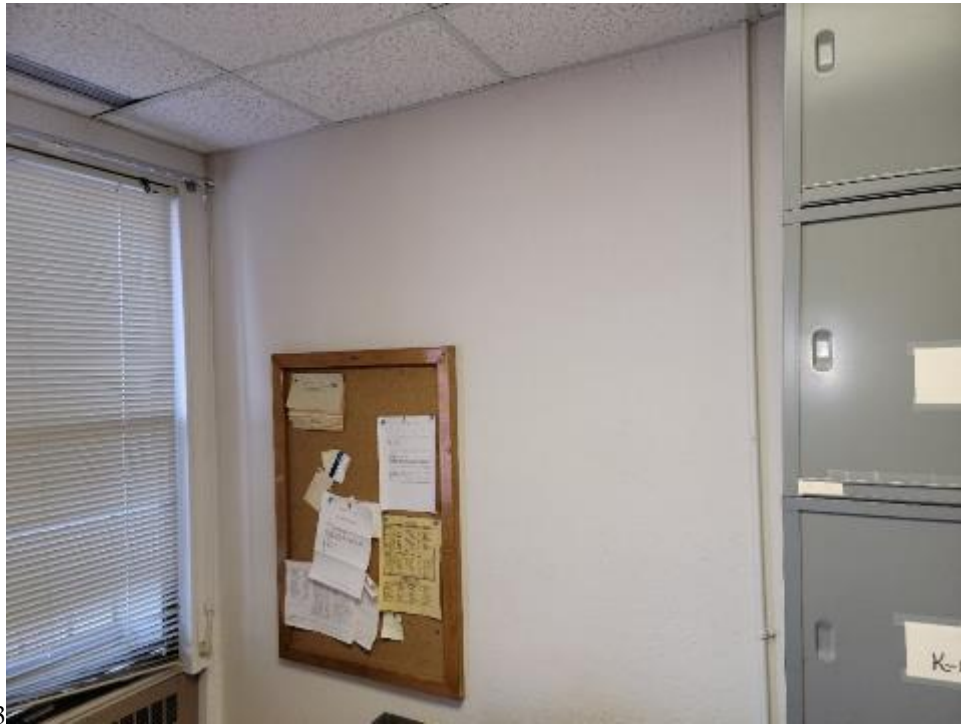
5

View of off-white paint on plaster walls. (13.4 mg/cm²)

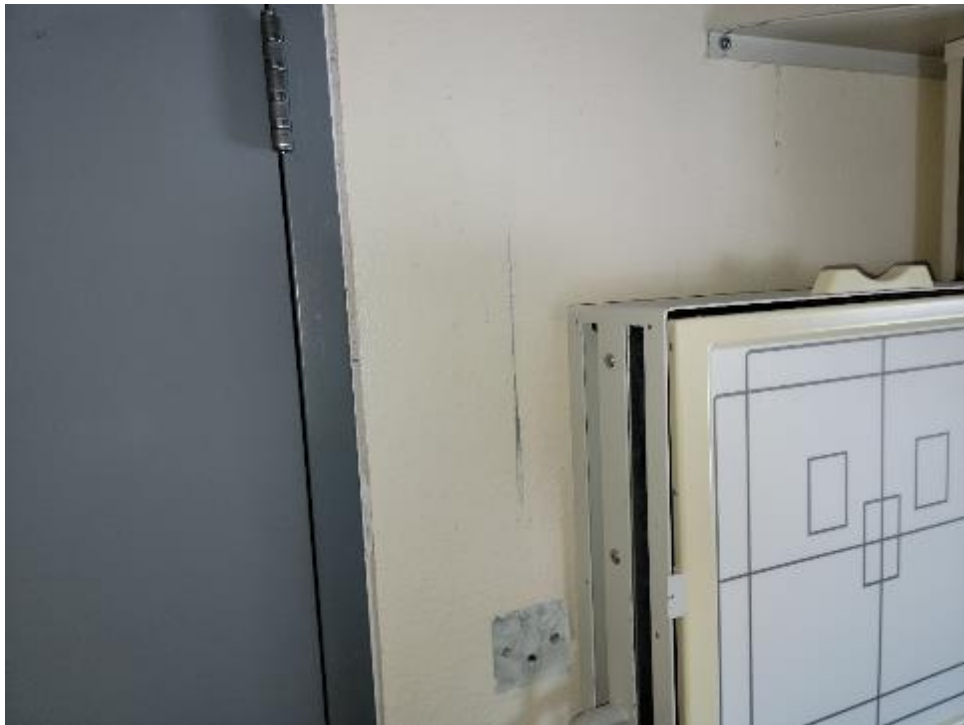
6

View of off-white paint on the walls (1.2 mg/cm²)

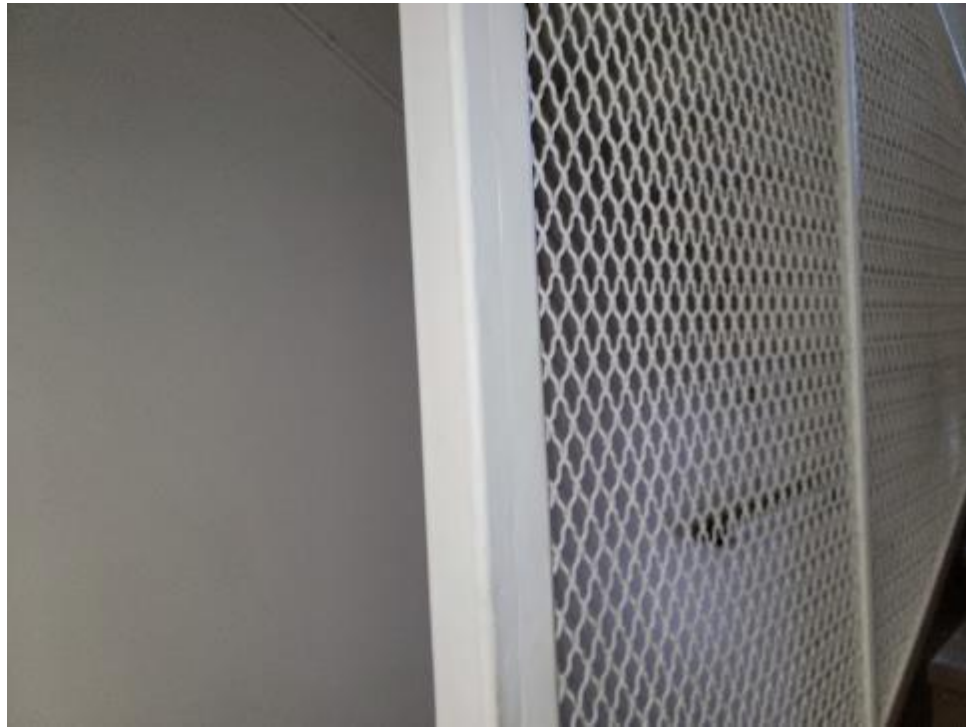
7

- Stair post and cage: An XRF sample reading found the white paint on the stair post and cage to contain 9.6 mg/cm². Based on the sample analysis, the white paint on the stair post and cage are considered lead-based paint.

View of white paint on stair post and cage. (9.6 mg/cm²)

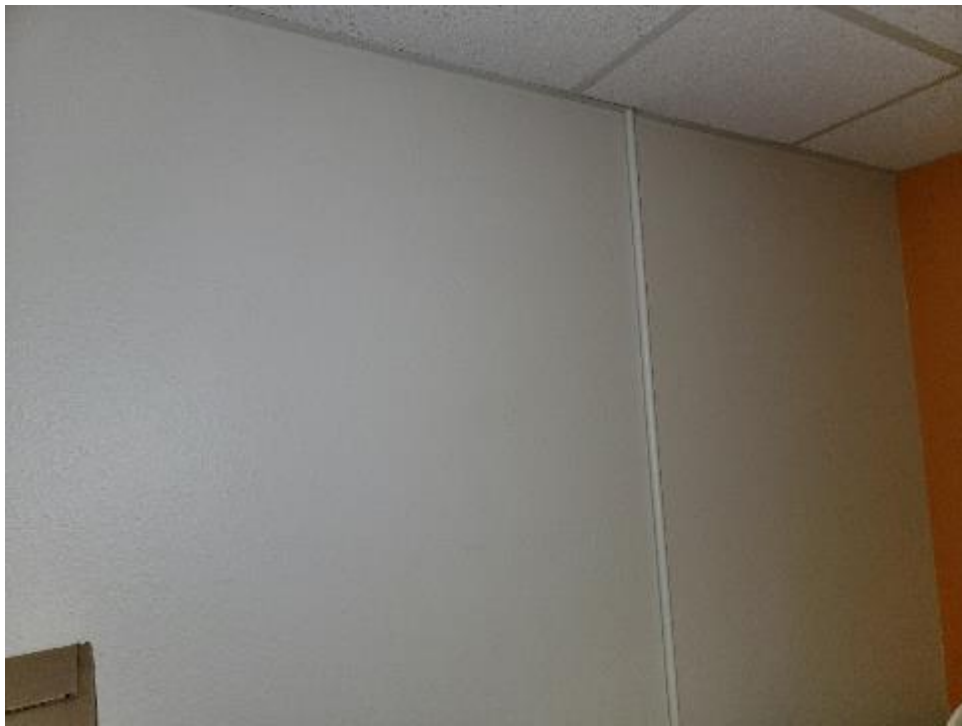
8

View of light yellow paint on the plaster walls. (17.3 mg/cm²)

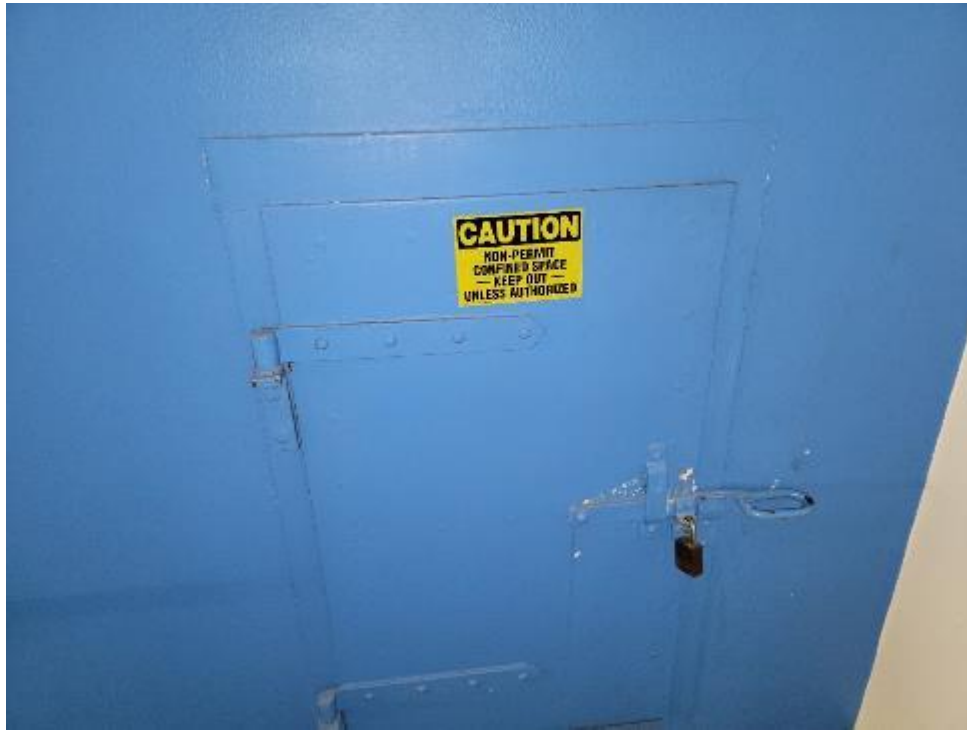
9

- Attic Access: XRF sample readings found the blue on the attic access on 3rd Floor to contain 1.0 mg/cm². Based on the sample analysis, the blue paint on the attic access is considered lead-based paint.

View of blue paint on metal attic access door. (1.0 mg/cm²)

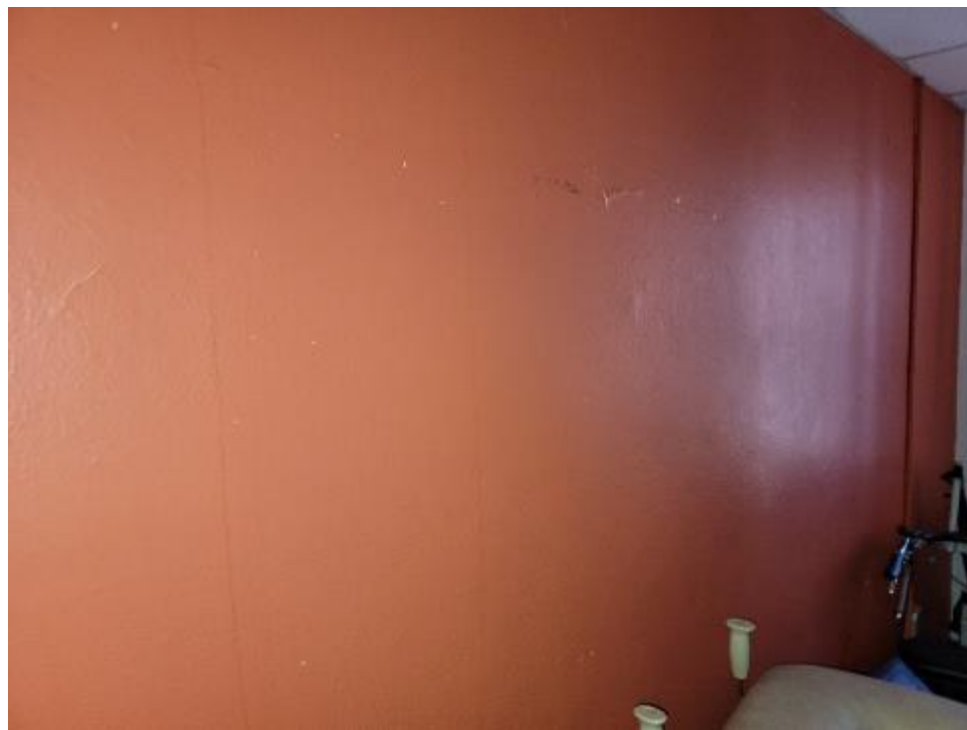
10

View of pink over orange paint on the plaster walls. (17.3 mg/cm²)

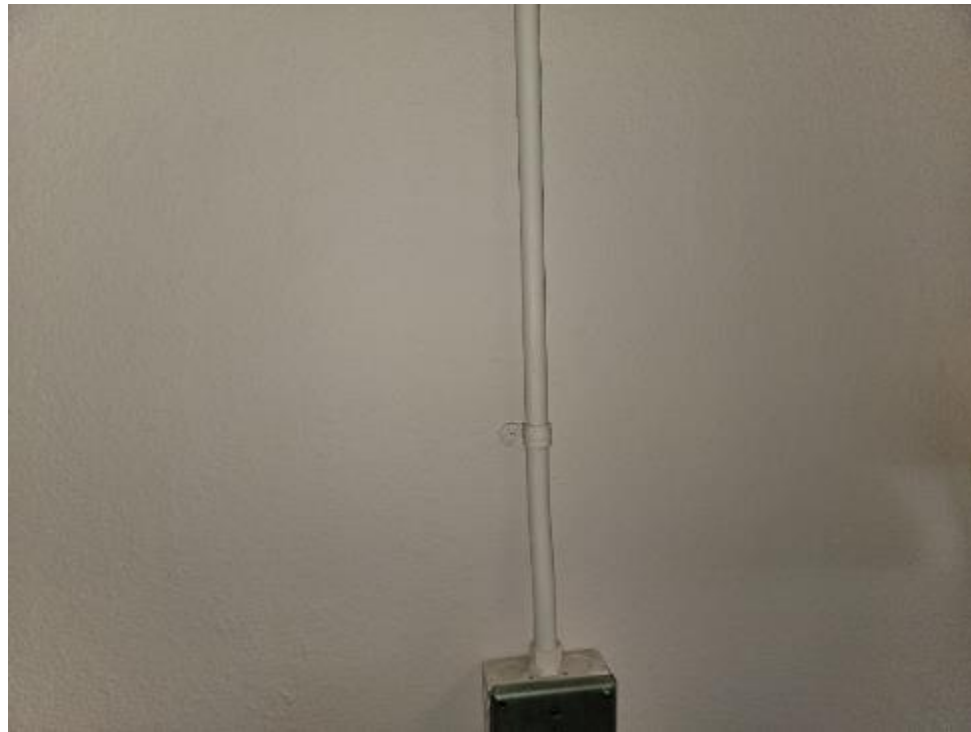
11

View of white paint on plaster wall in N stairway. (17.9 mg/cm²)

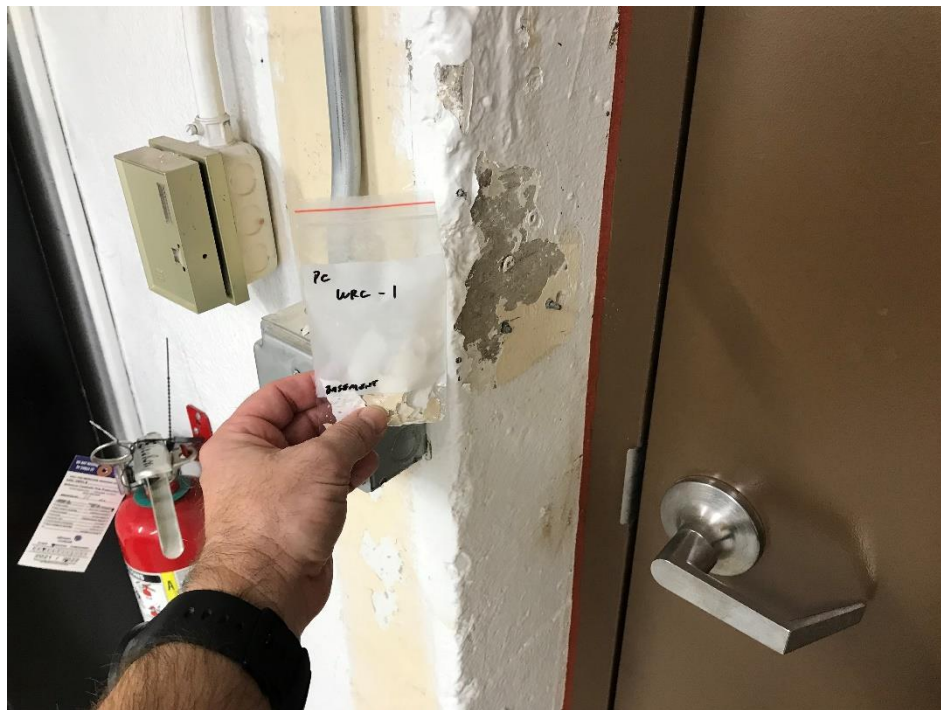
13

View of white paint on walls in basement. (0.048% wt)

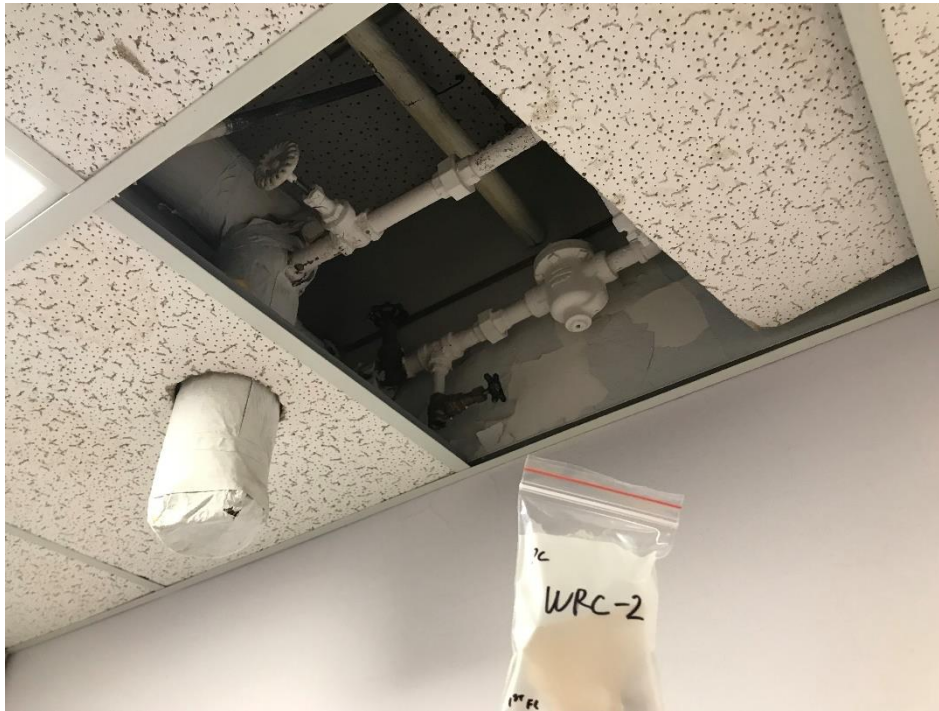
14

View of light blue paint on walls on 1st floor. (0.32 % wt)
