HAZARDOUS BUILDING MATERIALS SURVEY REPORT

Medical Center
1251 334th Street
Woodward, Iowa 50276

Report Date: November 9, 2023

Atlas Project ID: 204BS06333

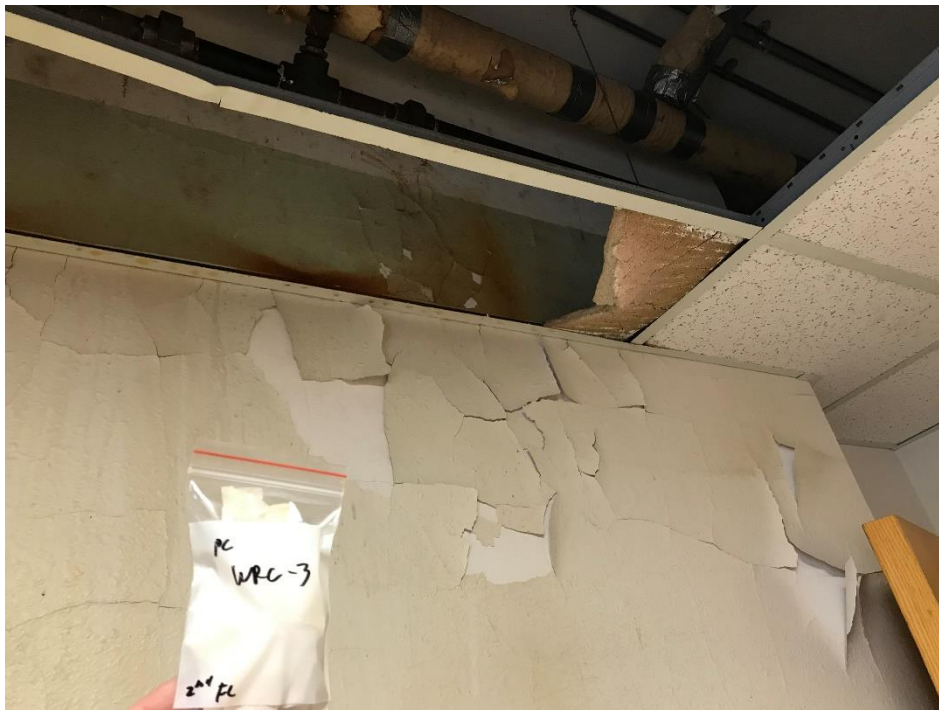
15

View of off-white paint on walls on 2nd floor (0.077% wt)

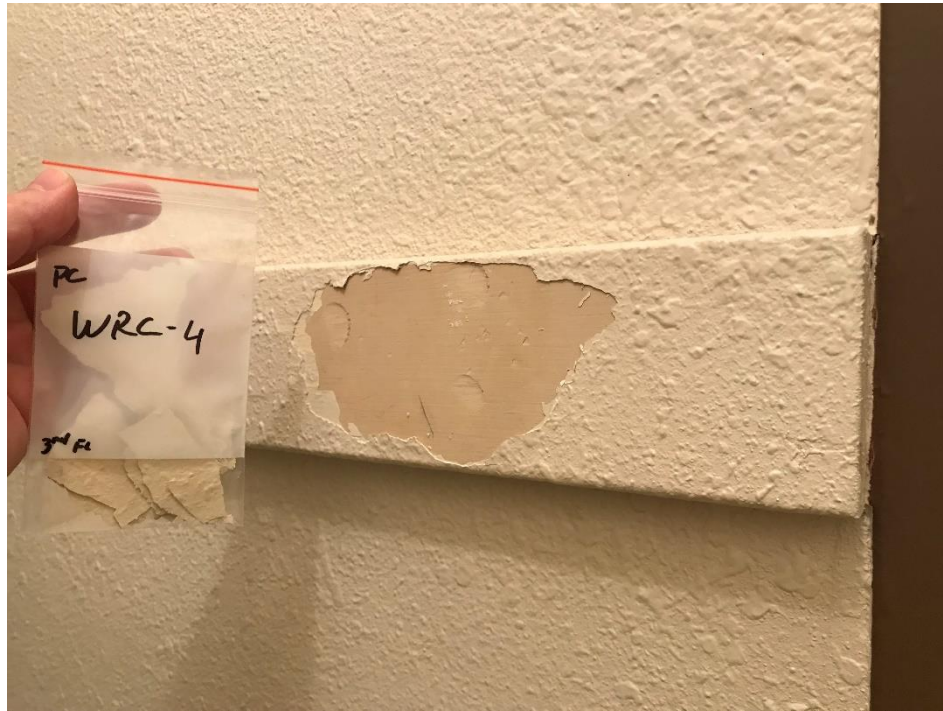
View of off-white paint on walls on 3rd floor. (0.0098% wt)
