August 12, 2021

Diagnostic Inspection
Clarinda Correctional Facility
2000 N 16th Street, Clarinda, Iowa 51632

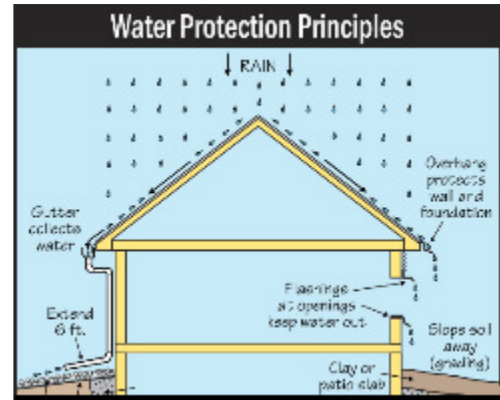
Air Leakage and Condensation Management:

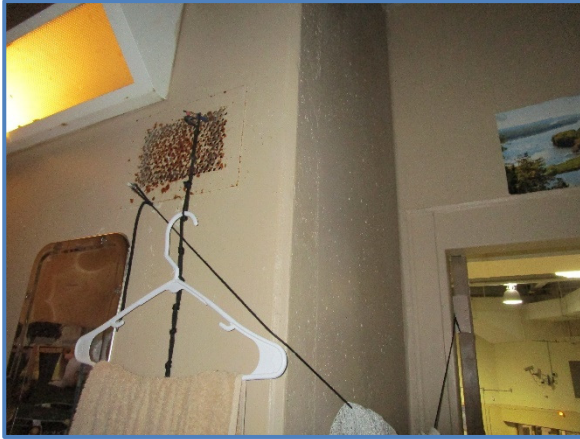
Photo 1: Ducted supply grilles in the cells have rusted, likely the result of condensation occurring on the cold surface.

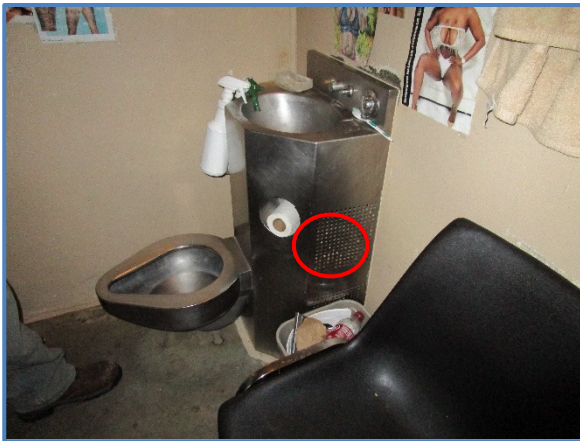
Photo 2: Metal toilet and sink combination in each cell has an opening into the plumbing chase that serves as the return plenum. Excess return airflow creates a significant negative pressure in the Pods.

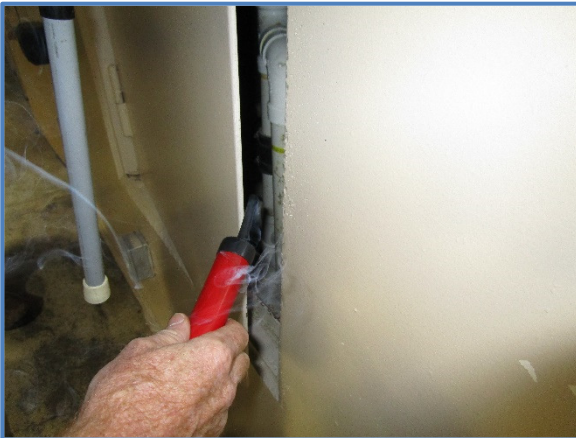
Photo 5: Synthetic smoke illustrates the plumbing chase at the access doors is under negative pressure. This type of un-ducted return air system is notorious for unintentional transport of air into the return stream from remote areas that could be laden with moisture or contaminants.

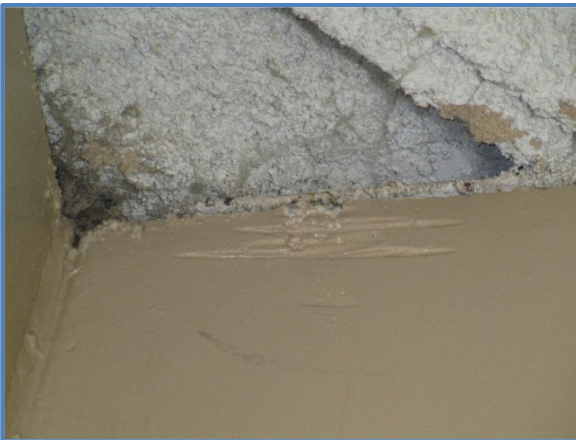
Photo 6: Cobwebs at the exterior wall to roof transition on the 2nd Floor demonstrates air leakage at this location. Synthetic smoke and infrared imaging confirm the story told by the spiders. The exterior wall to roof deck transition is unsealed in multiple areas; synthetic smoke clearly illustrates these areas as air leakage sites. Depending on the temperature difference between indoors and outdoors, airflow direction (and other factors) infrared imaging will not always show air leakage.

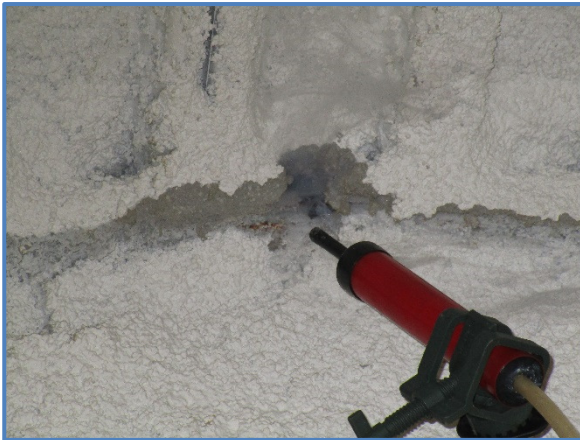
Photo 7: Synthetic smoke illustrating air leakage at the exterior wall to metal roof deck transitions where the spray fire retardant is not continuous.

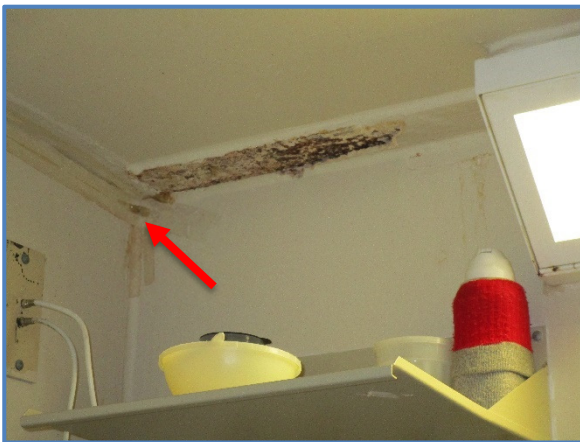
Photo 8: The metal structural angles to hold the concrete deck to the precast concrete panel located throughout the building are rusting; likely due to the bulk water entering from the roof assembly.

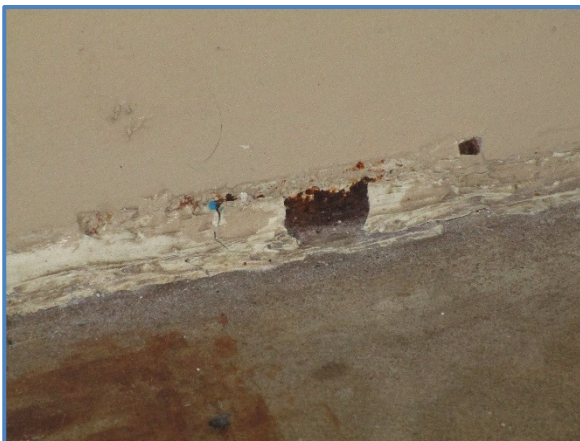
Photo 9: At the bottom of the wall on the second-floor the interior finishes have deteriorated exposing the metal structural angle supporting the concrete slab floor. Rust on the structural angle is a sign of long-term exposure to bulk water or high humidity levels.

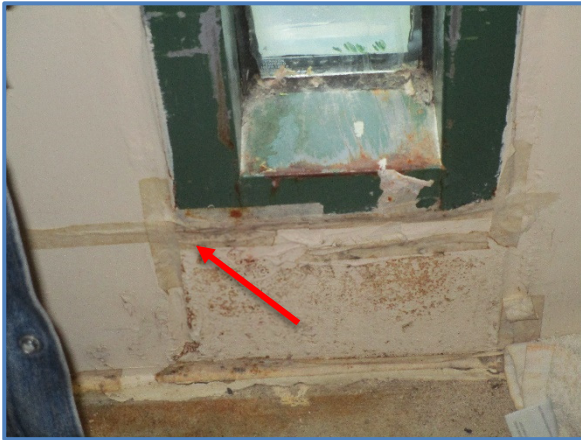
Photo 10: Tape (Red Arrow) has been installed in an attempt to prevent bulk water intrusion. Signs of bulk water intrusion were observed throughout Pod-C.

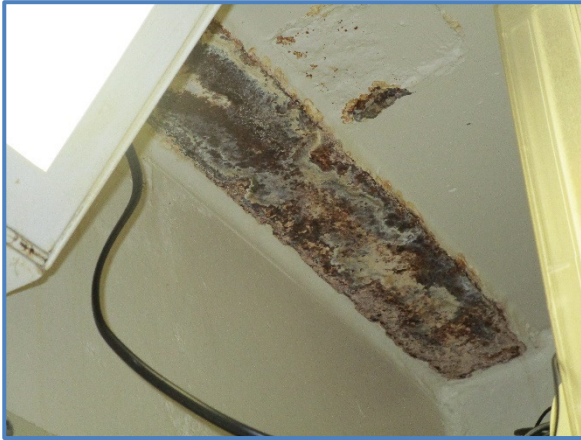
Photo 11: Rust on the structural angle supporting the concrete roof deck is observed throughout Pod-C. This is likely from prolonged bulk water intrusion from the concrete wall panel and concrete roof deck.

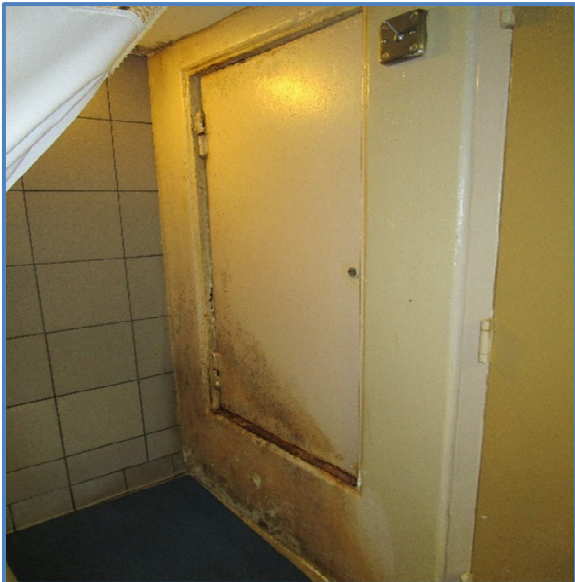
Photo 12: On the first floor the access panel for the plumbing/mechanical chase is located in a shower stall. Having an access panel located in a shower stall promotes the moisture pathway into the chase.

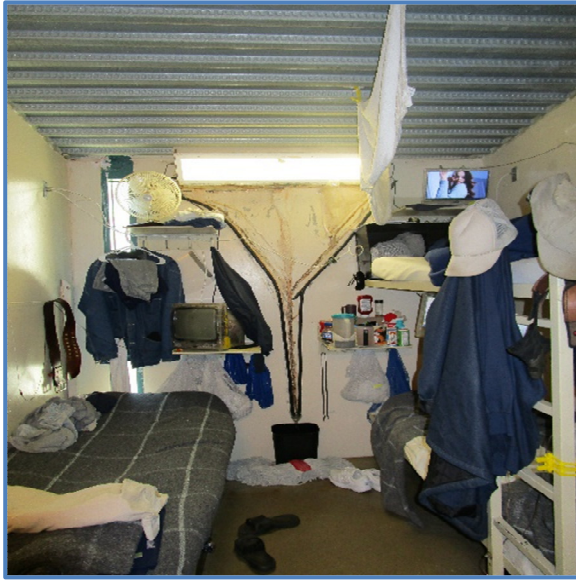
Photo 13: In Pod-C-Unit 1, Cell 16 an example of the occupants attempting to manage the bulk water intrusion occurring behind the light fixture. Gasket material was used to direct water into a trash can that reportedly must be emptied every 30 minutes during rain events. Dry mop heads are placed on the floor around the trashcan to absorb additional bulk water.

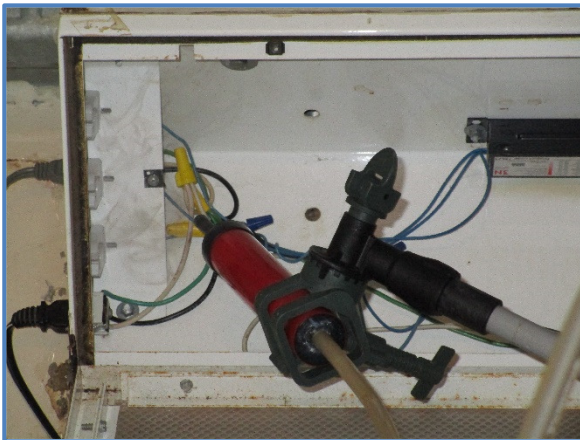
Photo 14: Synthetic smoke is blowing inwards illustrating the negative pressure induced air leakage occurring through the light fixture.

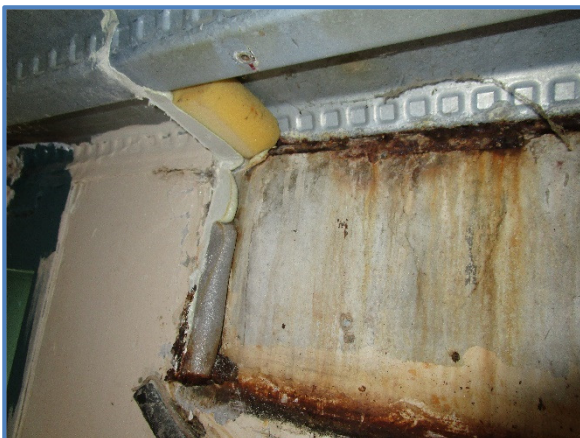
Photo 15: Removing the light fixture revealed that the metal deck is completely unsealed at the top of the concrete wall panel transition to the wall. Rust is occurring on the light fixture and on the structural metal angle.

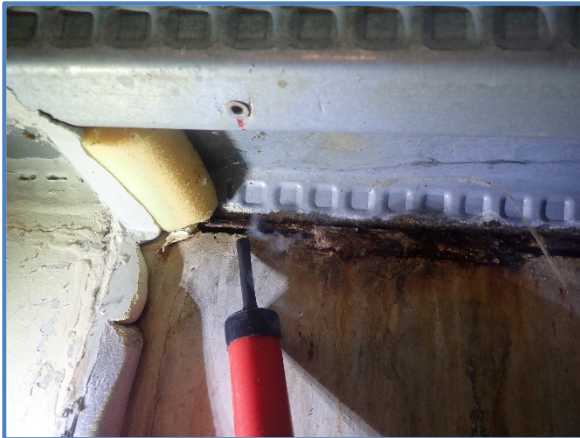
Photo 16: Synthetic smoke demonstrates inward air leakage occurring at the transition between the top of the concrete wall panel and the underside of the roof deck. Air leakage will add to the moisture load on the mechanical system and can cause condensation inside the light fixture.

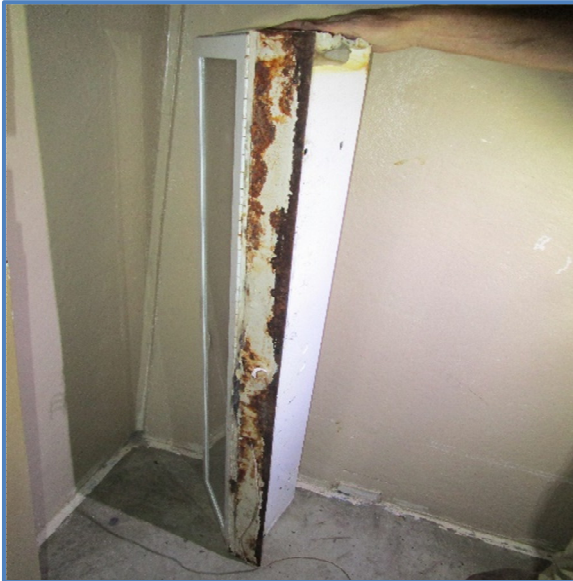
Photo 17: Rust occurring on the light fixture removed from Pod-C cell 16 as the result of air leakage and bulk water intrusion.

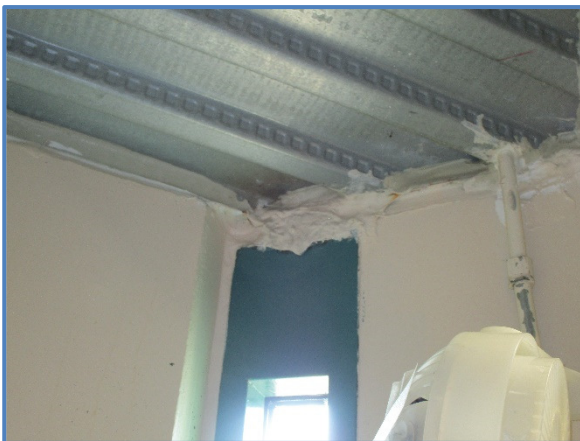
Photo 18: Exterior wall to roof deck transition has been repaired with caulk but the sealant is not continuous and will continue to fail until the bulk water intrusion from the roof is repaired.

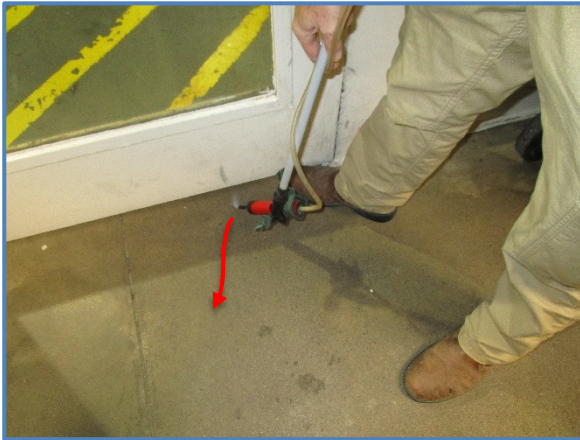
Photo 19: Synthetic smoke demonstrates the negative pressure between the Unit 1 of Pod-C. Standing in the hall area outside Unit 1, smoke directed at the Pod-C Unit 1 door is rushing back towards the hall.

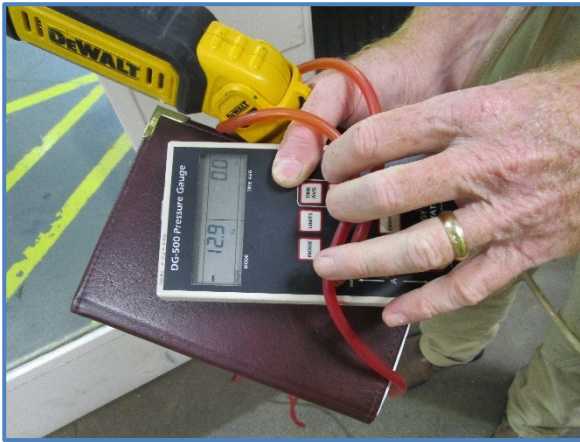
Photo 20: A digital manometer measured the negative pressure between Unit 1 of Pod-C and the common hall area to be -12.9 Pascals. This is a significant negative pressure resulting from an unbalanced HVAC system. This will cause outside air and moisture to be sucked into the occupied conditioned space.

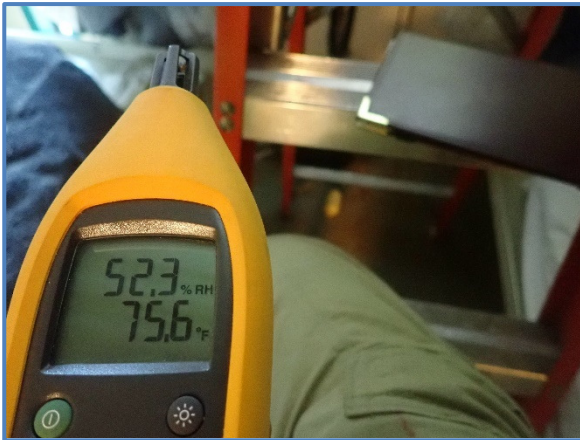
Photo 21: The temperature and relative humidity were periodically measured throughout the inspection.

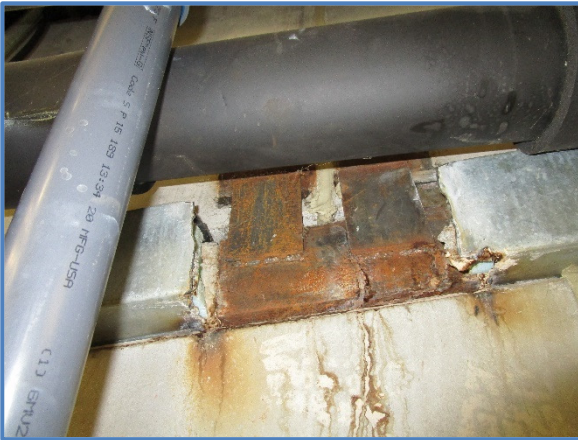
Photo 22: On the interior side of the smooth precast concrete wall panels connecting the Pods to the main area of the facility the structural connections and rigid insulation is visible where the roof deck ties into the building. Rust indicates that this is a moisture pathway.

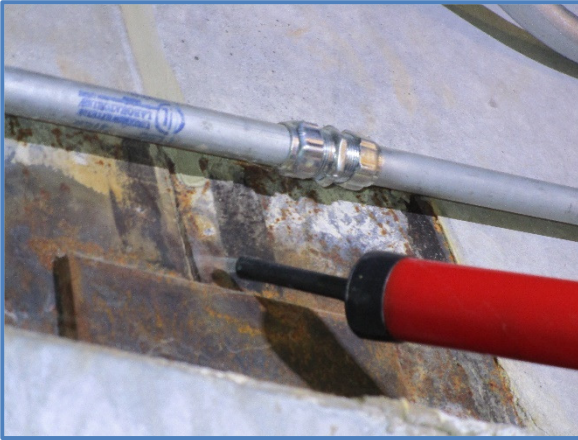
Photo 23: Synthetic smoke illustrates an air leakage pathway under the standing metal seam roof where the concrete roof deck ties into the smooth precast wall panel.

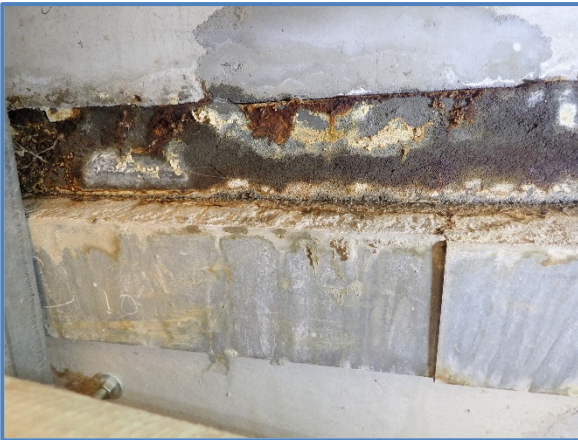
Photo 24: Deterioration is occurring at the metal structural plate holding up the concrete roof deck and concrete wall panel indicating prolonged exposure to bulk water infiltration.

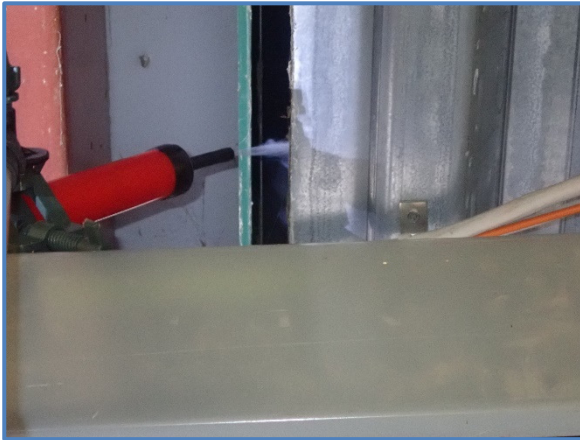
Photo 25: Where the Pod transitions to the main building there is an expansion joint; synthetic smoke rushing inwards demonstrates this area to be an air leakage site.

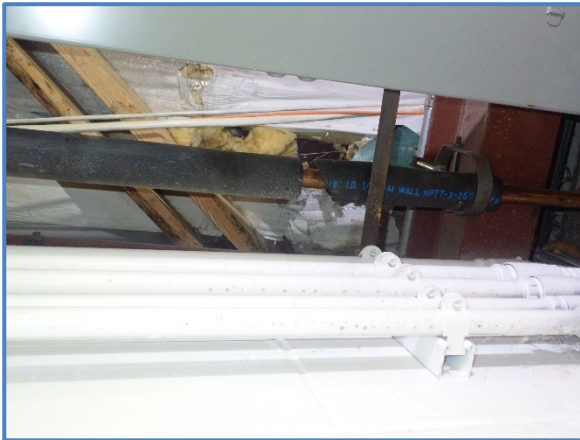
Photo 26: The roof over the main building is a different assembly than is observed over Pod-C. This roof assembly is a vinyl liner system over fiberglass insulation typically found in a pre-engineered metal building. With this roof assembly the vinyl liner is the air barrier – the air barrier is damaged in multiple locations allowing for uncontrolled infiltration. It is unclear how (or if) this air barrier transitions to the Pods air barriers. Non-continuous roof air barriers also cause air infiltration due to warm air rising and escaping out of the roof (stack effect).

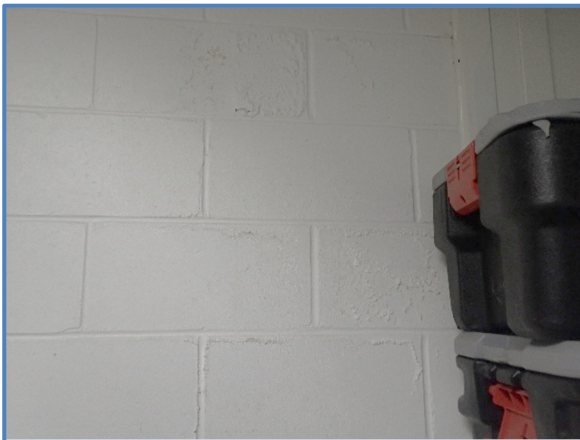
Photo 27: Areas of the painted CMU block wall, located on the second-floor of the main building used as a storage area and maintenance shop. The paint is peeling off the block wall, likely due to the CMU block wall absorbing water.

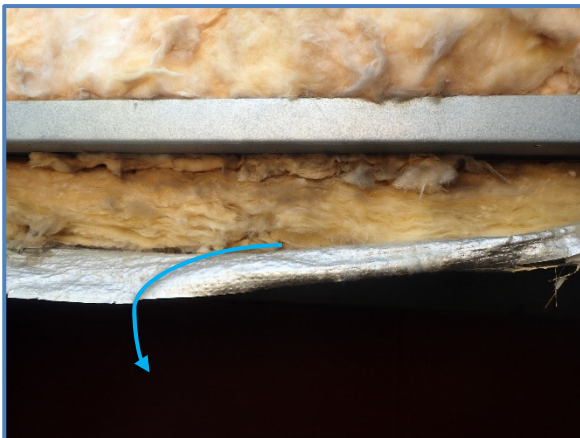
Photo 30: Water was observed dripping off the vinyl liner of the roof assembly in the main building. The source of the water could not be determined.

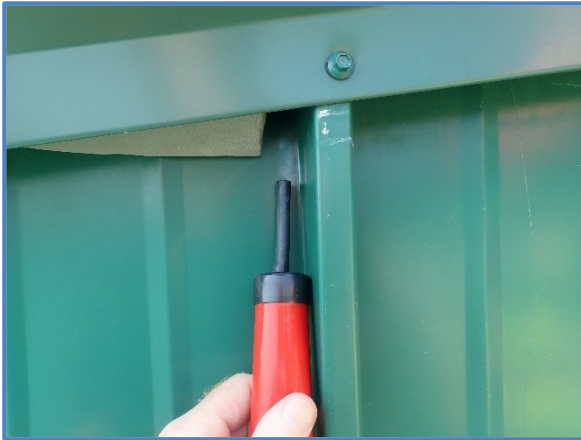
Photo 31: Along the area that was re-roofed in 2017 synthetic smoke demonstrated that outdoor air leakage into the building was occurring at this location.

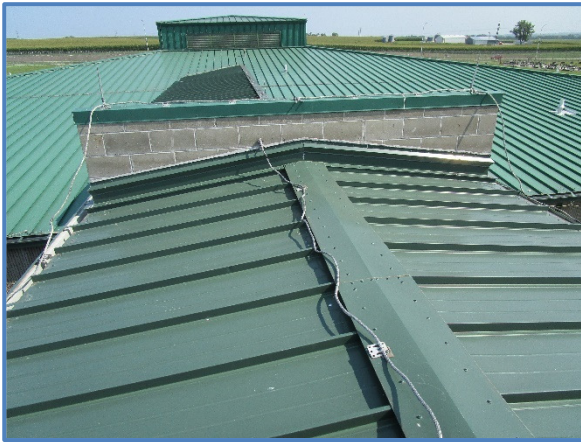
Photo 32: The CMU block wall located at the fire wall separating the Pod from the main building where 1 of 3 RILEM Tube tests were conducted. RILEM tubes are filled with water and situated to drain through the masonry; water levels in the tubes are checked every 5 minutes over a 20-minute period. An acceptable performance is achieved if the level of water drops no more than 20% of the original height during the 20-minute test period.

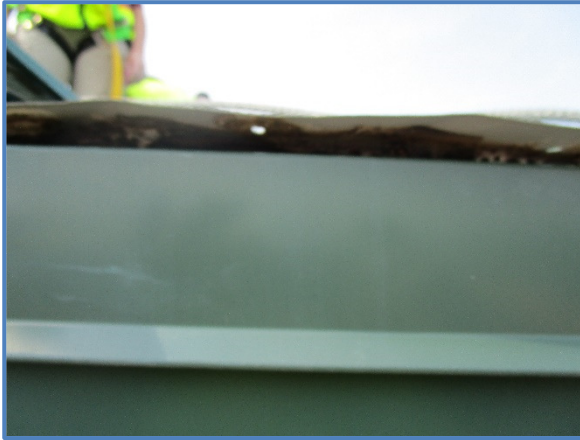
Photo 37: The standing metal seam roof panels are not continuously sealed to the metal drip edge. Some locations are missing screws. These defects will allow water to roll under the standing seam roof; wind driven rain will enter the assembly in even greater amounts.

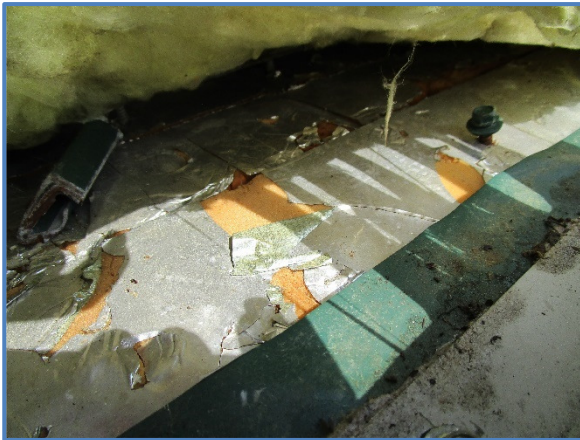
Photo 38: Lifting up the ridge cap revealed fiberglass batt stuffed in the ridge cap over rigid insulation board. No ice and water shield or vapor barrier was observed, as currently recommended. The rigid insulation was placed directly on top of the concrete roof deck; the seams in the rigid insulation were not taped. To minimize moisture intrusion an ice and water shield is normally installed over the rigid insulation.

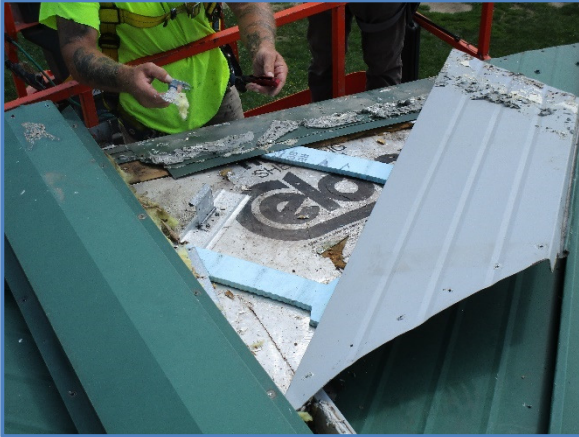
Photo 39: Removing the first section of standing seam roof panel illustrated sealant on the metal drip edge that was replaced after the original install. However, there was no hemmed edge on the panels to prevent water from rolling back over the top of the metal drip edge.

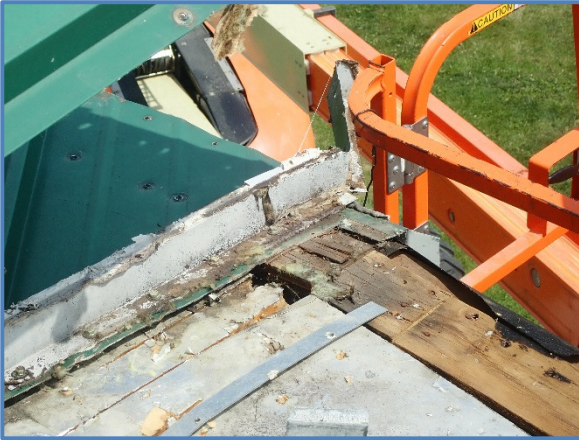
Photo 40: Removing the metal drip edge exposed the wood blocking that exhibits water stains and other signs of moisture intrusion. At the time of this inspection the wood blocking was not wet.

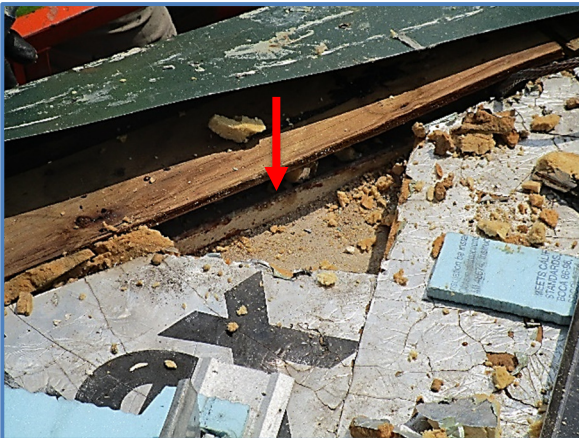
Photo 41: A section of the rigid insulation board was removed to allow for inspection of the concrete deck. There was no fully adhered vapor barrier installed underneath the rigid insulation board, as is common practice with concrete roof decks. The rusted metal structural angle (Red Arrow) is also visible from the Cells below.

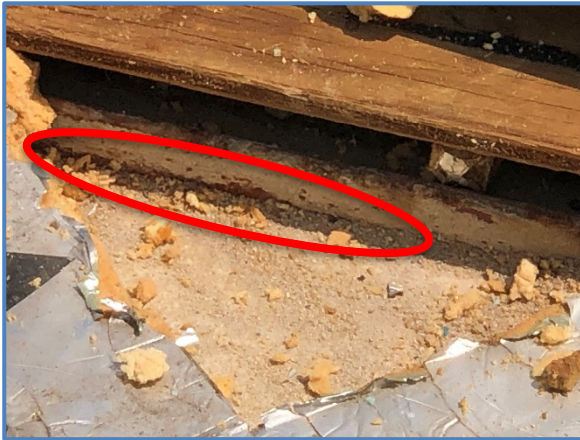
Photo 42: Close up view of the metal structural angle holding the concrete roof deck in place. A small crack is observed between the metal and concrete (Red Circle).

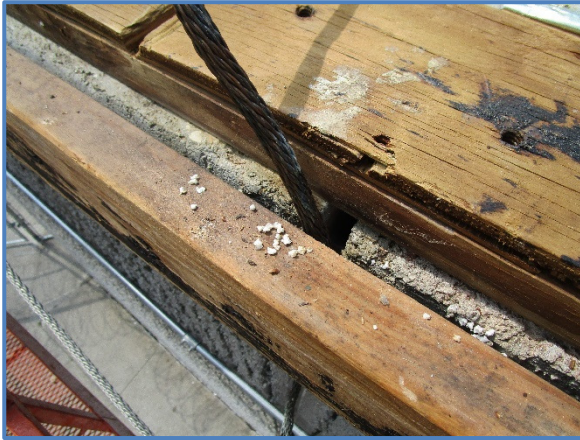
Photo 43: The lightning protection has been installed through the joint in the concrete fractured fin exterior wall panel.

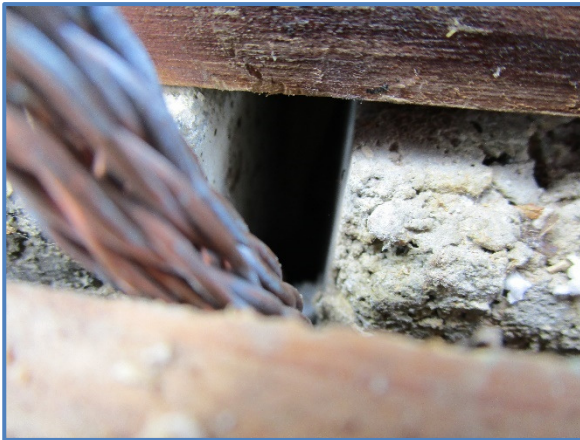
Photo 44: A closer inspection of the sealant joint in the concrete wall panel system revealed that the seam is open behind the wood blocking. This opening in the sealant joint allows bulk water to enter the concrete wall panel and enter the conditioned space.

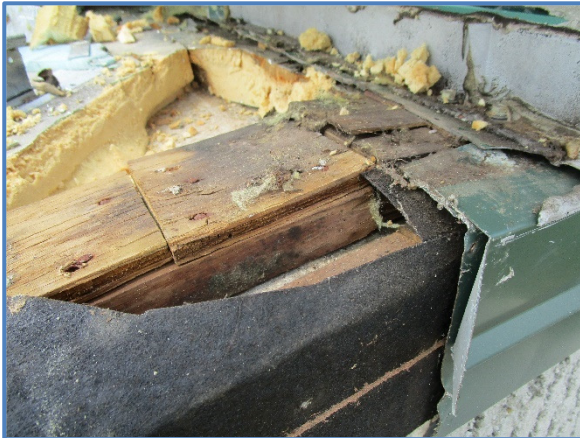
Photo 45: Removal of the metal drip edge revealed there are two separate sections of metal drip edge installed over a small section of membrane flashing. This does not match the detail from the construction drawings provided.

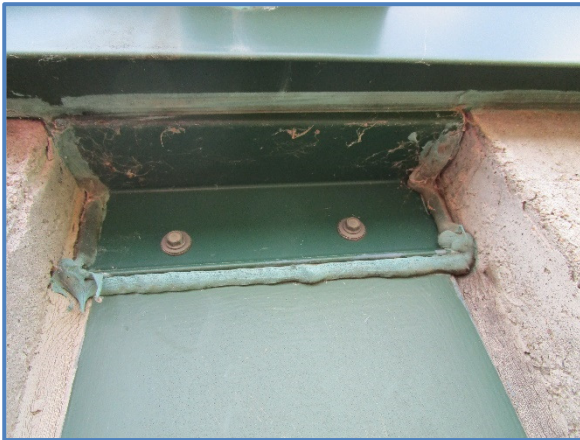
Photo 46: The metal drip edge for the roof assembly was sealed to the precast wall panel from underneath – it is reported that the metal drip edge was replaced after the original construction. A piece of metal drip edge appears to have been installed at a window head. No invasive inspection was conducted above the window assembly to document the construction in this area. The sealant around the perimeter of the metal is not continuous.

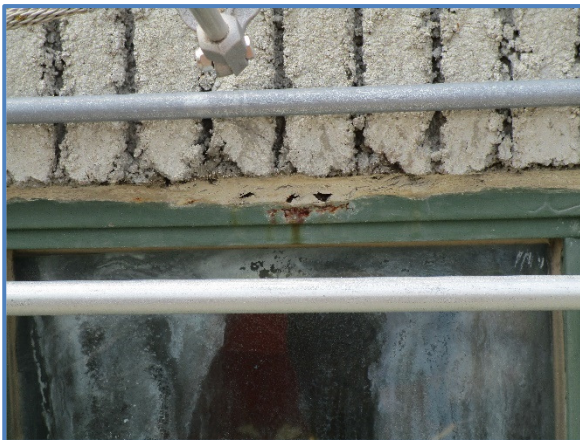
Photo 47: The caulk joint around the window assembly has deteriorated resulting in damage to the metal window frame and the glazing.

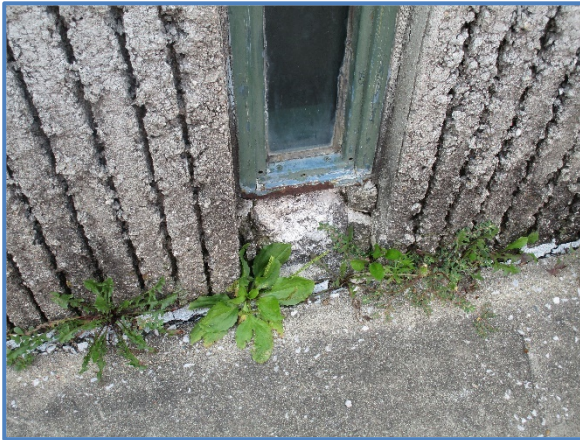
Photo 48: CMU block infill below the window assembly has been damaged. Rust is observed on the window frame.

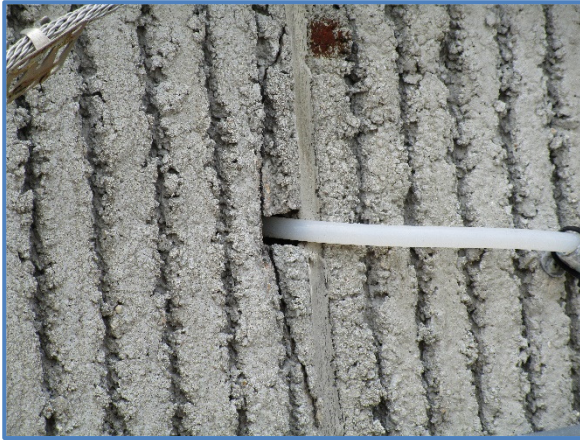
Photo 49: Multiple penetrations through the precast wall panel are unsealed. This added penetration appears to have cracked the face of the panels. Deterioration of the wall panel joint is visible throughout the exterior wall assembly. Water can run in through this penetration or be sucked in due to the negative pressure on the other side of the wall.

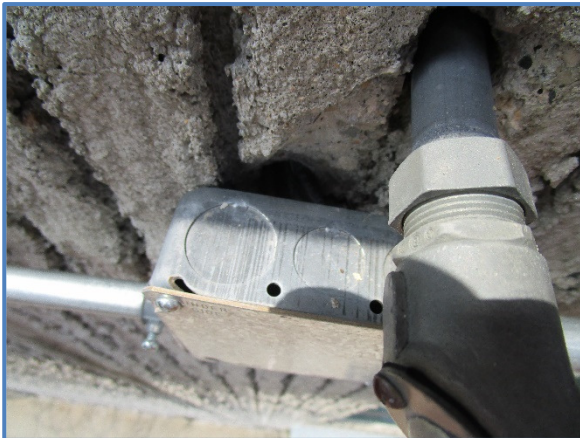
Photo 50: Multiple penetrations through the precast wall panel are unsealed. Water can run in through this penetration or be sucked in due to the negative pressure on the other side of the wall.

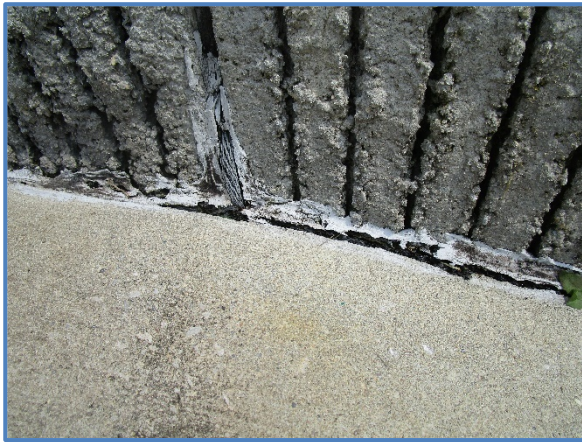
Photo 52: The caulk joints have deteriorated at the seams in the concrete wall panels as well as the joint between the wall and the sidewalk. These deteriorated joints allow for water intrusion.

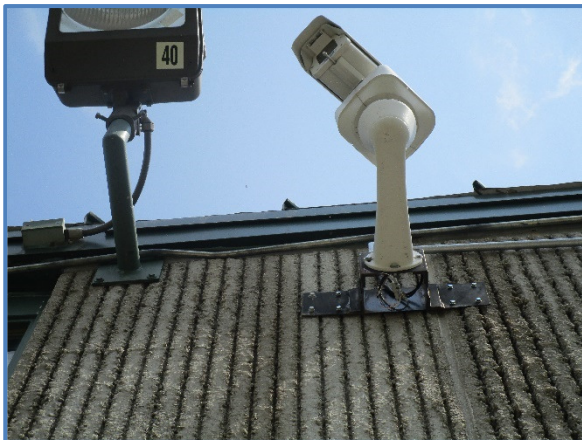
Photo 53: The metal roof panels do not extend over the metal drip edge allowing for water to roll back under the roof panels.

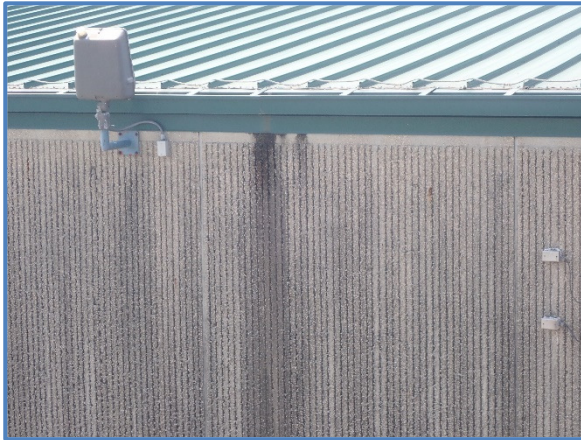
Photo 54: Staining on the concrete wall panel correlate to seams in the gutter system. Gutters are only located around portions of the Pods, not the entire perimeter as recommended for moisture management.

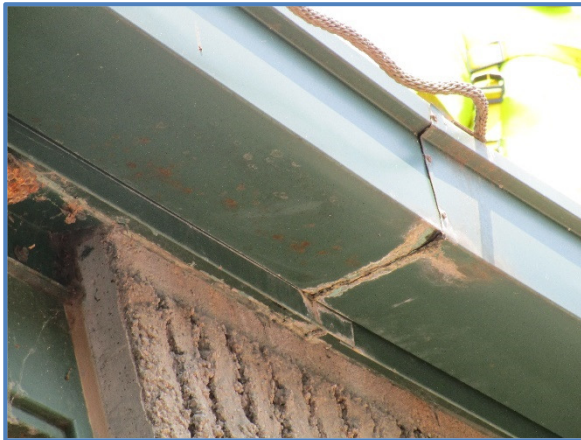
Photo 55: The gutter system has failed and does not properly manage the water from the roof. Seams in the gutter system that leak result in staining on the concrete wall panel and puddling on the sidewalk below.

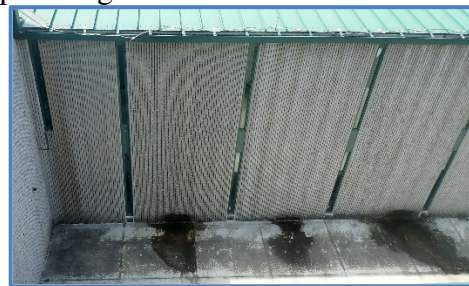
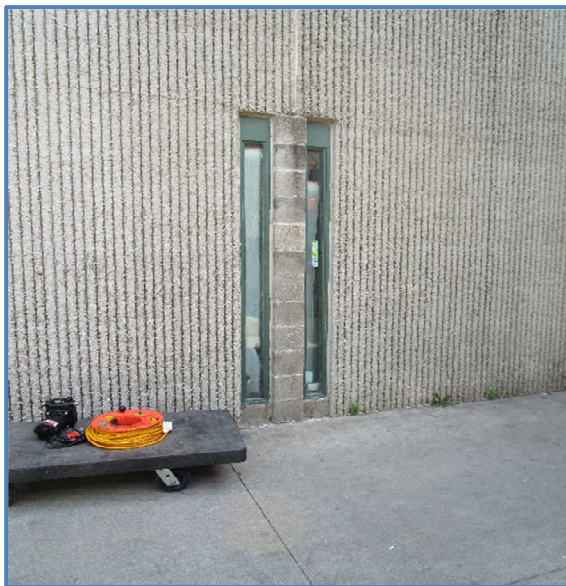
Photo 56: Around the main area of the facility CMU block is observed between the fixed windows. These blocks appear uncoated and likely allow water to penetrate as was demonstrated with the Rilem test for the CMU block at the fire walls.

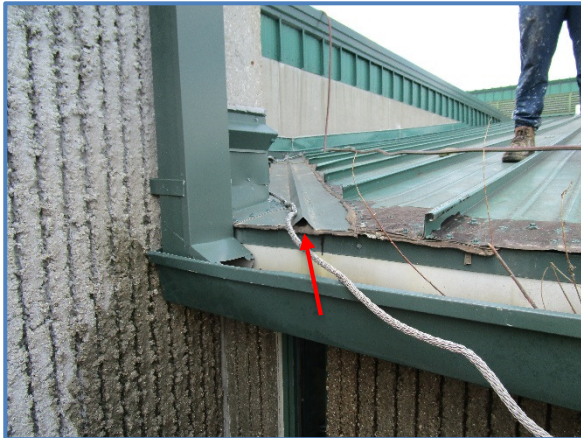
Photo 57: AAMA 501 nozzle was used to test for water penetration at the roof over Pod-C Unit 1 along the south elevation to determine the cause of the bulk water intrusion. Nozzle testing at the valley determined water entry was occurring under the panels (Red Arrow).

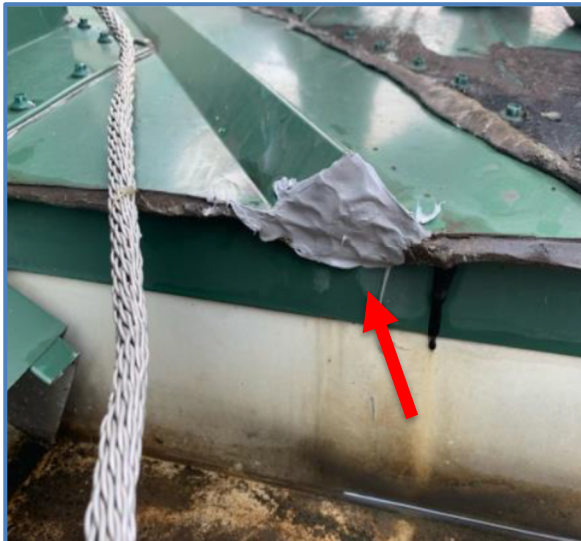
Photo 58: Temporary repair was completed by Tremco while onsite to prevent further bulk water intrusion at this location.

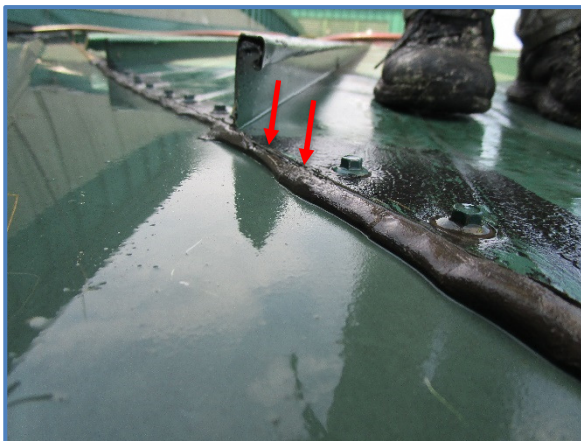
Photo 59: During the nozzle testing, bubbles occurred at the sealant joint between the roof panels and the valley pan (Red Arrows) indicating water is getting under the roof panels past the sealant joints.

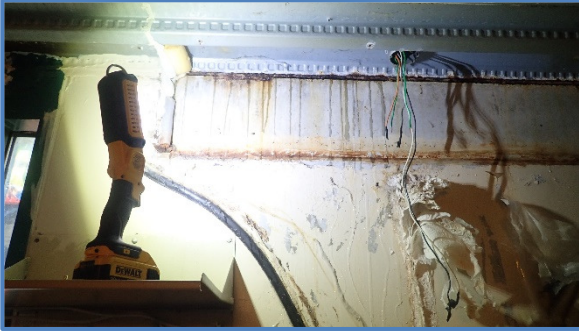
Photo 60: When nozzle testing was conducted around the valley pan, water was observed running down the inside of the precast wall panel in Pod-C-Unit 1, Cell 16. at the unsealed location behind where the light fixture had been removed.

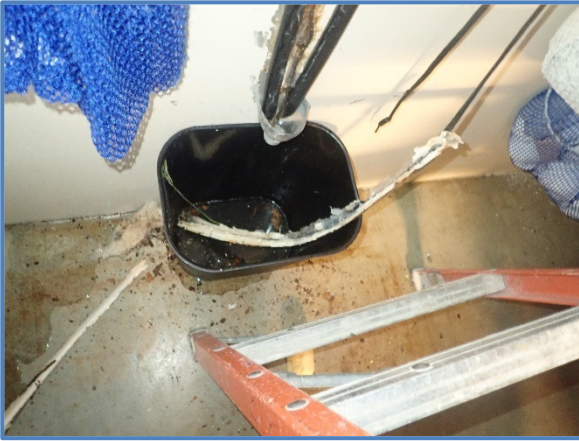
Photo 61: The trashcan filled quickly from the nozzle test around the valley pan.

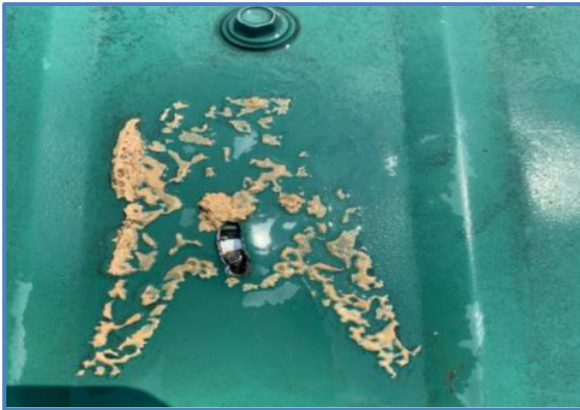
Photo 63: Hole in the metal roof panel where the lightning protection damaged the roof.

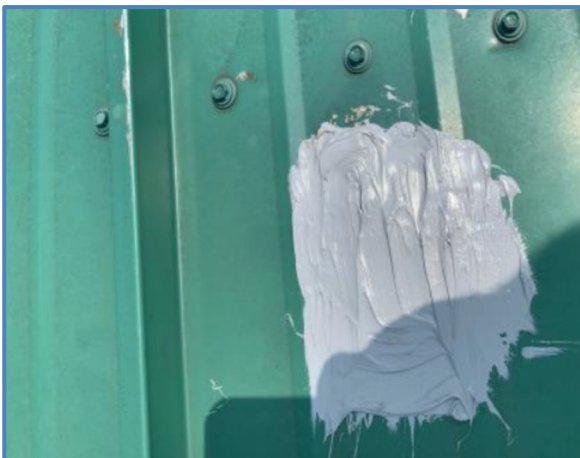
Photo 64: Temporary repair was completed by Tremco while onsite to prevent further bulk water intrusion at this location.

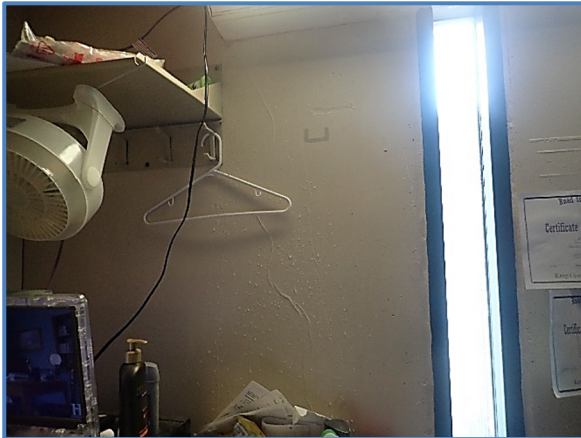
Photo 65: Water was observed running down the wall during the nozzle test at the hole from the lightening protection.

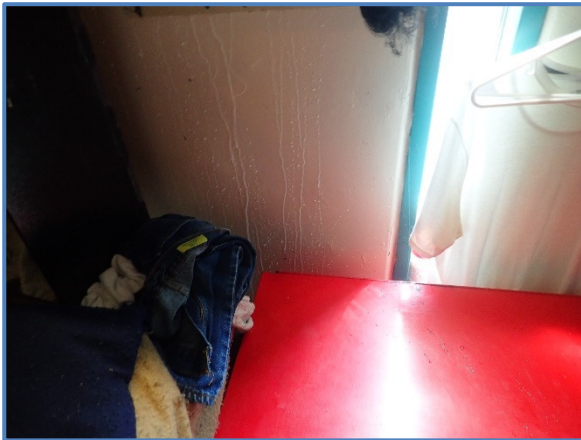
Photo 66: Water was observed running down the wall during the nozzle test at the hole from the lightening protection.

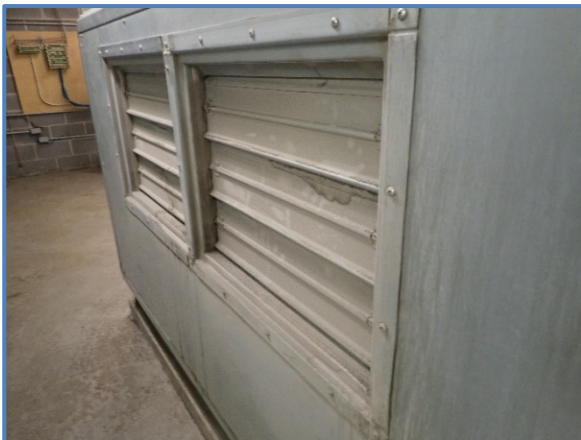
Photo 67: Relief dampers on the Pod HVAC System. Some HVAC System's relief dampers were open, some closed, some partially open. With similar indoor and outdoor conditions, the relief dampers should be tracking each other. This observation combined with the measured negative pressures strongly suggest the need to conduct retro-commissioning on the HVAC system including a test and balance to resolve the negative pressure issues.
