## **Addendum 02 for RFQ926801-02**

Project Name: DAS CC Tunnel Vent Repair  
DAS RFQ #: 926801-02  
DAS Project #: 9268.01  
Date: 5/28/24

**Subject: Hazardous Building Materials Survey Report**  
Des Moines Capitol Complex – Capitol Complex Tunnel Repair Project #9268  
E. 13th Street and E. Grand Ave  
Des Moines, Iowa  
Atlas Project No.: 204BS07103

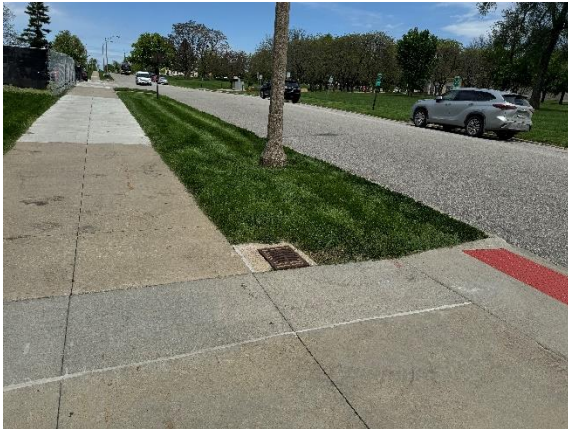
**Photo #1** Looking north along E 13<sup>th</sup> street at one of the vents.

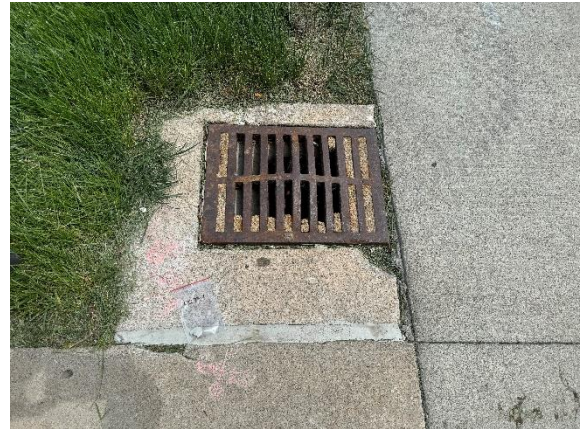
Sample	Description	Appearance	Non-Asbestos		Asbestos
			% Fibrous	% Non-Fibrous	% Type
CCT-1 <small>042409539-0001</small>	13th St. Vent - Gray Caulk	Gray Non-Fibrous Homogeneous		100% Non-fibrous (Other)	None Detected
CCT-2 <small>042409539-0002</small>	Grand Ave Vent - Lt. Gray Caulk	Gray Non-Fibrous Homogeneous		100% Non-fibrous (Other)	None Detected

**Photo #2** Caulking on metal grate at on E 13<sup>th</sup> street (vent 12+63 on map)  
Sample CCT-1

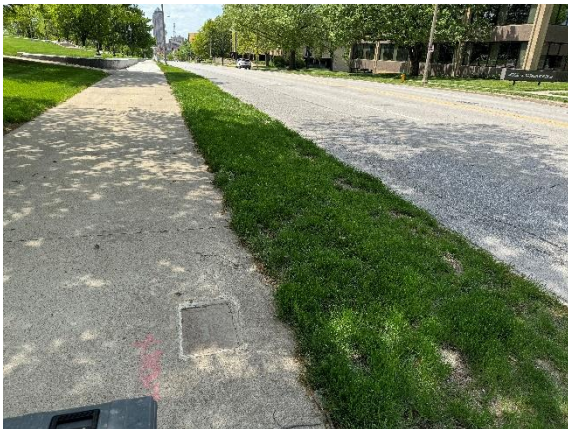
**Photo #3** Looking west along E Grand Ave at one of the vents.

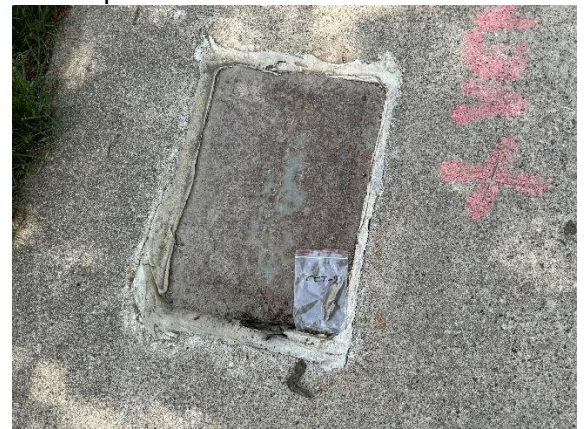
**Photo #4** Caulking on metal lid at on E Grand Ave (vent 24+67 on map)  
Sample CCT-2

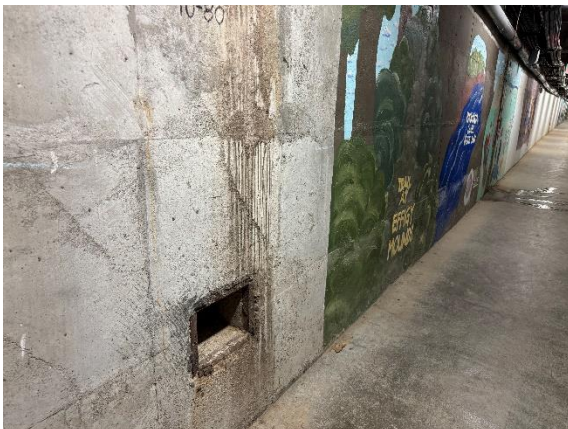
**Photo #5** Inside the E 13<sup>th</sup> Street tunnel, looking at one of the vents.

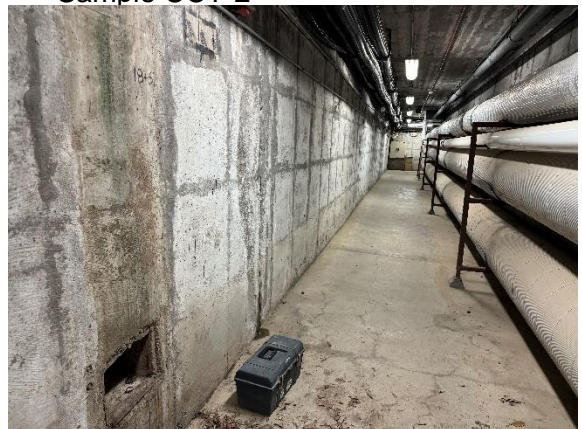
**Photo #6** Inside the E Grand Ave tunnel, looking at one of the vents.

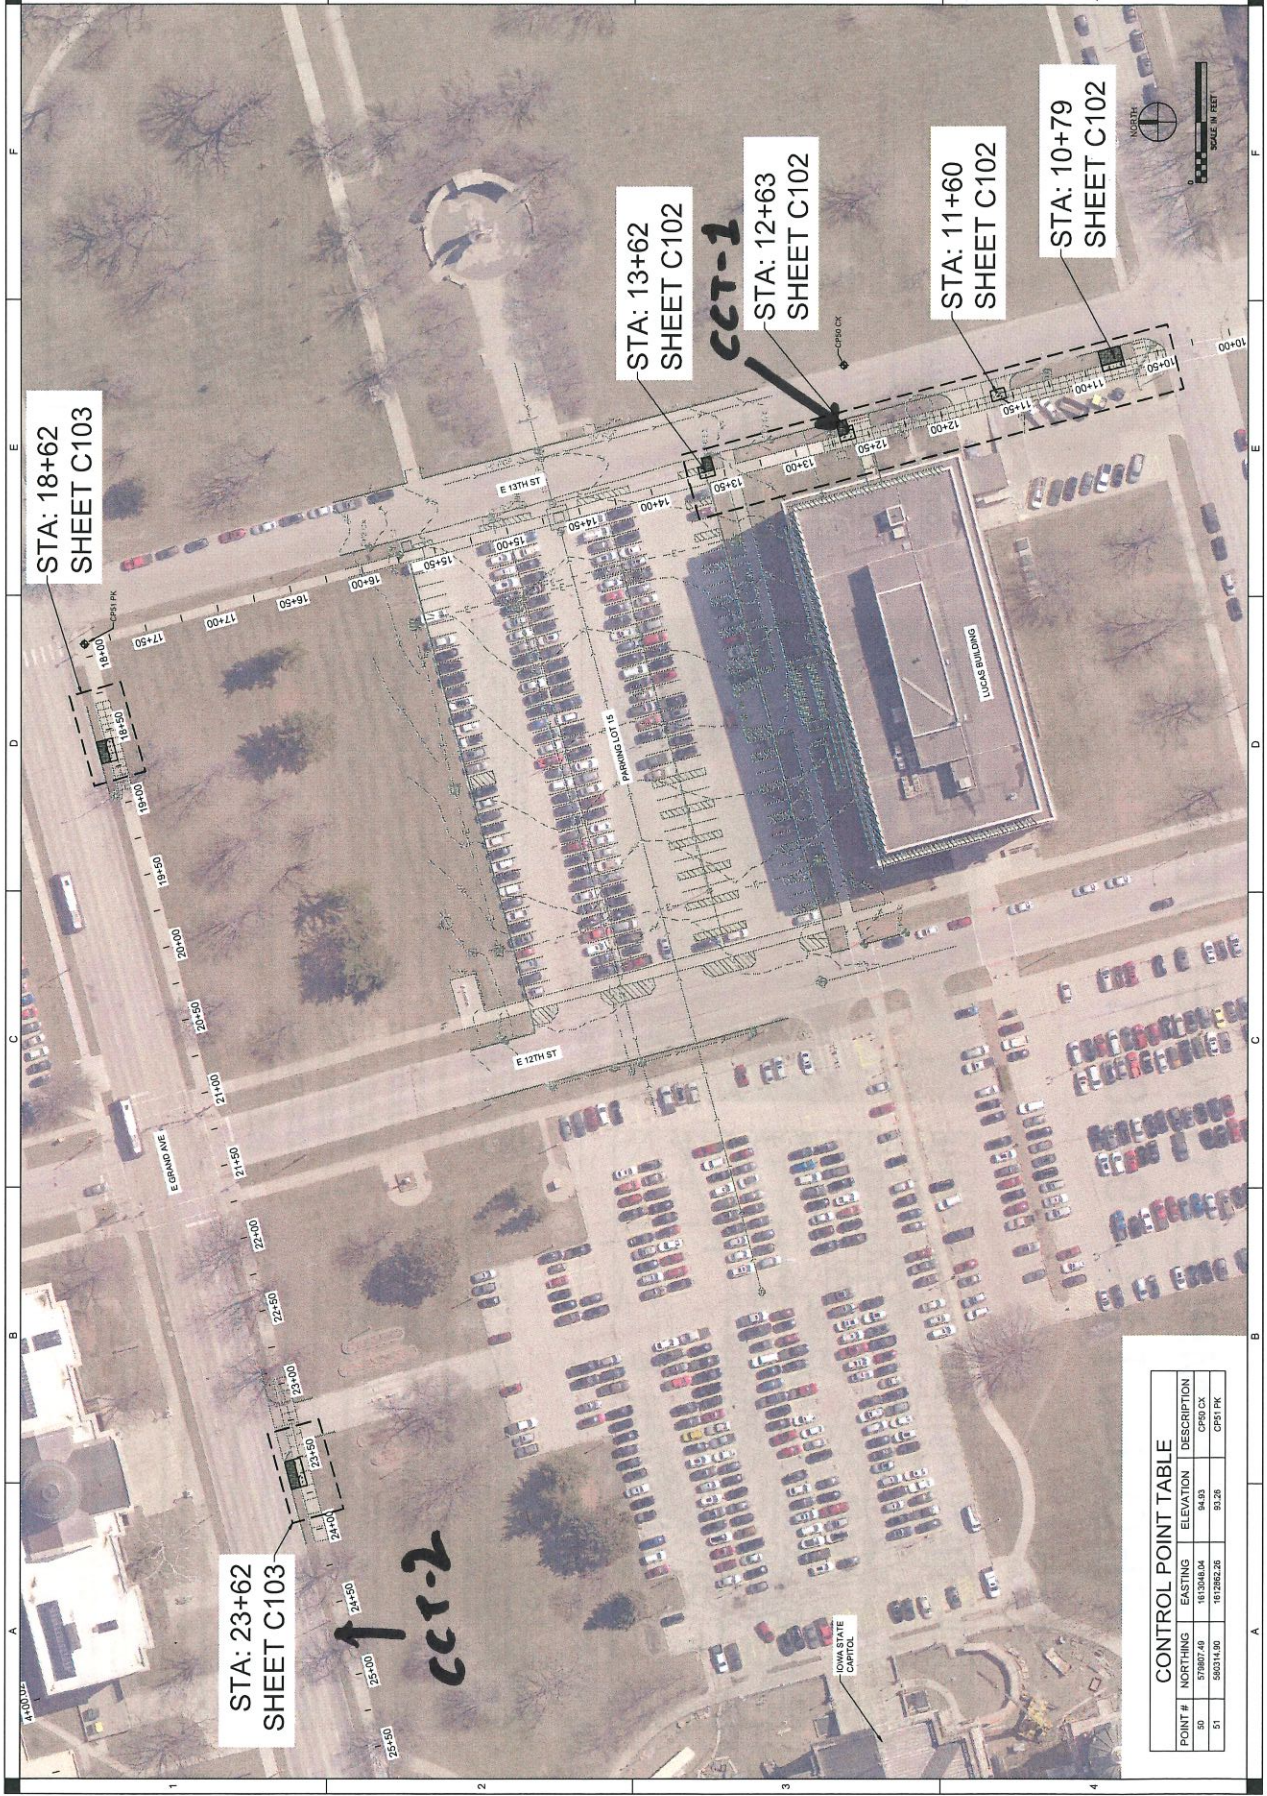
DCI Group and Shive Hattery investigated vent at 13+62, it was determined that this vent is not just beneath the dirt. According to the survey that was done, it is located under concrete.
