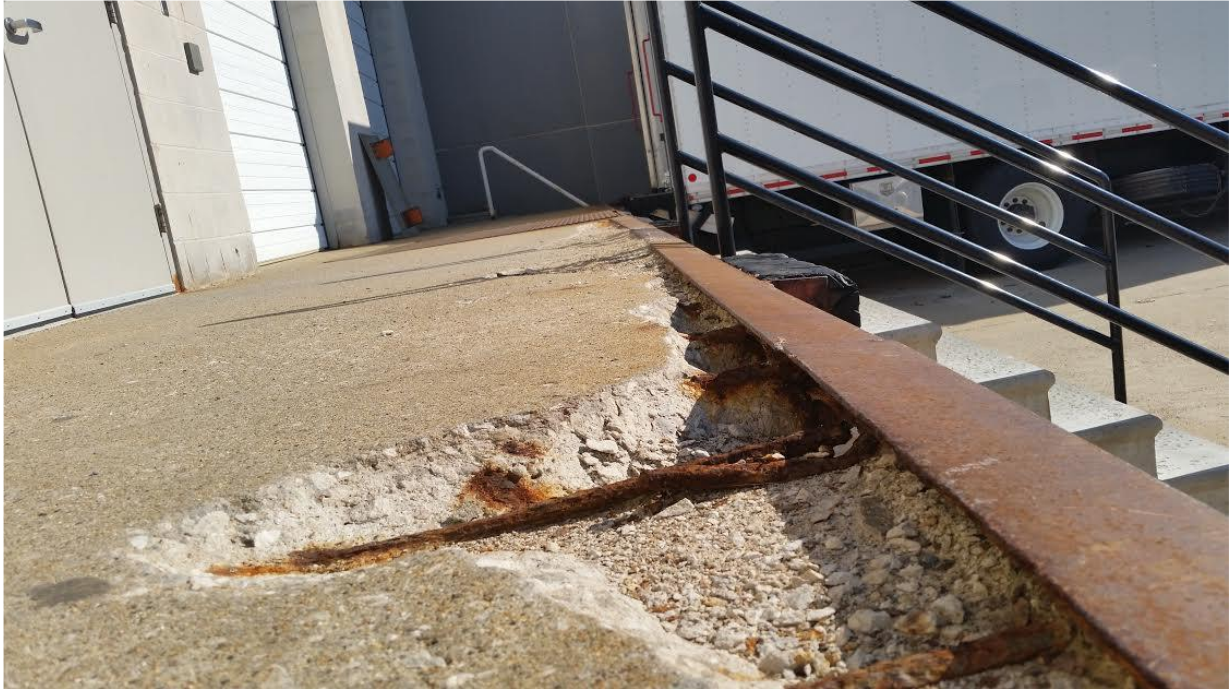
Edge of Dock, facing North. Precast stair (pre-failure) visible. 05/05/2017

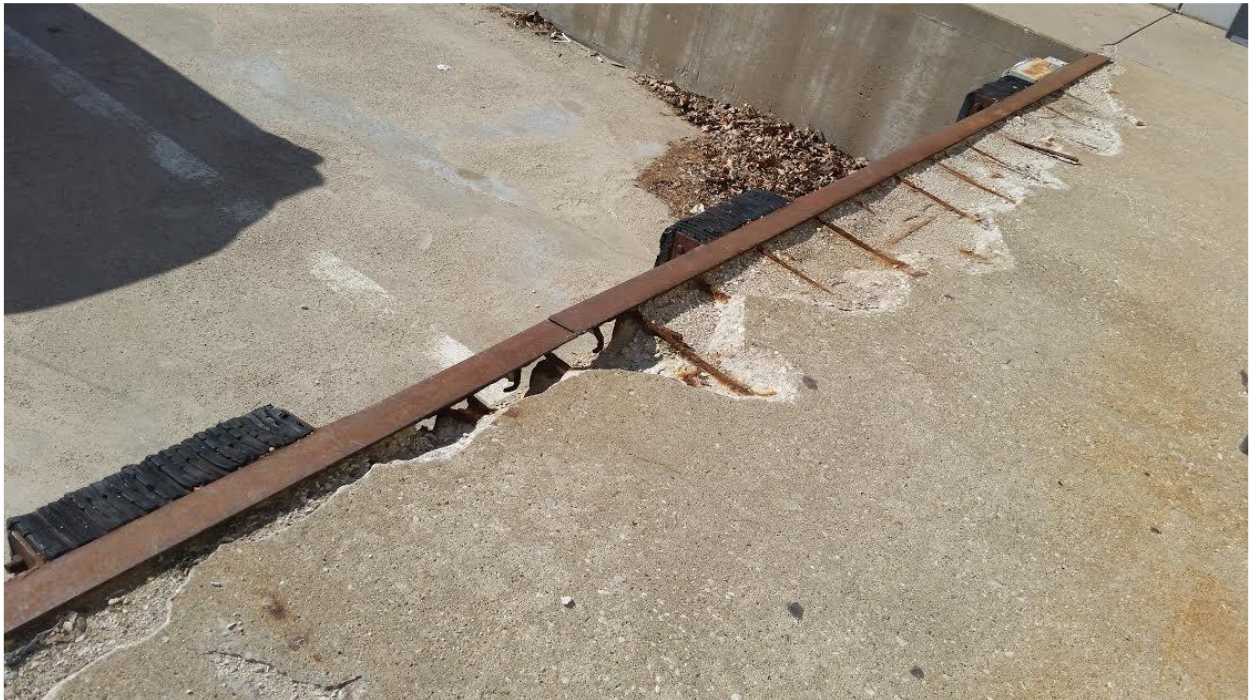
Middle of dock, facing South. Shows where concrete has eroded.
05/05/2017

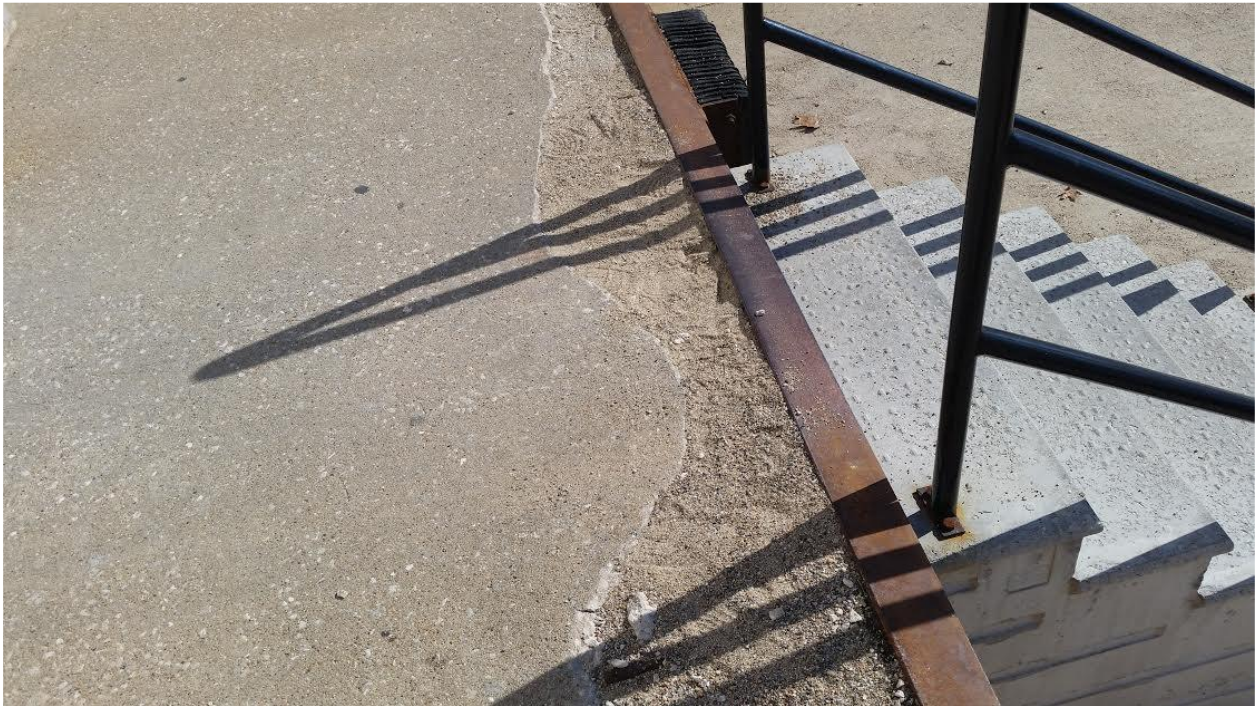
Dock area directly in front of double door entrance to building. Precast Stair (pre-failure) visible. Area where concrete eroded and filled with sand temporarily.
05/05/2017
