Ref : Law Enforcement Academy, Des Moines, IA

Based on our site visit made on the 10th of September 2024 we can inform you as follows.

There has been the problem of longitudinal cracks and deformations reported.

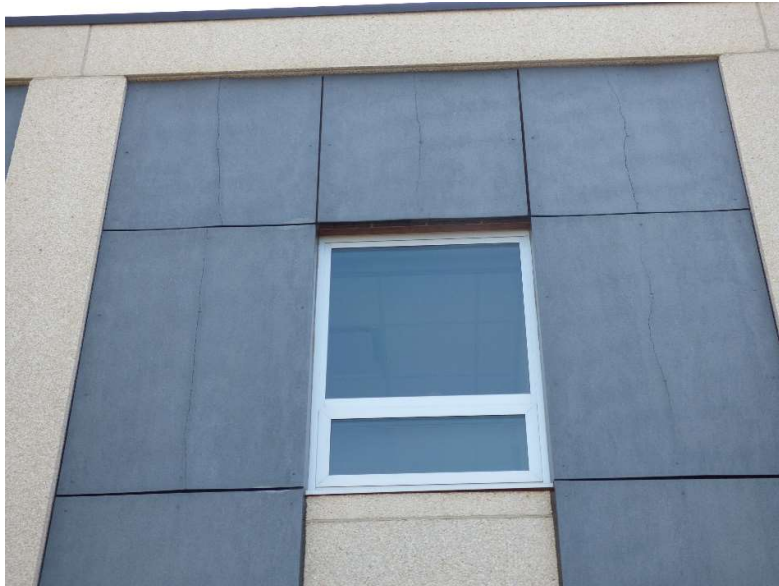
Cracked boards found on the facade

In conclusion, observed defect of the fiber cement boards installed on the facade can be attributed to a combination of factors, prominently inadequate ventilation, mistakes in fixing system and improper profiles used to support the boards.

The insufficient ventilation led to excessive deformation in the central and edge areas. Additionally, too small holes restricted any necessary expansion or contraction movement. Also the improper subframe contributed to the boards deformations as it isn't able to hold the boards in a proper way. **This combination of unfavorable conditions exceeded the material's tolerance, ultimately causing cracks to form in the central sections.**

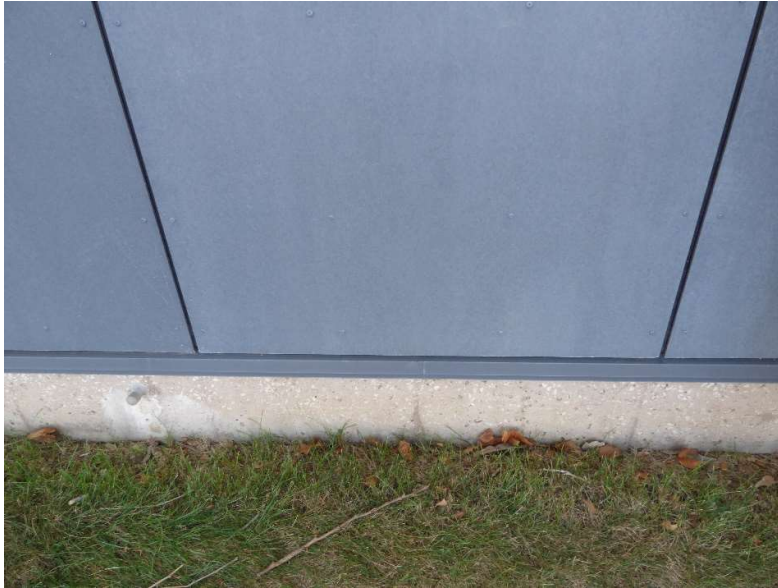
We found the whole façade as lacking the ventilation as it is shown on the following pictures.

No ventilation inlet at the bottom of the facade

To meet the general ventilation requirements, a continuous and unobstructed gap must be present behind the boards. The minimum dimensions for the air inlet and outlet should be at least 3/4 inch.

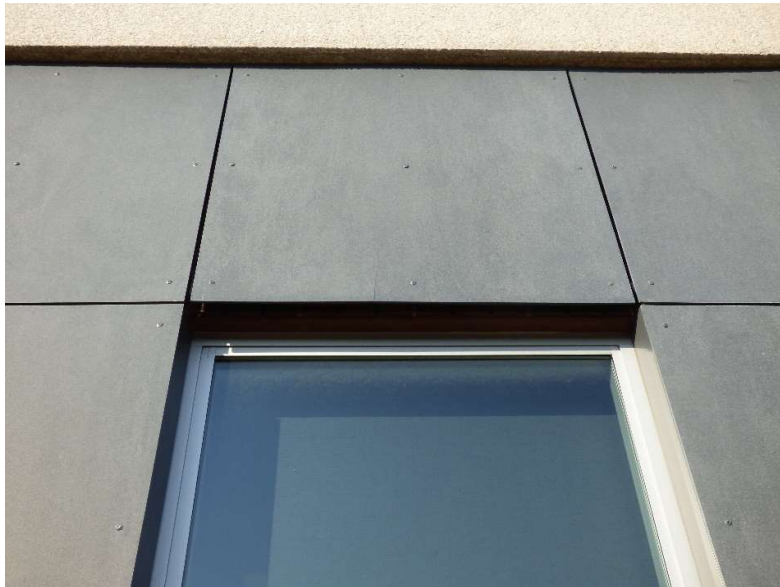
The boards are installed very tight below the parapet. There is no gap.

Fiber cement boards are subject to significant moisture movement, which increases the risk of defects in facades that are inadequately or non-ventilated. When ventilation is insufficient, the boards tend to warp and crack. This typically occurs when one side of the board becomes wet while the other remains dry, such as during periods of sunlight following rainfall or during transitional times of the day like dawn and dusk.

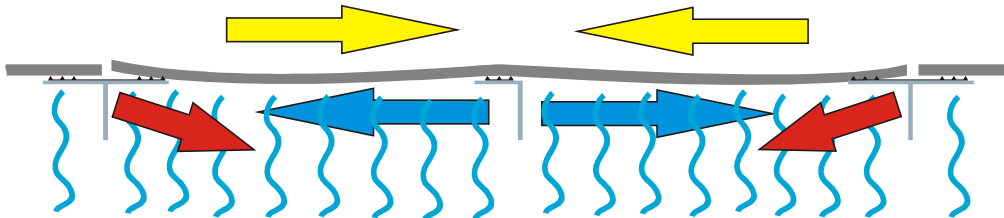
As illustrated in the accompanying image, the top side of the board remains dry and undergoes negative contraction (represented by yellow arrows), leading to shrinkage. Meanwhile, the bottom side remains wet and expands (indicated by blue arrows). This imbalance in moisture levels causes deformation, creating significant tension in the central and edge areas.

These forces become concentrated in the critical areas, which are inherently weakened by pre-drilled holes for mounting, making this region particularly susceptible to cracking. The issue is exacerbated by prolonged exposure to weather, and is most likely to first manifest on façades oriented toward the south and west, which receive the most direct sunlight.

The described phenomenon was observed and measured during an onsite inspection, confirming the impact of inadequate ventilation on the structural integrity of the fiber cement boards.

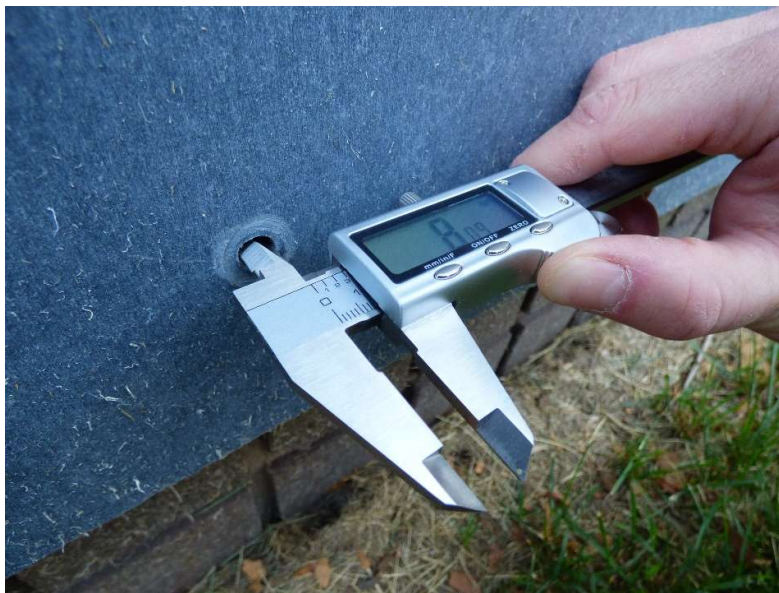
Holes are predrilled only for diameter equal to 8 mm

Too small holes restricted any necessary expansion or contraction movement caused by the natural moisture dilation of fibercement material.

3. Pre-drill holes in panel. Diameter of the fixed and gliding point holes are all 11.1mm (7/16"). Drill bits supplied by AFC.

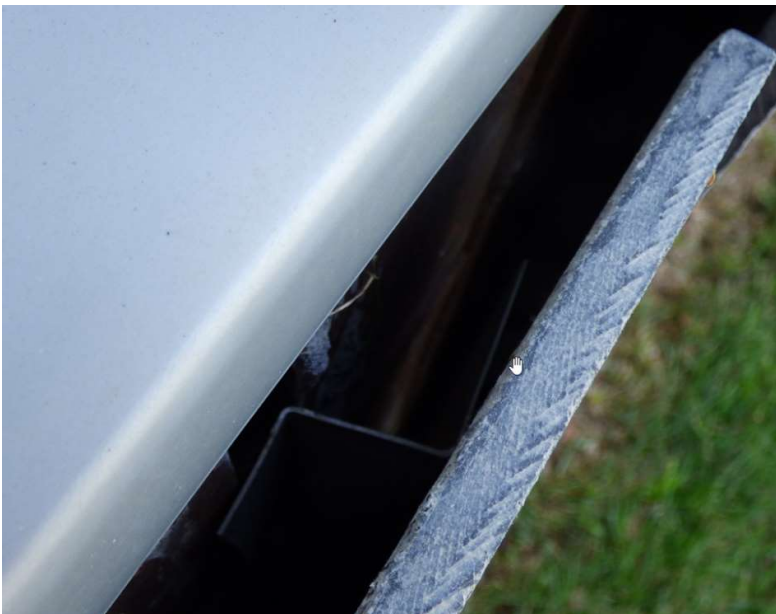
"Z" profile are visibly installed in an improper way, these are fixed askew and deformed

As shown on the previous page, the profiles don't seem to provide sufficient screw-holding strength. Also the used material and the thickness of the profiles supporting the edge areas of the boards are questionable.

We recommend to check whether the profiles meet the basic requirements.
