RE: IDAS – DOC Anamosa State Penitentiary Partial Tunnel Evaluation  
IDAS Project No. 9386.00

The purpose of this memo is to summarize our findings of the Anamosa utility tunnels in the two locations specified by the State where there were concerns regarding structural integrity. On January 30, 2024, Shive-Hattery structural engineers, Matt Mettemeyer, PE and Chris Marvin, PE completed an onsite review of two areas of the utility tunnels to observe conditions and evaluate the need for remedial measures to maintain operation. Locations reviewed were Tunnels 6, 6A, 7, and 8, located north of Living Units B and D and tunnels 5, 5A, 5B, and 5C located at the north central portion of the yard.

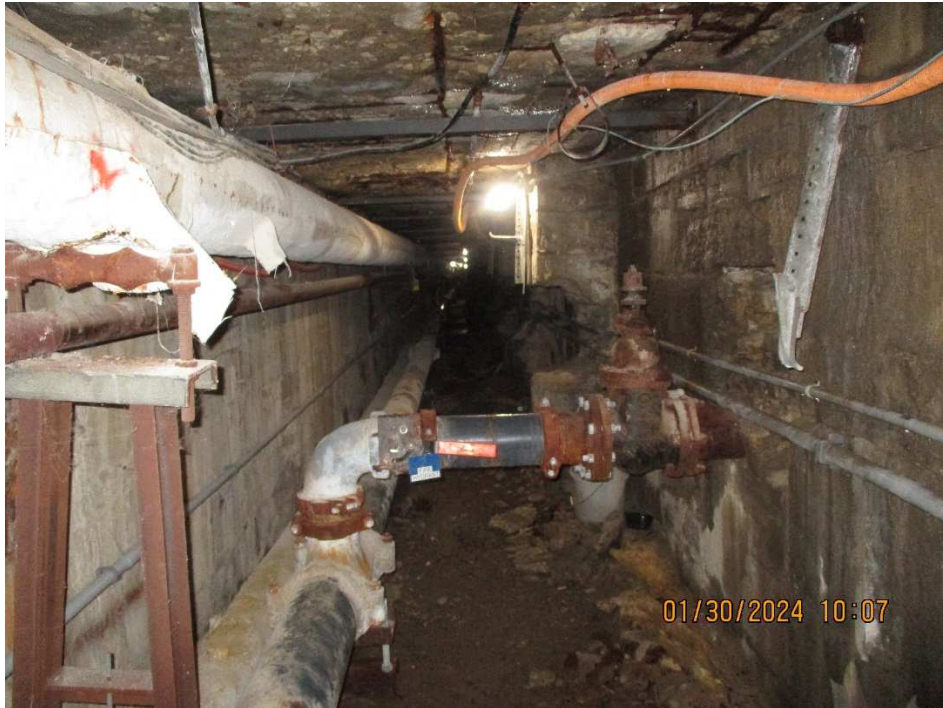
*Photo 1: Location 6*

Tunnel appears to house steam, water, electrical, and communication lines. Walls were made of concrete in front of Living Unit D and transitioned to stone about 100 feet to the east towards Living Unit B. Walls are in decent condition overall considering their age. Tunnel roof is concrete and is severely deteriorated. There is a significant amount of spalled concrete on the floor that has fallen from the underside of the roof. There is at least one crack in the roof that is visible from the pavement above. The majority of the tunnel roof has spalled and delaminated concrete with visible corroded reinforcement with significant section loss.

Tunnels 6, 6A, 7, and 8 are severely deteriorated. The structural capacity of the roof over this tunnel is significantly diminished. Large vehicles should be prevented over this area unless temporary shoring is installed in this area of the tunnel, which is approximately 350 feet in length. Foot traffic and small vehicles such as golf carts are acceptable. Repairs to this area, including roof replacement, should be planned for within the next two years. Full closure in certain areas or emergency shoring may be required before repairs can occur. The tunnels should be monitored for any additional significant concrete spalling, cracking, settlement, or failure that may pose potential hazards at the surface and/or

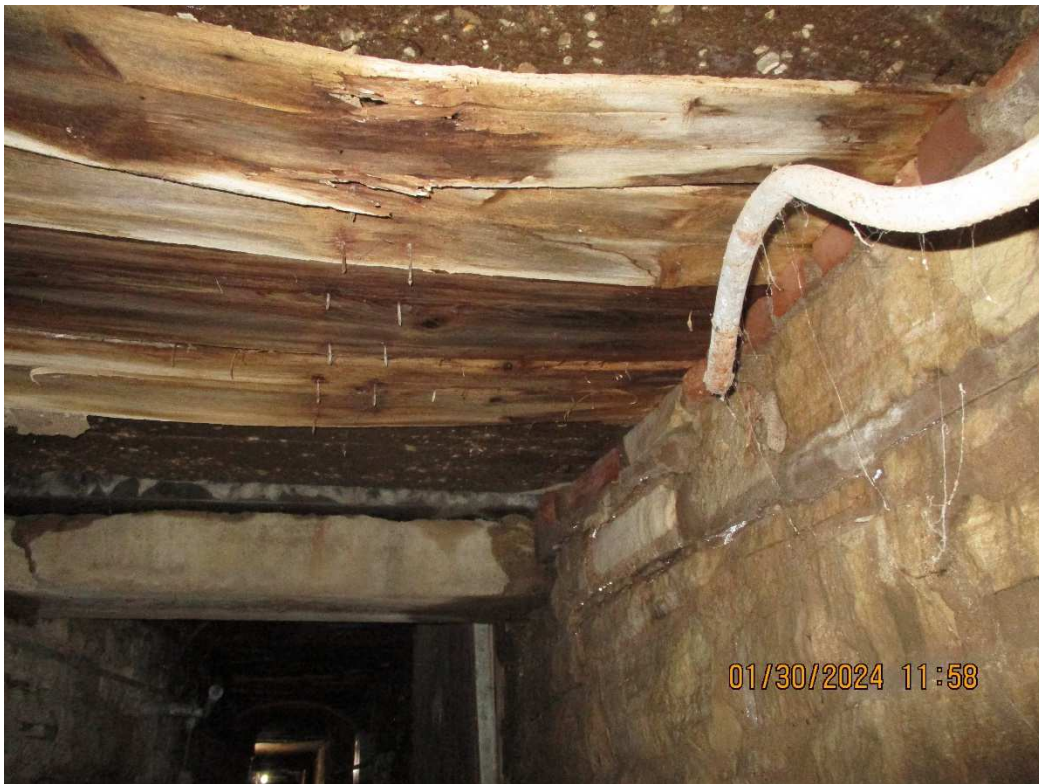
Photo 8: Location 5

This tunnel appears to only house a water line and some minor electrical cables. At one location near the far north end there is a large section of concrete crossing and partially obstructing the tunnel that likely houses another utility. Walls consist of stacked limestone and roof is concrete with some wood forms left in place. Walls appeared to be in good condition for their age with some signs of stone degradation including mineral deposits where ground water had leached through the walls. Portions of the tunnel roof appeared to have been repaired in the past with full depth replacements. Near the north end of the tunnel the roof is severely deteriorated. There are large spalls and delaminations in the roof with exposed reinforcement that is severely corroded with significant section loss. The roof at this location appears to be supported by the iron gate below, preventing the gate from being opened. This area of the roof also has some substantial cracking visible from the surface. The facility has barricaded this area to prevent any loading on the roof.

Tunnels 5, 5A, 5B, and 5C is severely deteriorated at the north end. This area should remain barricaded until the roof can be replaced. If the facility leaves the barricades in place until the repairs are complete, no temporary shoring is needed in this area. The recommended repair includes approximately 25 linear feet of full depth roof replacement. The rest of this area of the tunnel is anticipated to last longer than 2 years. The attached opinion of probable construction costs, based on current construction data and bid results, suggests approximately \$67,000 for recommended repairs. Consideration could also be given to abandoning the tunnel due to the limited number of utilities in this section. Abandonment or relocation of utilities should only be considered along with verification that utility operations and access to the other tunnels at the facility would not be impacted. Abandonment of this tunnel may include filling the tunnel with a low strength grout mixture followed by a removal of the roof and repouring the sidewalk as a slab on grade.
