# **Addendum 1 for RFB951900-01**

Project Name: IMHI Infirmary Building Roof Replacement  
DAS RFB #: 951900-01  
DAS Project #: 9519.00  
Date: 8/18/2026

# **ASBESTOS INSPECTION REPORT**

**Independence Mental Health Institute  
Infirmary Roof  
2277 Iowa Ave  
Independence, IA 50644**

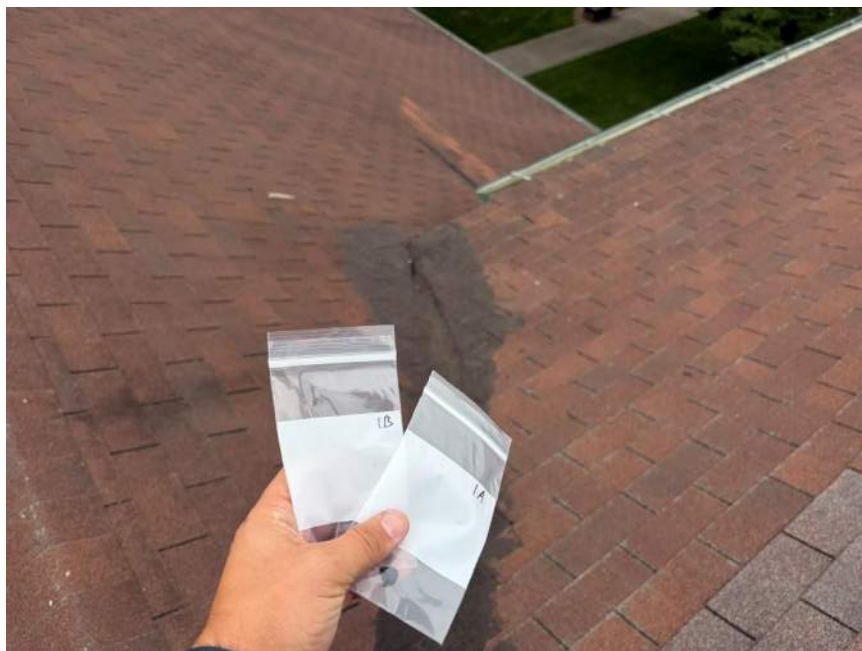
1A-Hard Rubberized Coating, Roof Valley SW Side-None Detected  
1B-Hard Rubberized Coating, Roof Valley SW Side-None Detected

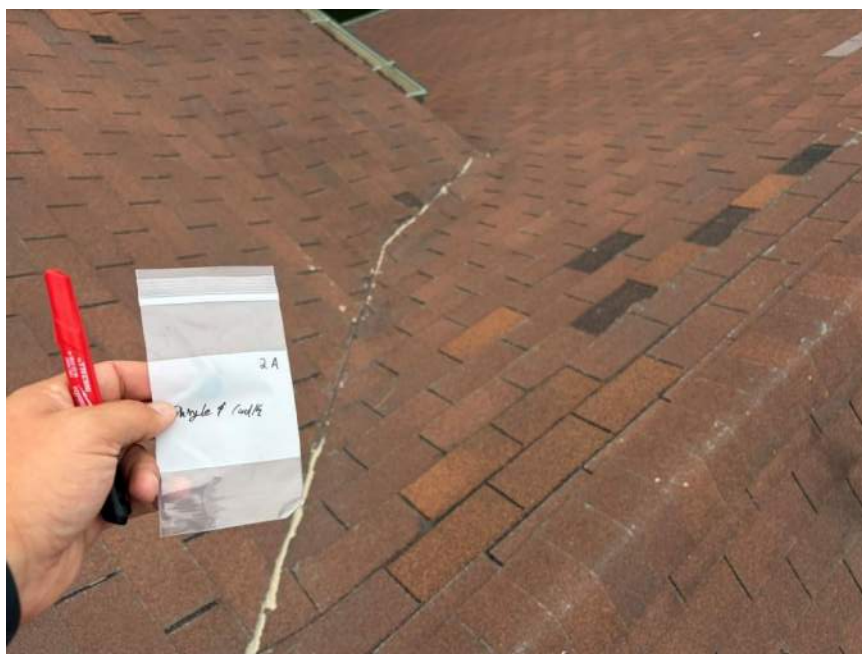
2A-Shingle, Middle Upper Roof SW Facing Side-None Detected

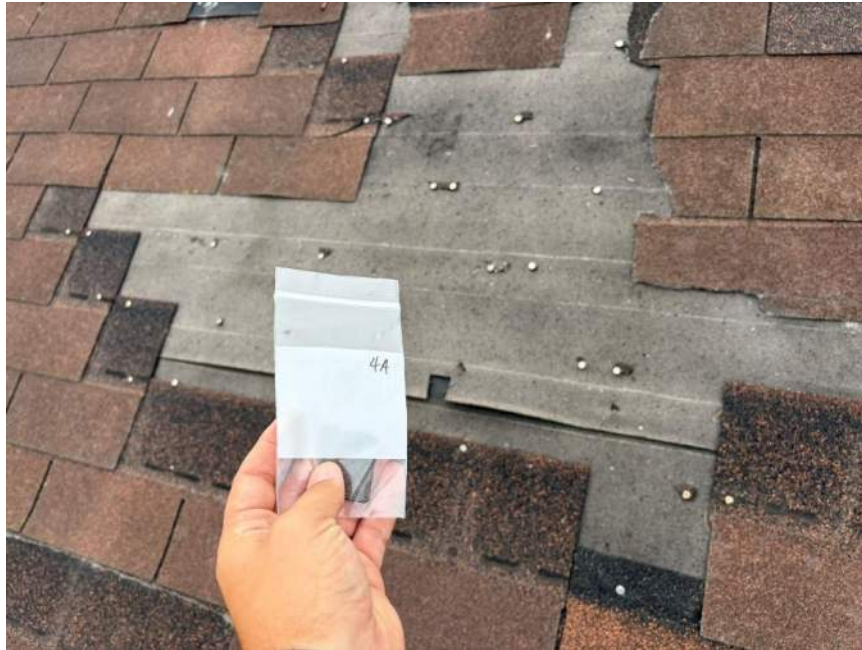
4A-Roofing Felt, Middle Upper Roof NE Facing Side-None Detected

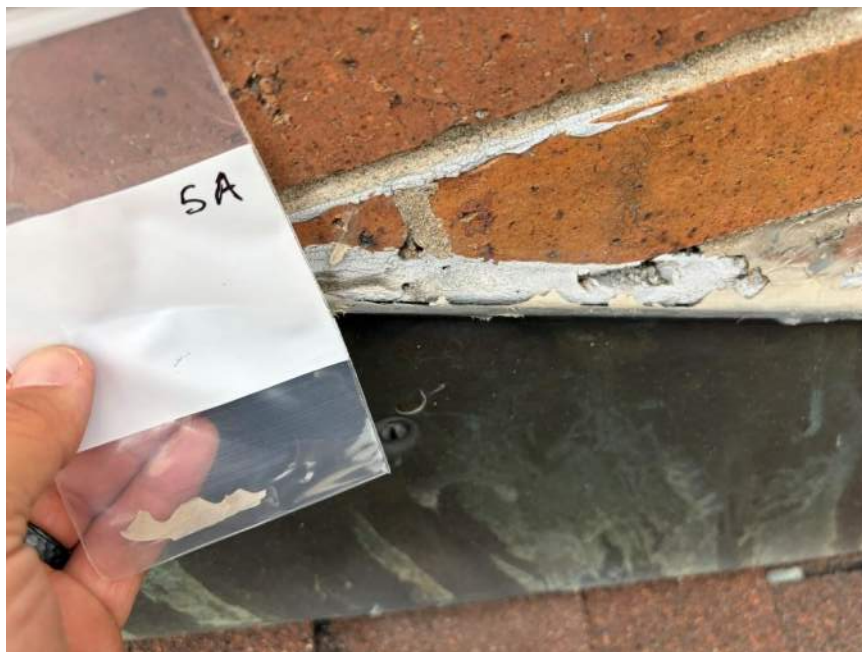
5A-Caulking, Middle Upper Roof NW Facing Side-None Detected

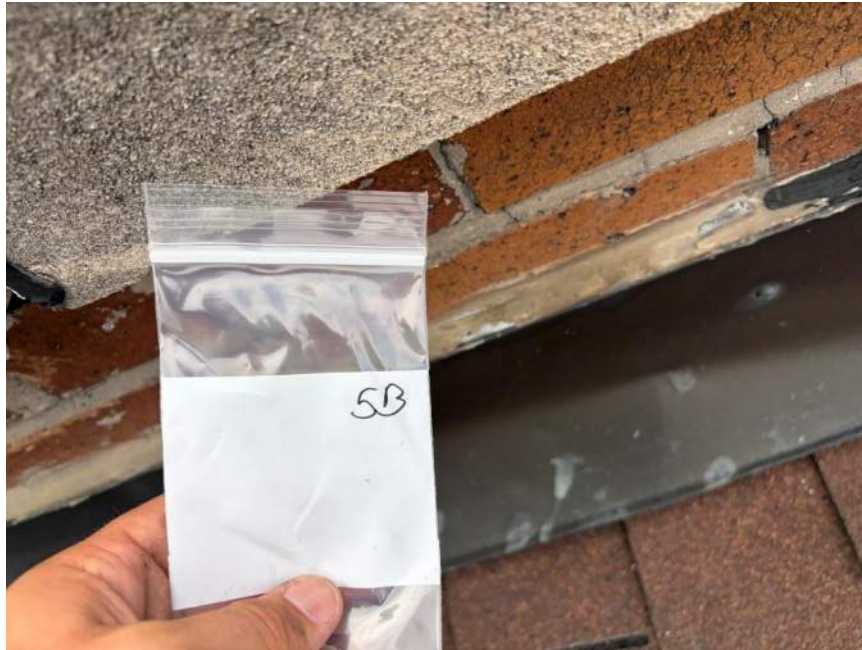
5B-Caulking, Middle Upper Roof NW Facing Side-None Detected

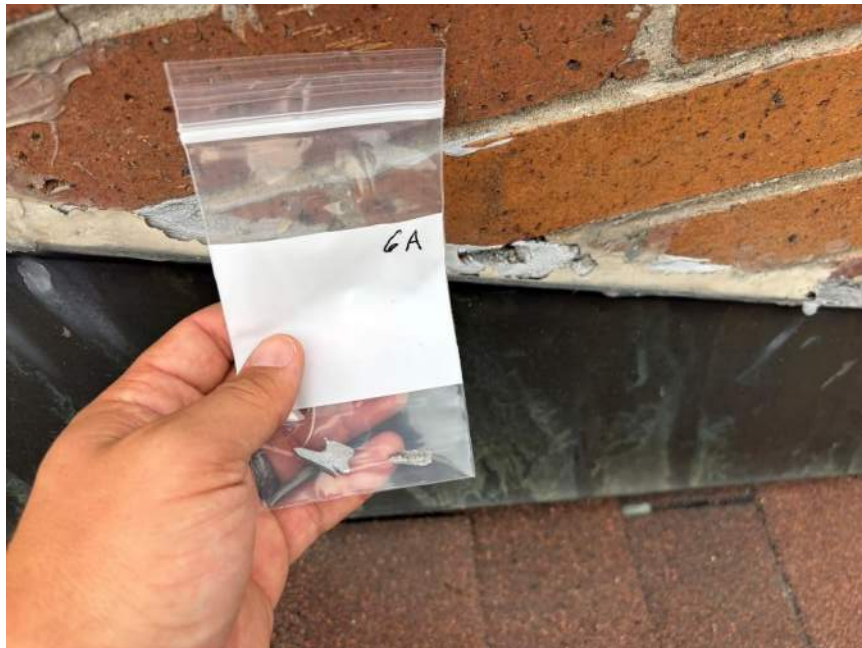
6A-Caulking, Middle Upper Roof NW Side-None Detected

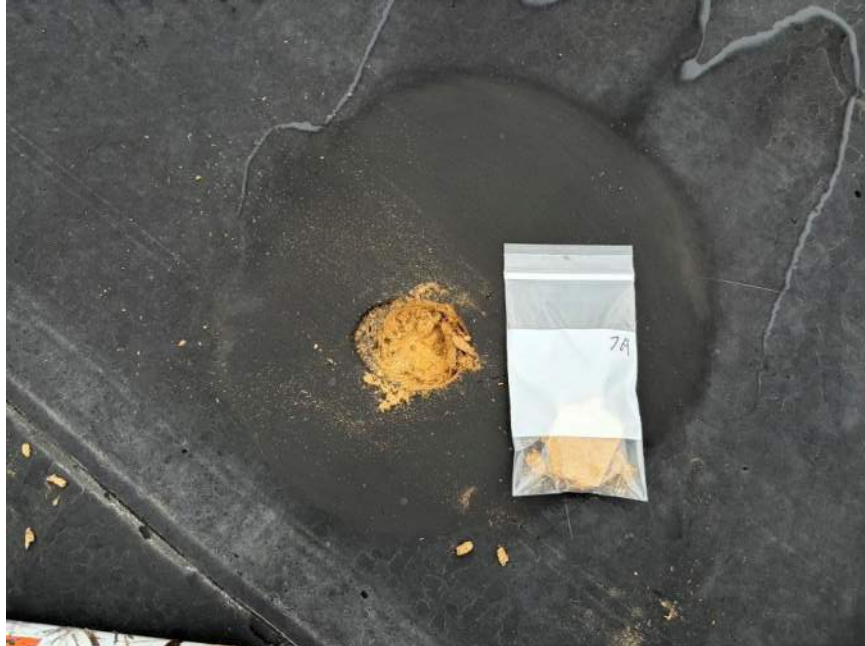
7A-Flat Roofing Core, Northern Most Flat Roof-None Detected

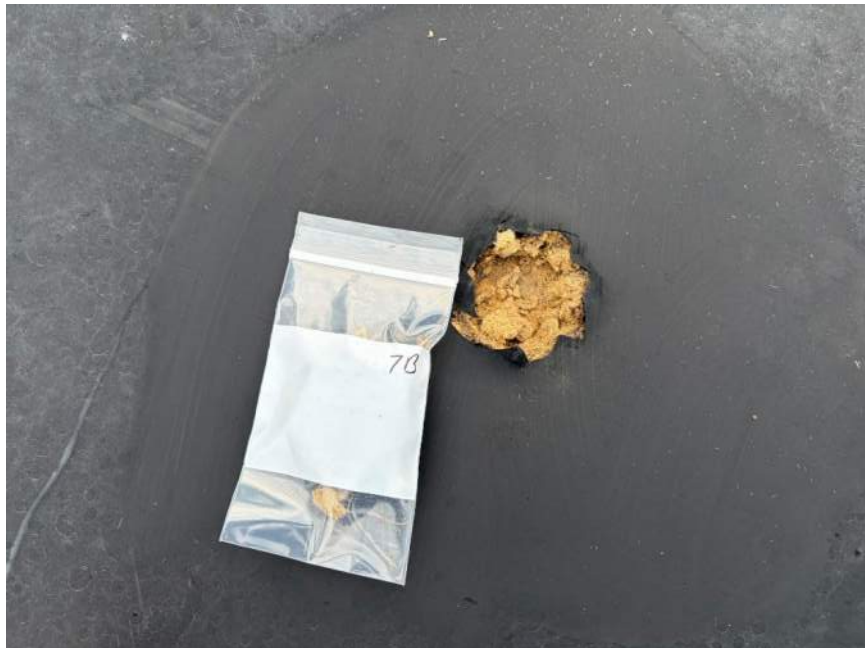
7B-Flat Roofing Core, Southern Most Flat Roof-None Detected

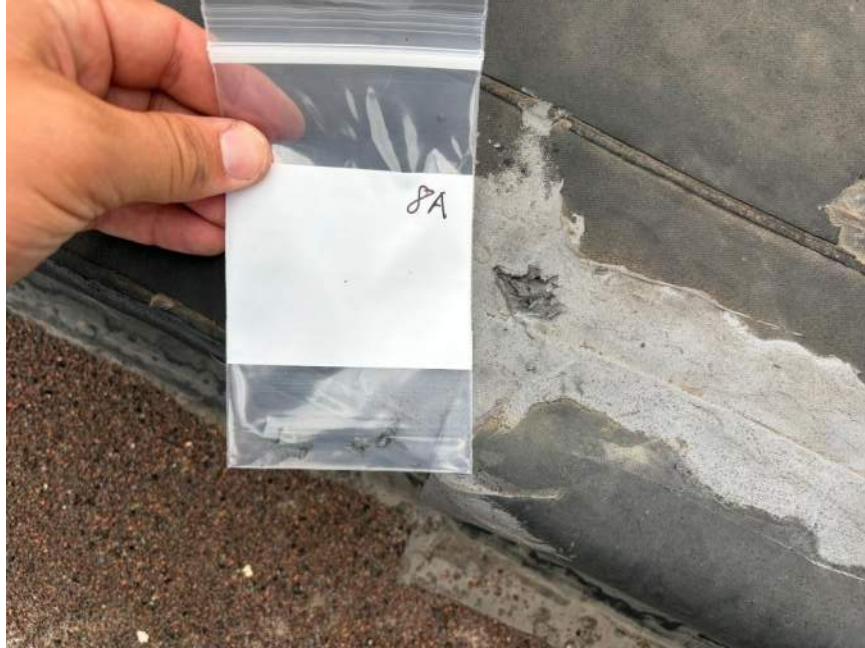
8A-Parapet Tar, Southern Most Flat Roof-None Detected

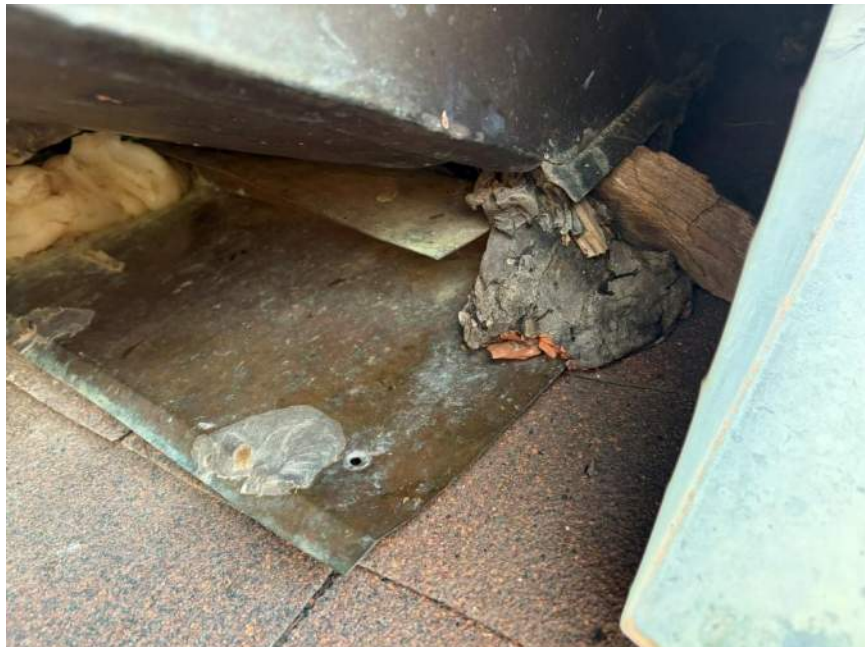
| Material | Color | Location | Results | Qty |
|---|---|---|---|---|
| Tar | Black | Middle Upper Roof Southern Overhang | Chrysotile 5% | 20 Sq Ft. |

| # | Sample No | Material | Color | Location | Current Condition | Results |
|---|---|---|---|---|---|---|
| 13 | 9A | Roofing Tar | Black | Middle Upper Roof Southern Overhang | Good | Chrysotile 5% |

9A-Roofing Tar, Middle Upper Roof Southern Overhang-Chrysotile 5%

1: Removal of all asbestos containing materials prior to demolition by a Permitted asbestos company with the Iowa Department of Inspections, Appeals, and Licensing.

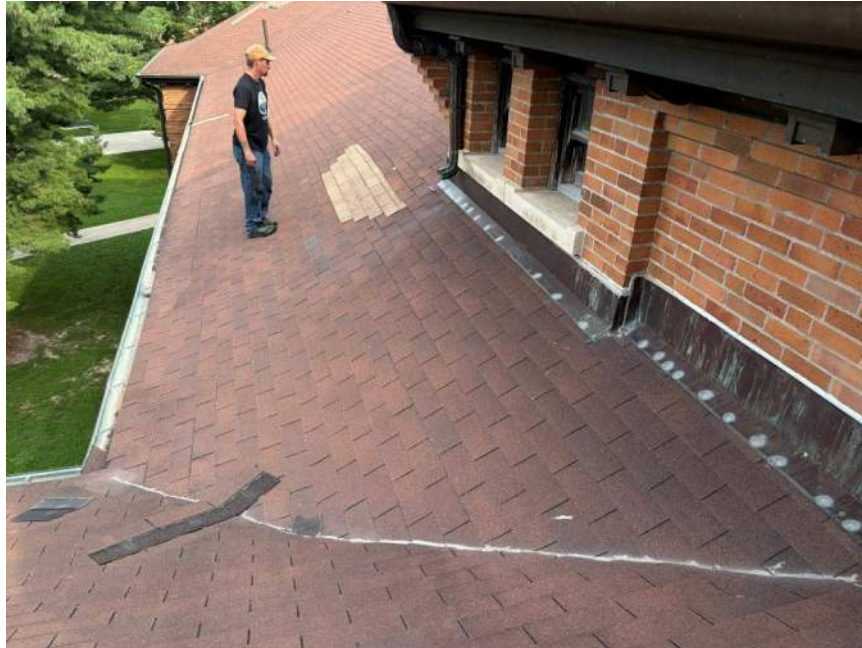
10A-Shingle, North Western, Lower Roof Patch-None Detected

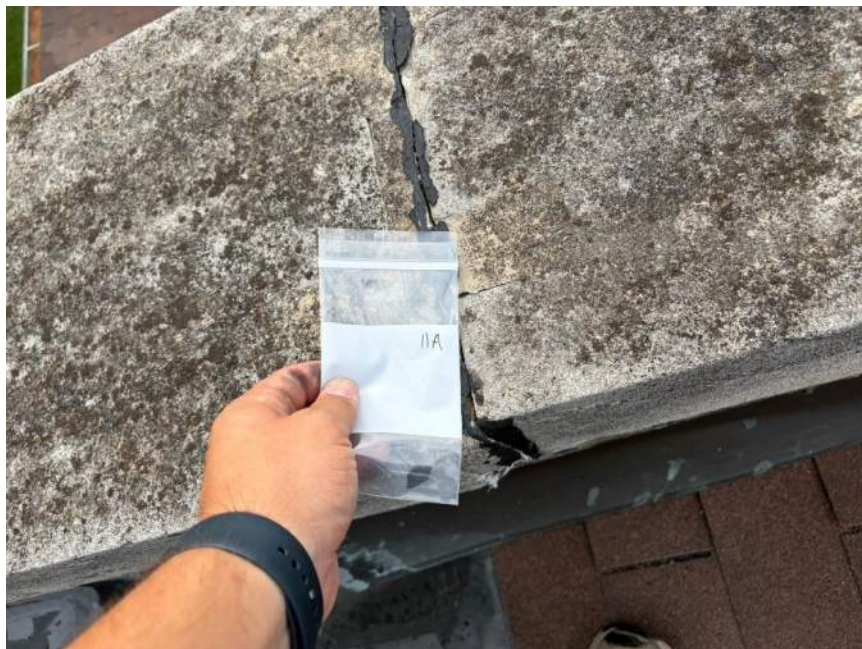
| Material | Color | Location | Results | Qty |
|---|---|---|---|---|
| Tar | Black | Seam Tar on Masonry Detail Middle Upper Roof | Chrysotile 3% | 75 Linear Ft. |

| # | Sample No | Material | Color | Location | Current Condition | Results |
|---|---|---|---|---|---|---|
| 15 | 11A | Roofing Tar | Black | Middle Upper Roof Northern Parapet Seam | Good | Chrysotile 3% |

11A-Roofing Tar, Middle Upper Roof Northern Parapet Seam-Chrysotile 3%
