To: All Potential Respondents  
From: Construction Procurement  
Subject: RFQ939700-01 IVH Dispatch Building Repair

# HAZARDOUS BUILDING MATERIALS SURVEY REPORT

DVA IVH Dispatch Building Repair Project #9397  
1301 Summit Street  
Marshalltown, Iowa

**Re: Hazardous Building Materials Survey Report**  
DVA IVH Dispatch Building Repair Project #9397  
1301 Summit Street  
Marshalltown, Iowa  
Atlas Project Number: 204BS07513

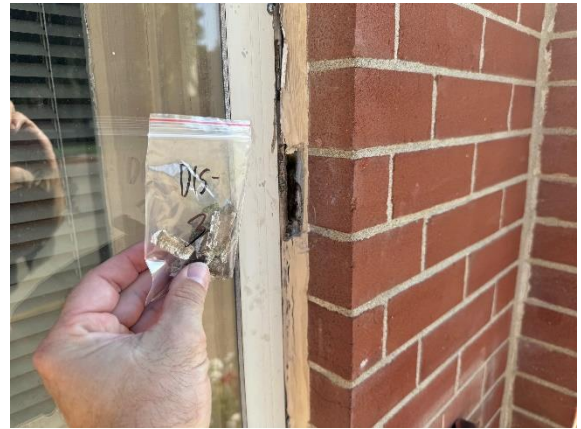
**Photo #2** Looking at the exterior window caulking. (DIS-3, 20-35% Chrysotile)

- Asbestos was identified in the window caulking and the caulking around the exterior SE door frame.
- Lead-based paint was identified in the light tan paint on exterior doors and windows.
- Lead-containing paint was identified in the tan, green, silver, light olive, gray, and white paints found on walls and miscellaneous surfaces on the building interior.

- h. Contractor shall be aware of asbestos containing materials in the joint sealants at windows and a door frame as well as lead containing paint at the windows. Asbestos removal at the window sealants and the removal of loose paint at the windows will be conducted by a third party abatement contractor prior to work beginning. Reference Exhibit F for the Hazardous Materials Report conducted by Atlas.

- iii. This contractor shall be responsible for all new backer rods and joint sealants between the windows and masonry.
  - iv. This contractor shall be responsible for the patching of existing ceilings to match existing finishes following the removal of temporary shoring.
