Addendum 02 for RFB935800-01

Project Name: Lucas ICN CRAC Replacement
DAS RFB #: 935800-01
DAS Project #: 9358.00
Date: 6/18/24

DAS PROJECT # 9358.00 LUCAS BUILDING ICN CRAC UNIT REPLACEMENT

HAZARDOUS BUILDING MATERIALS SURVEY REPORT

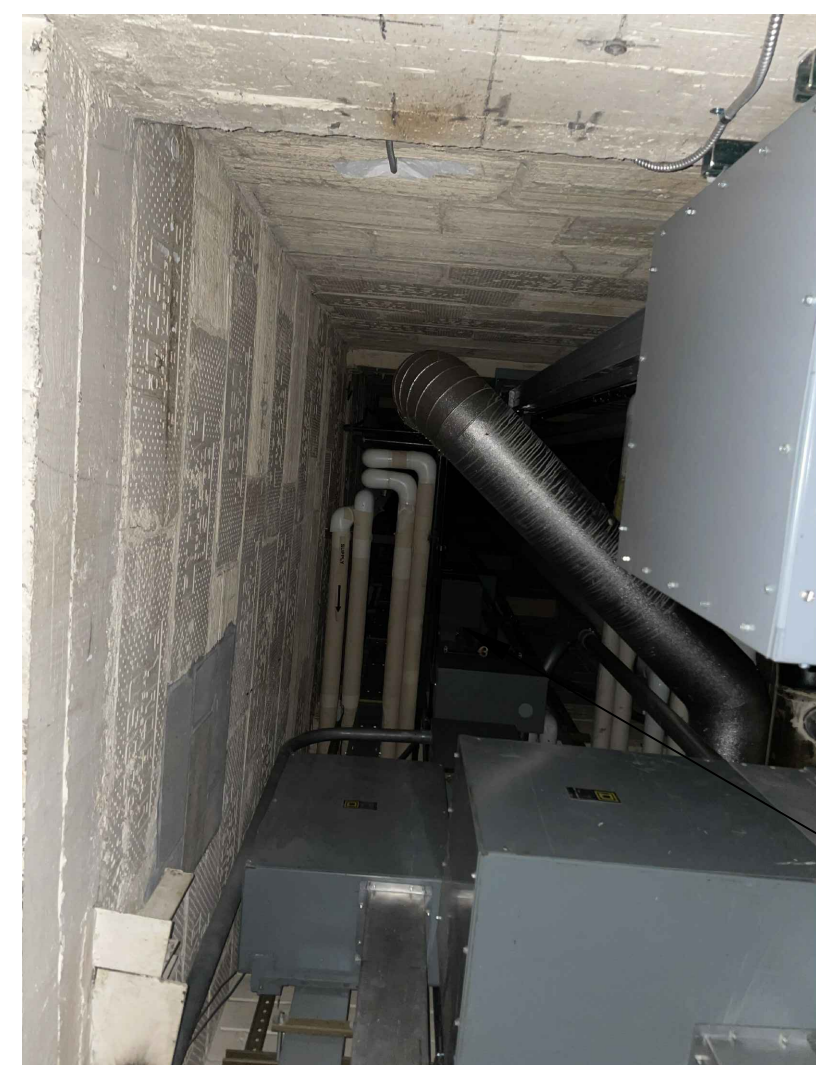
2 PICTURE OF EXISTING SHAFT PIPING

PIPING ASSOCIATED WITH REMOVED CRAC UNITS IN SHAFT SHALL BE REMOVED ALL THE WAY UP TO PENTHOUSE. REFER TO ROOF DEMO SHEET FOR CONTINUATION.

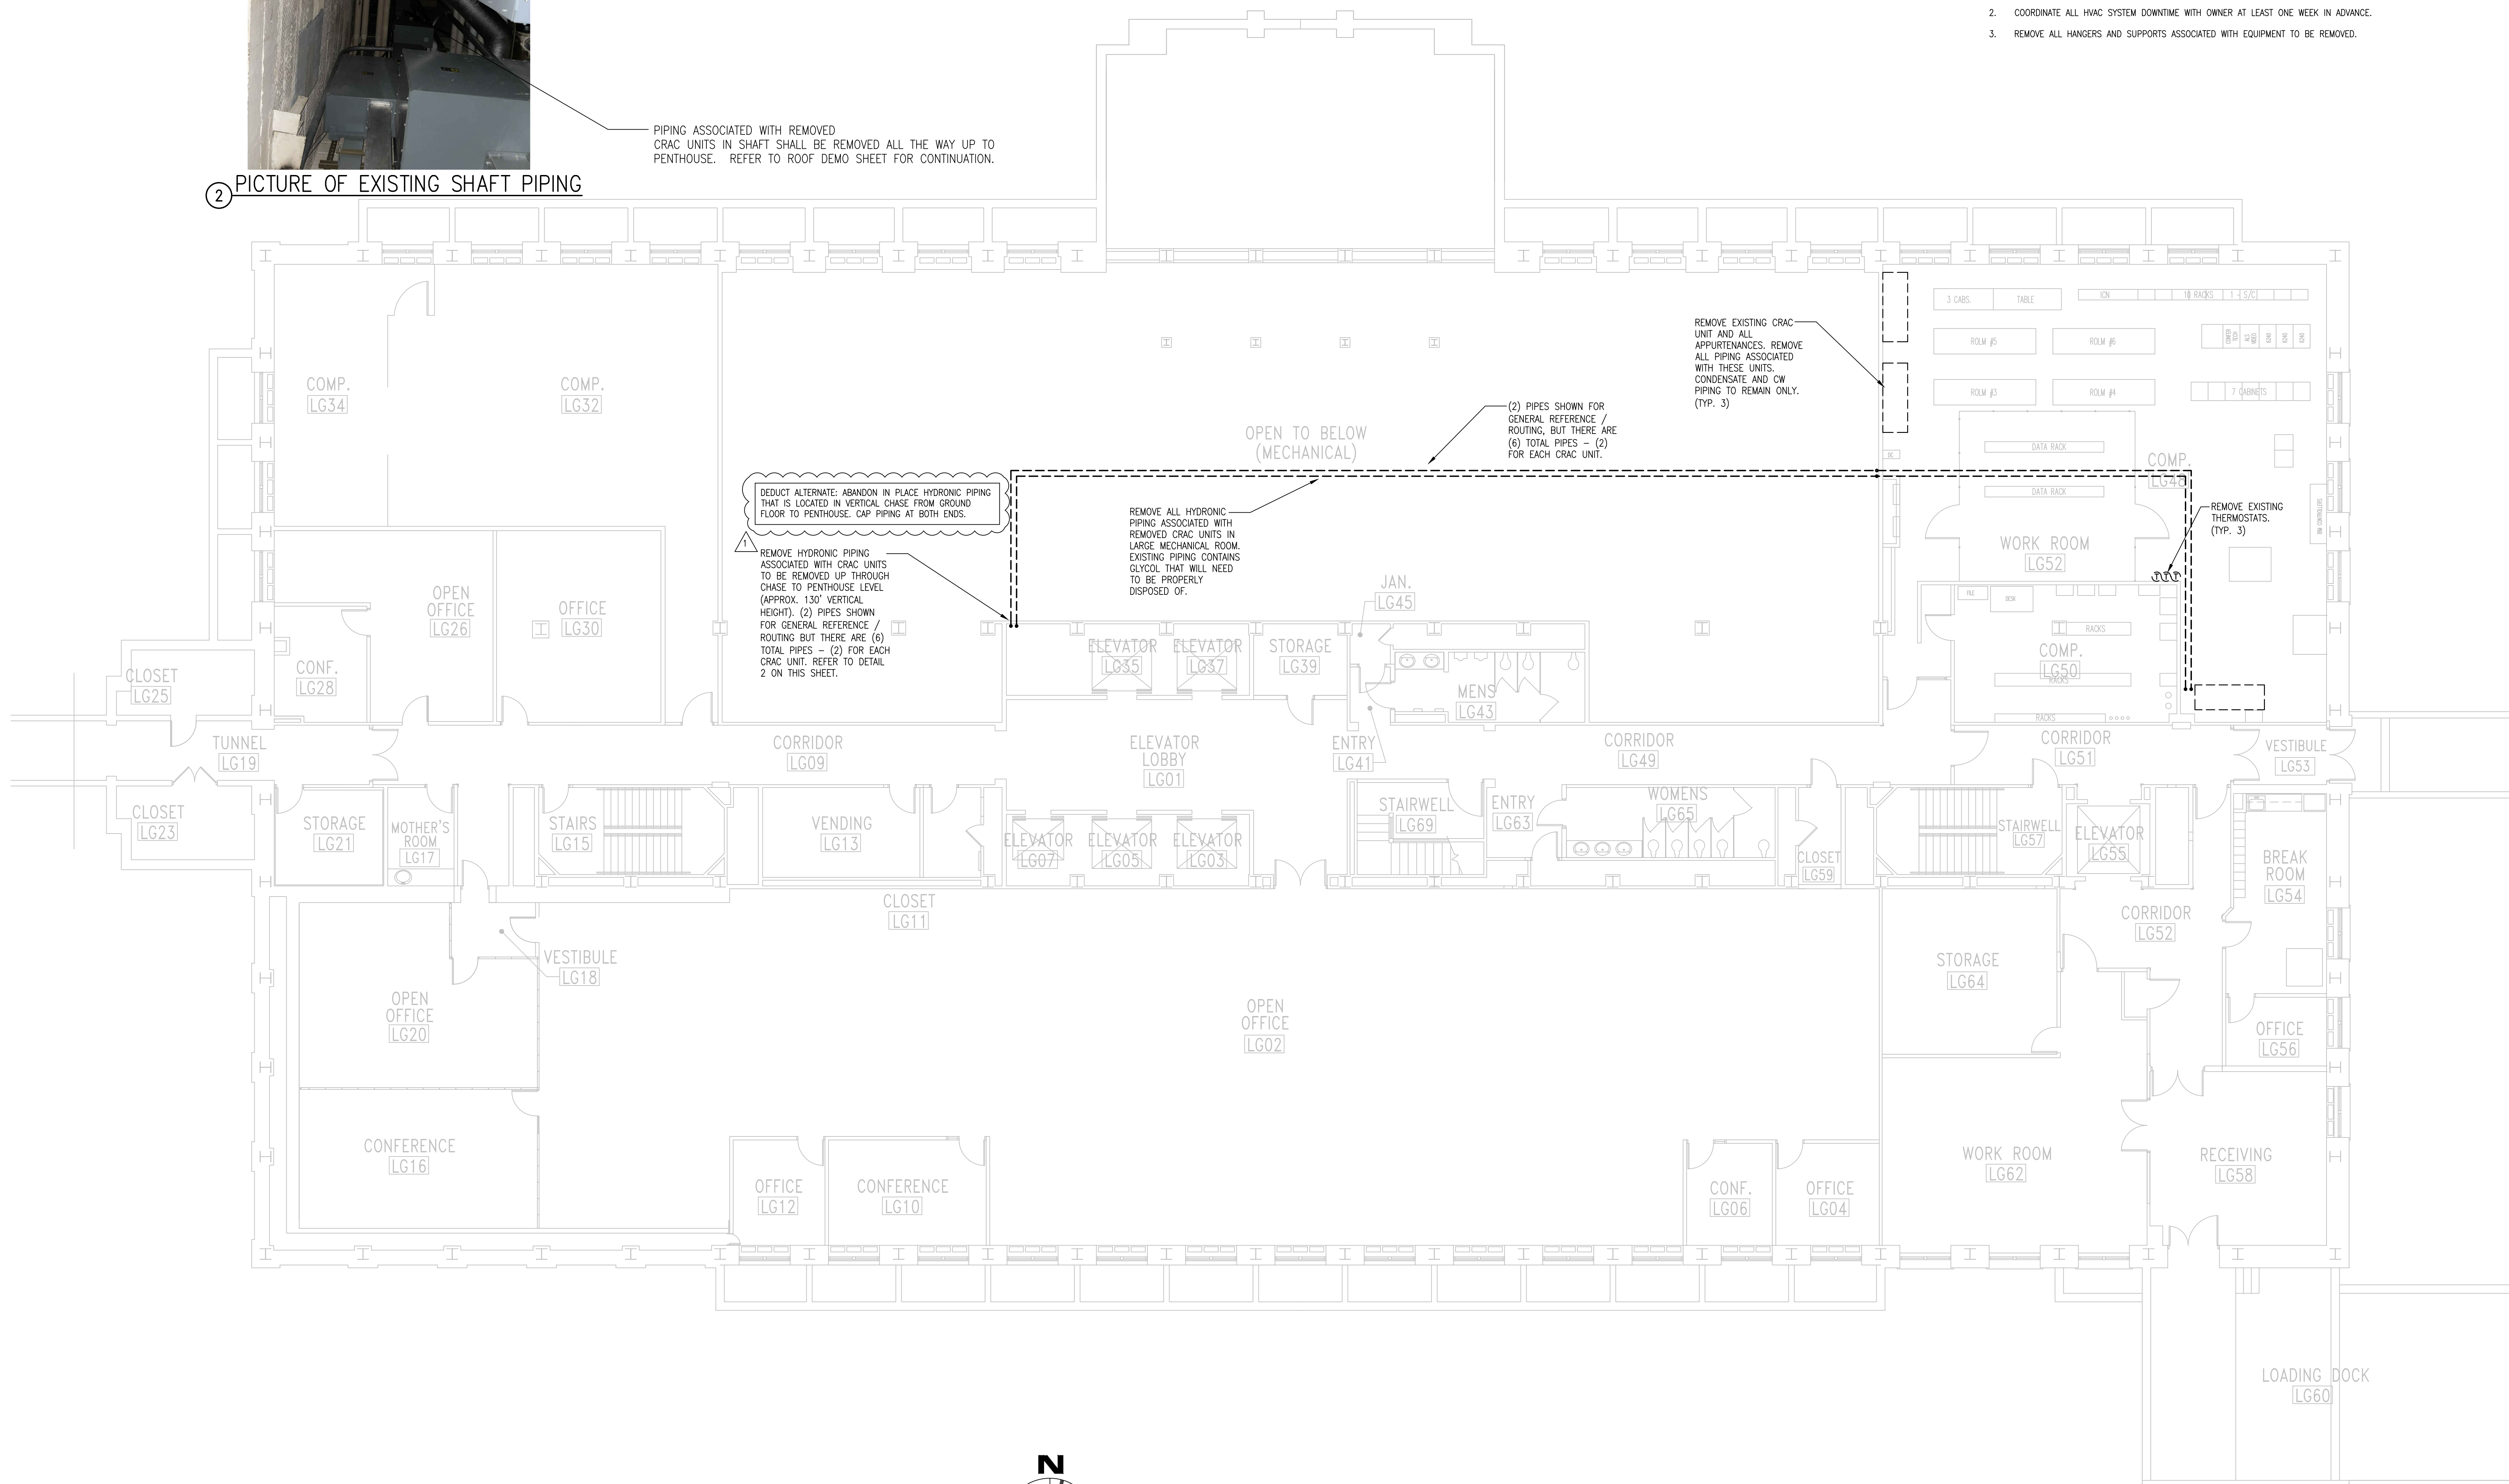
GROUND FLOOR PLAN - HVAC - DEMO

1. Drawing MD1 – Ground Floor Plan – HVAC - Demo:
 - a. ADD note about deduct alternate to abandon piping in vertical chase.
 - b. Refer to attached full size sheet MD1.
2. Drawing MD2 – Penthouse and Roof – HVAC - Demo:
 - a. ADD note about deduct alternate to abandon piping in vertical chase.
 - b. Refer to attached full size sheet MD2.
3. Drawing M2 – Mechanical Details and Schedules:
 - a. ADD note about owner provided /contractor installed equipment.
 - b. ADD note to Computer Room AC unit and CRAC Unit Condensing Unit schedules about owner provided/contractor installed equipment.
 - c. Refer to attached full size sheet M2.

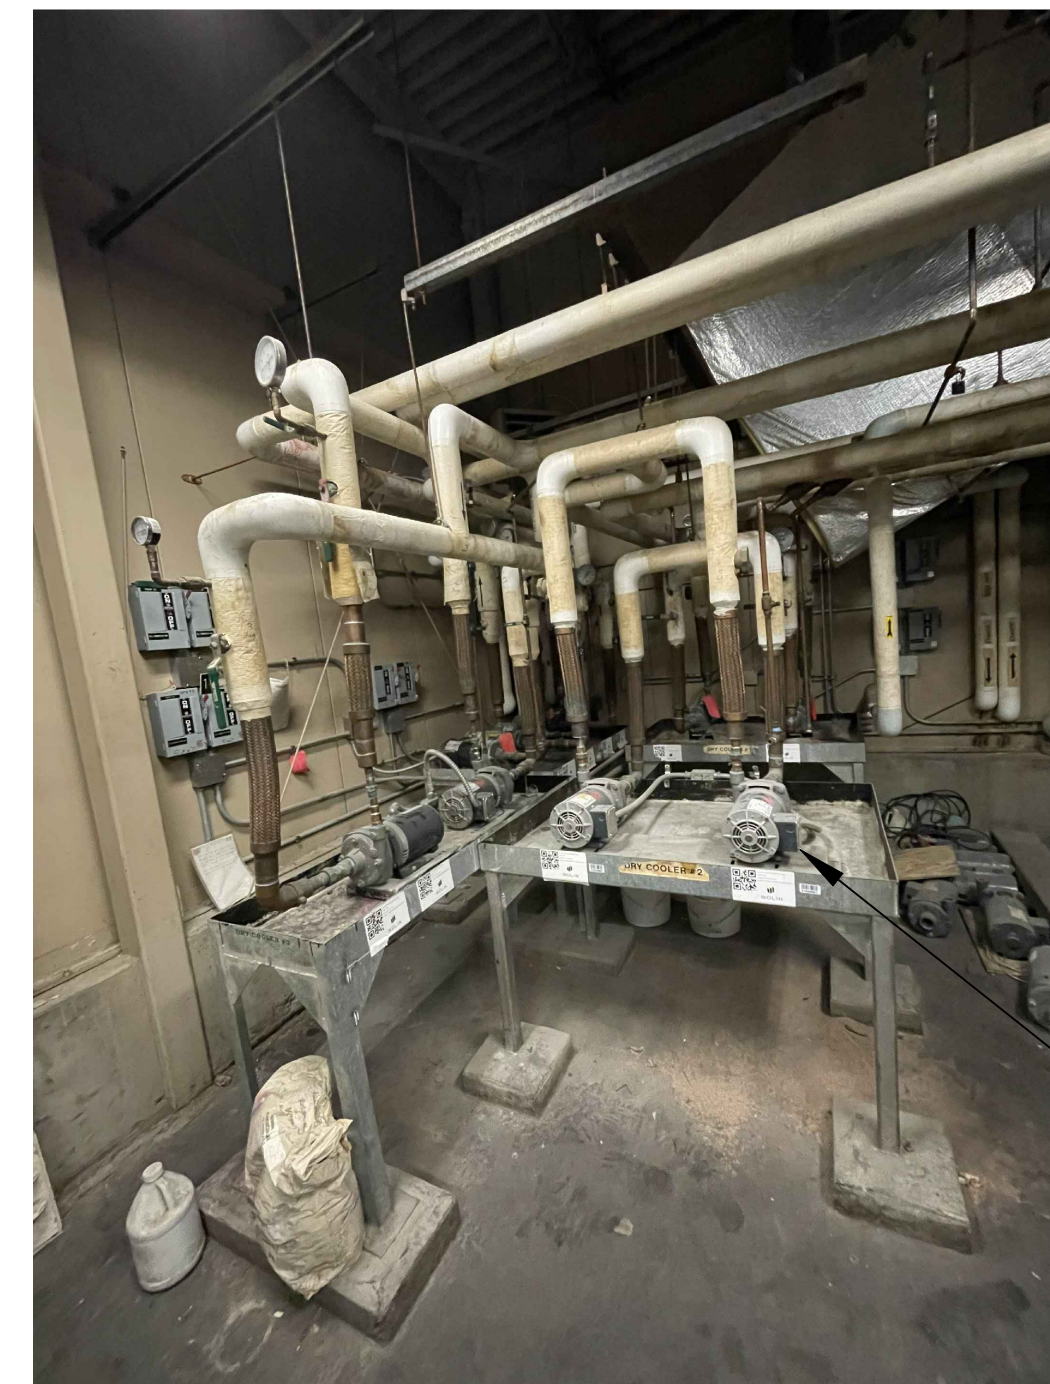
2 PICTURE OF EXISTING PUMPS AND PIPING

REMOVE ALL PIPING AND ACCESSORIES FOR DRYCOOLERS TO BE REMOVED.

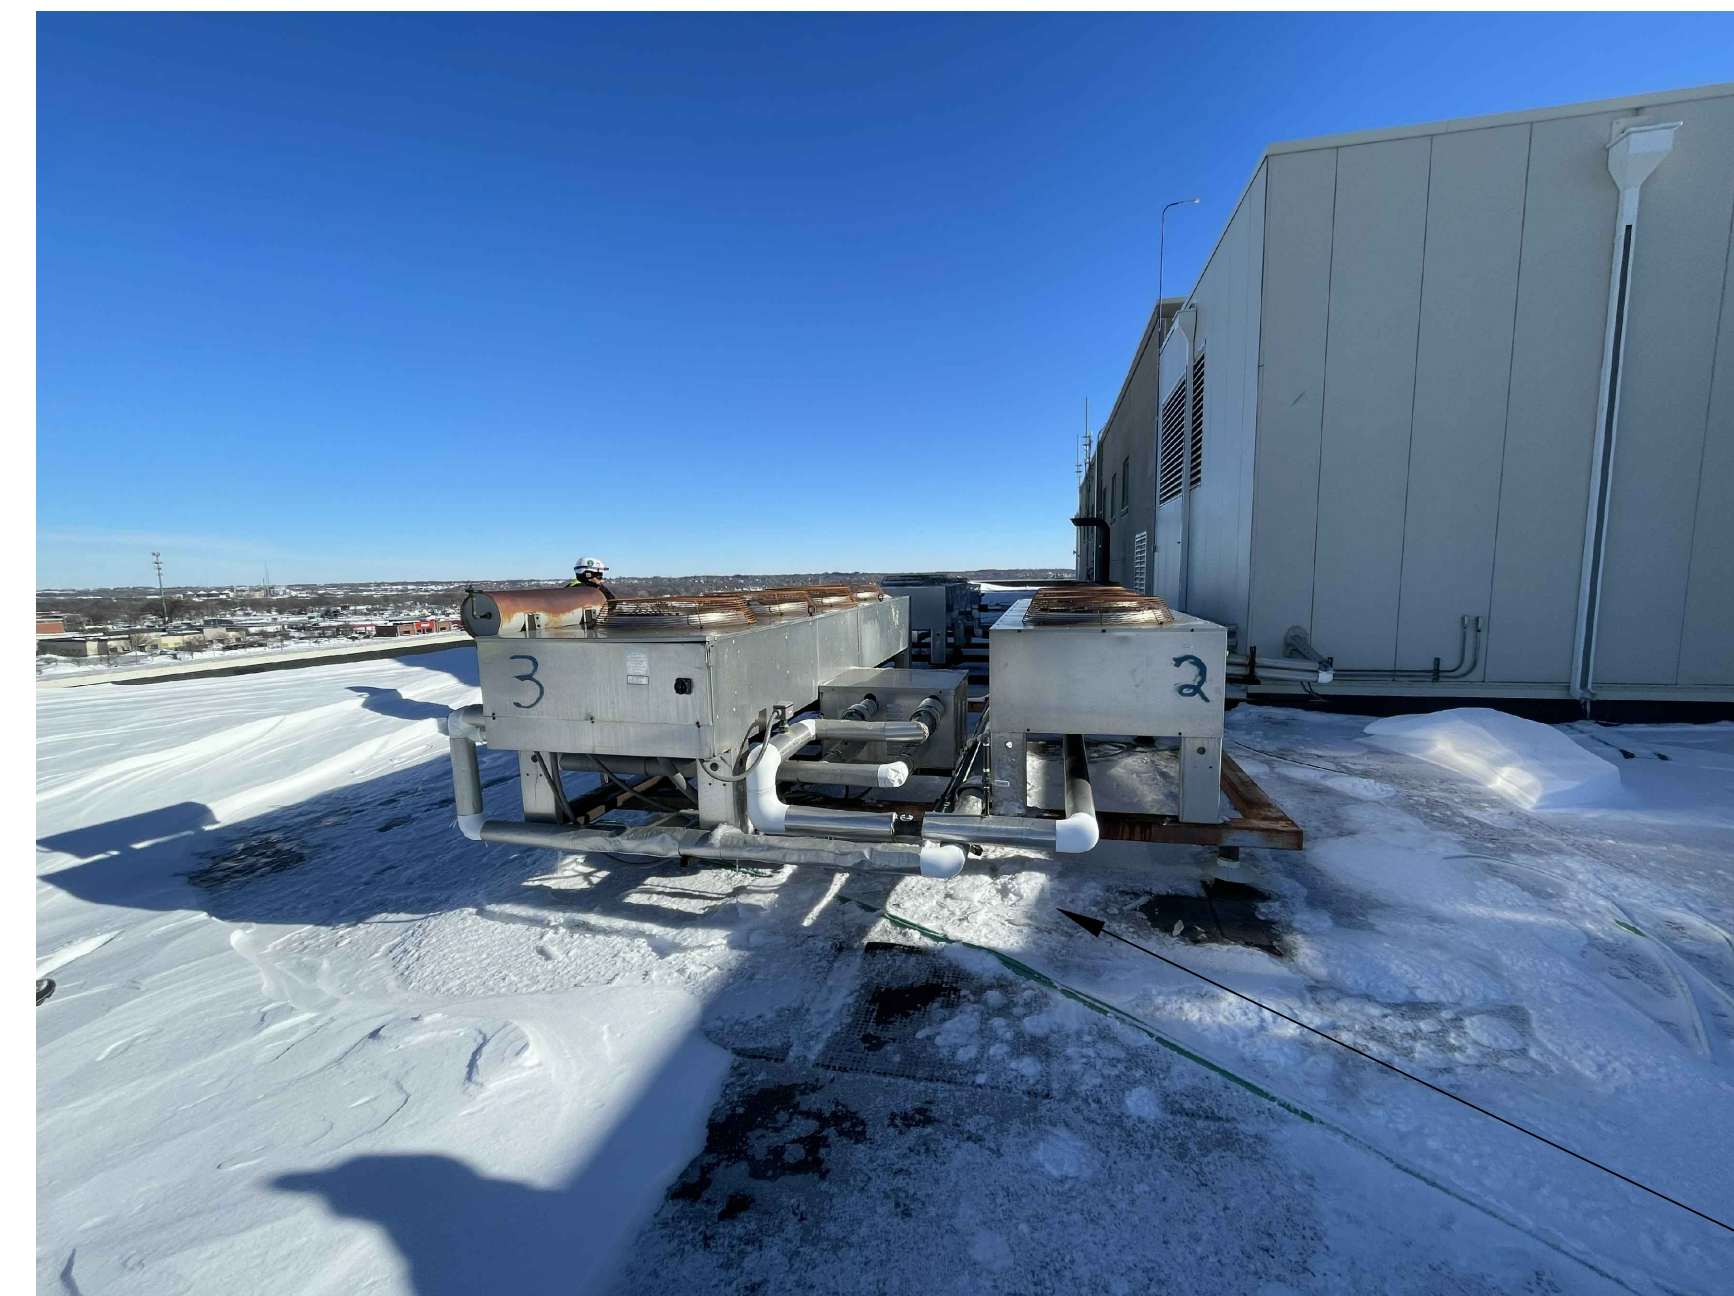
3 PICTURE OF EXISTING DRYCOOLERS

REMOVE ALL PIPING AND ACCESSORIES FOR DRYCOOLERS TO BE REMOVED.

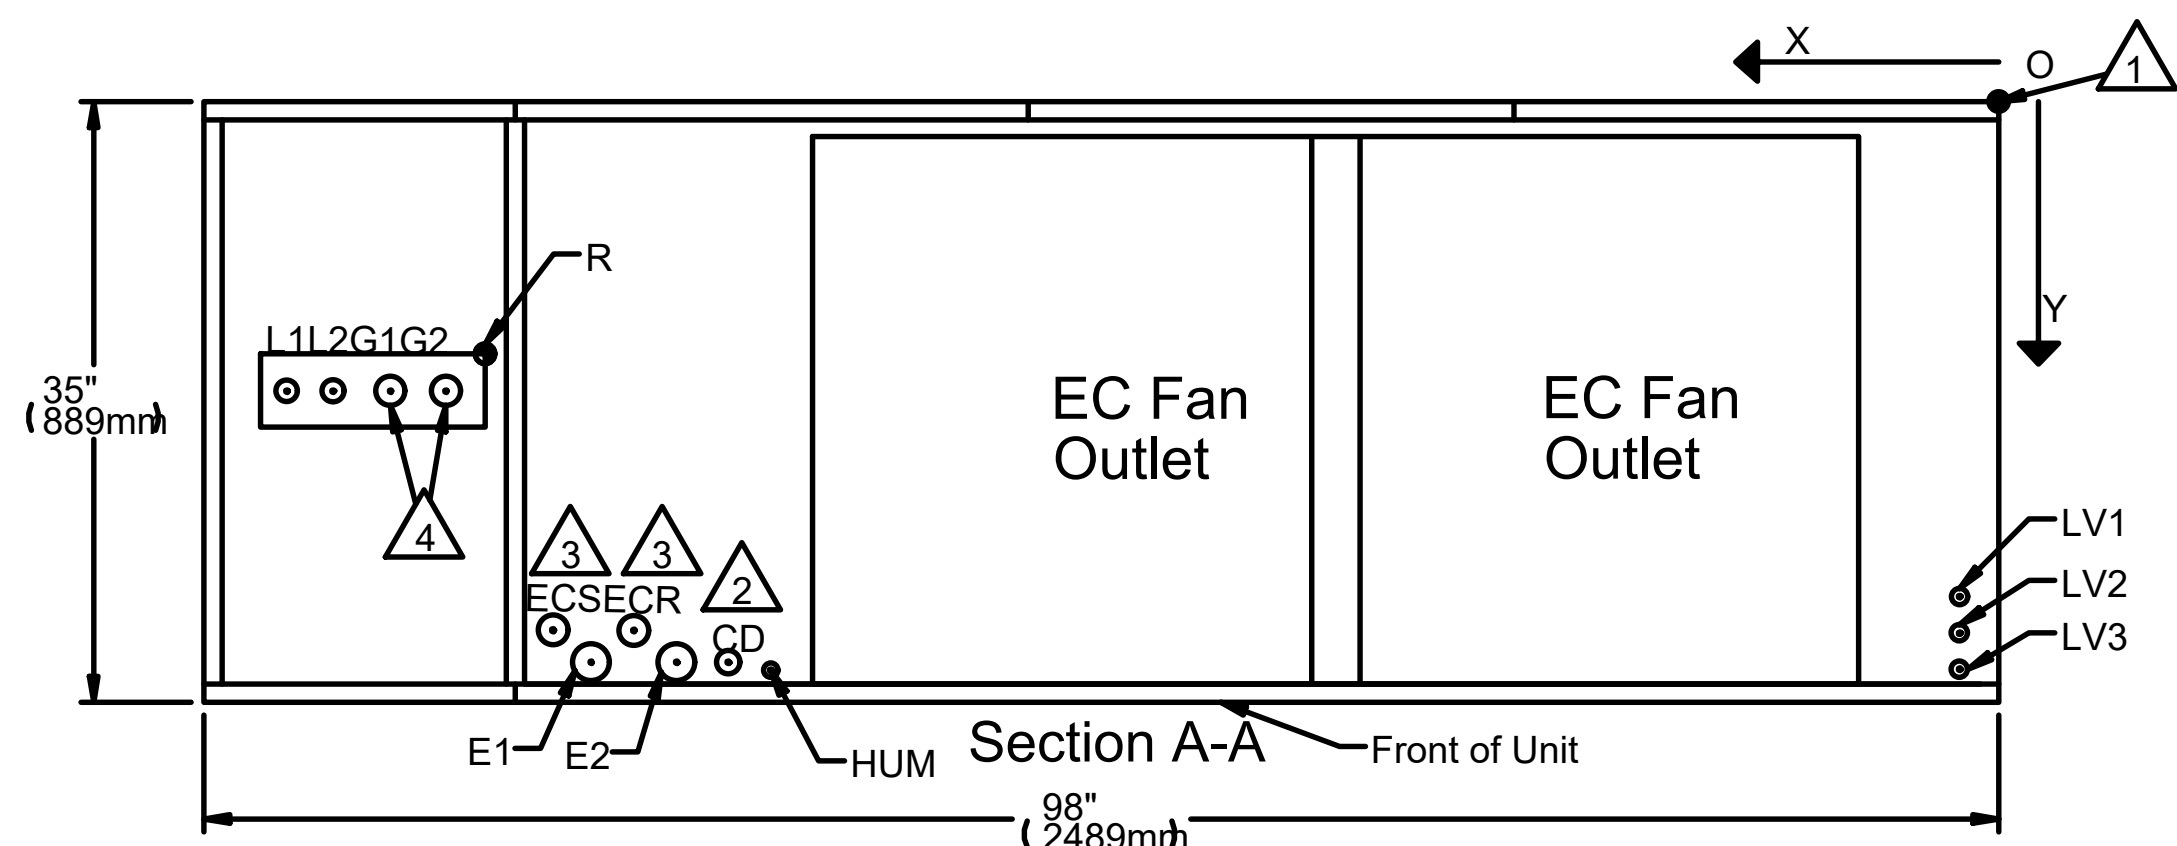
A INDOOR UNIT CONNECTION DETAILS

POINT	DESCRIPTION	X in. (mm)	Y in. (mm)	CONNECTION SIZE / OPENING
R	REFRIGERANT ACCESS	81-3/4 (2076)	14-3/4 (375)	12-3/16" (310mm) X 4" (102mm)
				53kW (15 TONS) 70 & 77kW (20 & 22 TONS)
L1	LIQUID LINE SYSTEM 1	94-11/16 (2405)	16-3/4 (425)	1/2" O.D. Cu 5/8" O.D. Cu
L2	LIQUID LINE SYSTEM 2	91-7/8 (2334)		
G1	HOT GAS DISCHARGE 1	88-3/4 (2254)	16-3/8 (416)	7/8" O.D. Cu 1-1/8" O.D. Cu
G2	HOT GAS DISCHARGE 2	85-9/16 (2173)		
CD	CONDENSATE DRAIN (infrared humidifier or no humidifier) W/ OPTIONAL PUMP	68-3/8 (1737)	31-3/8 (797)	3/4" NPT FEMALE 1/2" O.D. Cu
HUM	HUMIDIFIER SUPPLY LINE	76-1/2 (1943)	29 (737)	1/4" O.D. Cu
ECS	LIEBERT® ECON-O-COIL SUPPLY	78-5/8 (1997)	22-1/4 (565)	
ECR	LIEBERT® ECON-O-COIL RETURN	73-15/16 (1878)	26-9/16 (675)	2-1/8" O.D. Cu
E1	ELECTRICAL CONN. (HIGH VOLT)	78-1/2 (1994)	31-1/8 (791)	2-1/2"
E2	ELECTRICAL CONN. (HIGH VOLT)	75-3/8 (1915)		
LV1	ELECTRICAL CONN. (LOW VOLT)		29 (737)	
LV2	ELECTRICAL CONN. (LOW VOLT)	2 (51)	30-7/8 (784)	7/8"

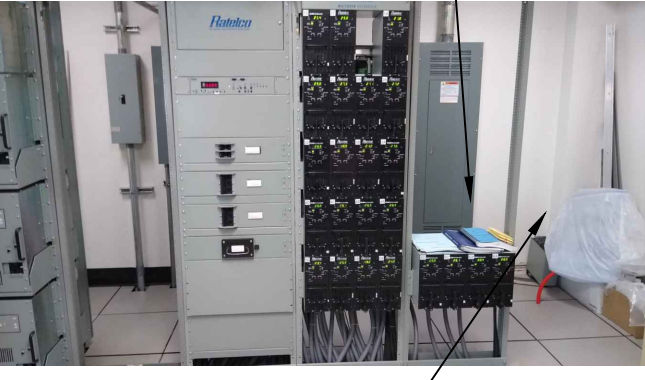
INSTALL BUS TAPS AT PANEL.

INSTALL NEW DISCONNECT WITHIN 10' OF PANEL TO MEET NEC 240.21 REQUIREMENTS. COORDINATE EXACT LOCATION WITH OWNER.

- INSTALL 200A DISCONNECT WITH 175A FUSES TO MATCH MOCP RATING OF CRAC UNIT. INSTALL DISCONNECT IN ACCESSIBLE LOCATION AND COORDINATE LOCATION WITH OWNER.
- INSTALL BUS TAP IN PANEL SW TO ADD (2) DISCONNECTS TO PANEL. REFER TO PHOTO AND ONE-LINE FOR MORE DETAILS.
- INSTALL BUS TAP IN PANEL ET2 TO ADD (1) DISCONNECT TO PANEL. REFER TO PHOTO AND ONE-LINE FOR MORE DETAILS.
- INSTALL (3) 15A 3P BREAKERS IN EXISTING PANEL SW (SQUARE D NO PANEL) FOR CONDENSING UNITS OUTSIDE.
- INSTALL (2) 15A 1P BREAKER IN EXISTING PANEL ET-2A (SQUARE D I-LINE PANEL). (1) FOR POWER TO TEMPERATURE RECEIVER AT EACH CRAC UNIT AND (1) FOR MAINTENANCE RECEPTACLE.

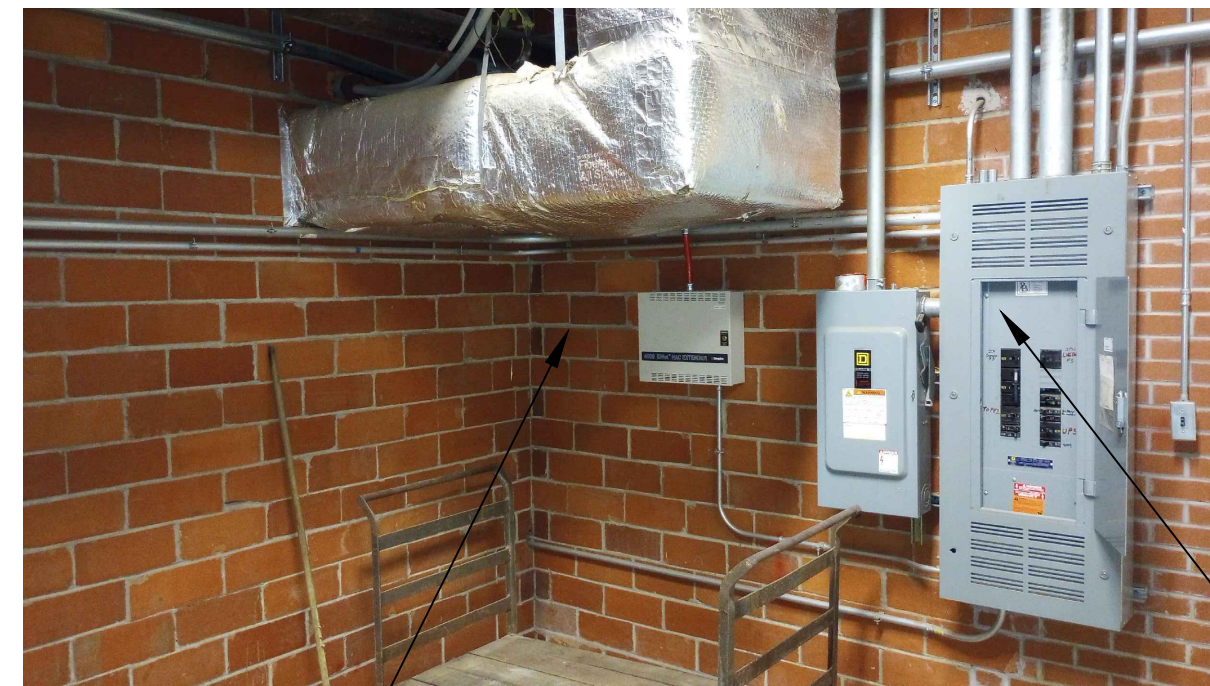
FIRST FLOOR PLAN - ELECTRICAL

INSTALL NEW DISCONNECT WITHIN 10' OF PANEL TO MEET NEC 240.21 REQUIREMENTS. COORDINATE EXACT LOCATION WITH OWNER.

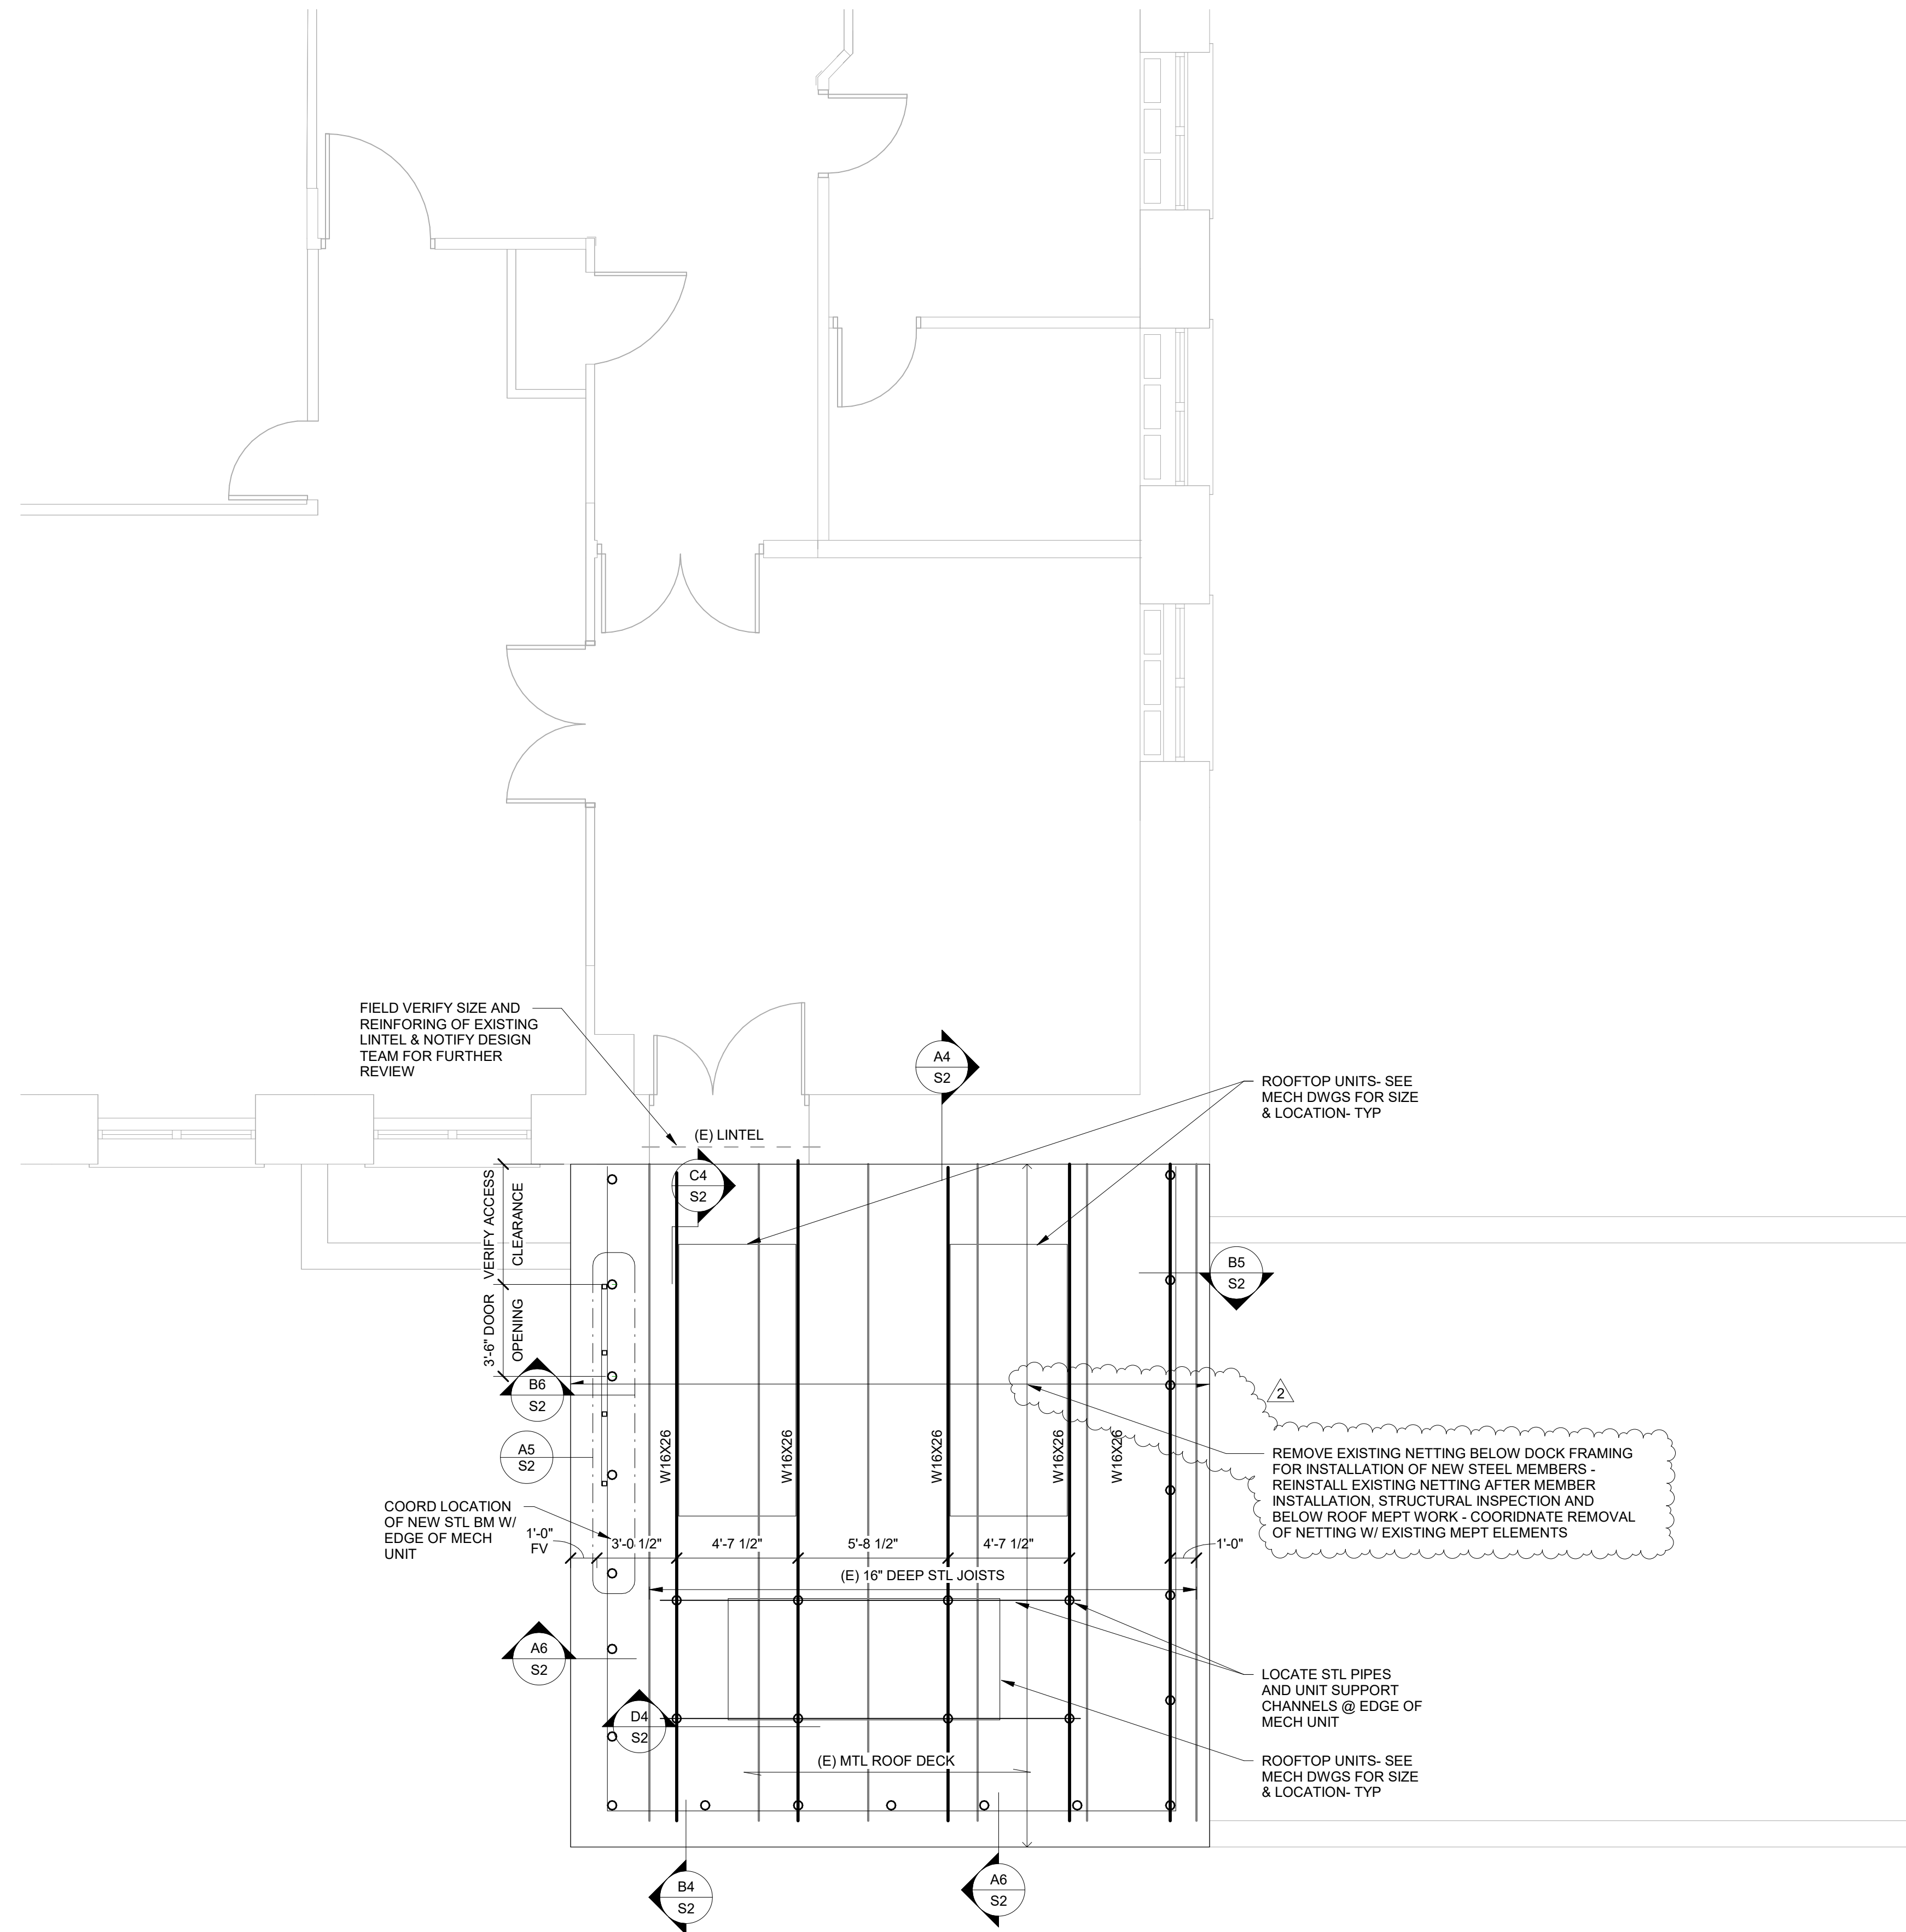
1 ROOF FRAMING PLAN
 1/4" = 1'-0"

- NOTES:
- VERIFY EXISTING CONDITIONS PRIOR TO CONSTRUCTION
 - ——— INDICATES DIRECTION OF EXISTING DECK SPAN
 - ALL ROOF OPENINGS TO RECEIVE ANGLE FRAME PER TYPICAL DETAILS. SOME ROOF OPENINGS MAY NOT BE SHOWN ON STRUCTURAL DRAWINGS. VERIFY SIZE & LOCATION OF ALL OPENINGS W/ MECH CONTRACTOR
 - FOR TYPICAL SCREEN WALL CORNERS & AT EXISTING BUILDING, SEE C6/ S2
 - CUT AND REPLACE EXISTING BRIDGING IN KIND FOLLOWING NEW STL BEAM ERECTION, SEE B5/ S2

1. Drawing S1 – Structural Notes & Roof Framing Plan
 - a. REVISE note MP3.
 - c. ADD note for removing and reinstalling existing netting to ROOF FRAMING PLAN.

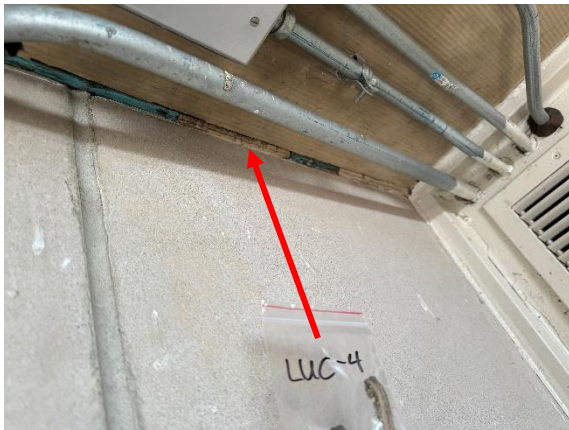
Photo #3 View of Brittle Asbestos Containing Caulk above Loading Dock Doors.

- Asbestos was identified in the sample of White Brittle Caulk on the Loading Dock Doorway.
- Lead-Based Paint was identified in the metal doorframe of the loading dock.
- No hazardous building materials were identified that would be disturbed as part of planned CRAC Unit Replacement Project activities, with the exception of the coolant system in the CRAC Units themselves.

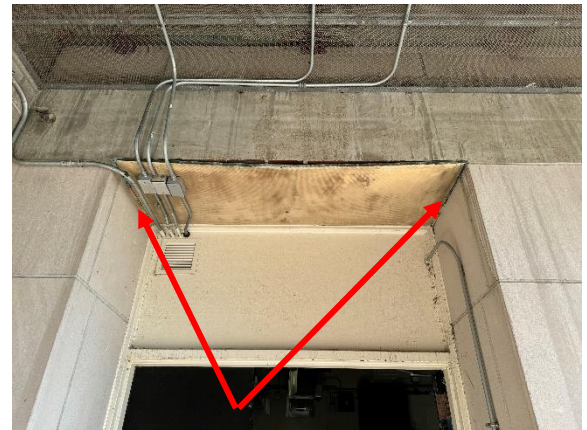
Photo #4 Another Photo of the Asbestos Containing Caulk above Loading Dock Doors.

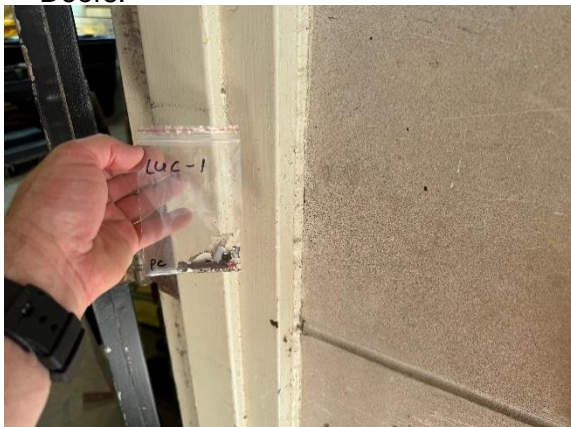
Photo #5 View of Off-white LBP on Loading Dock Doorframe.

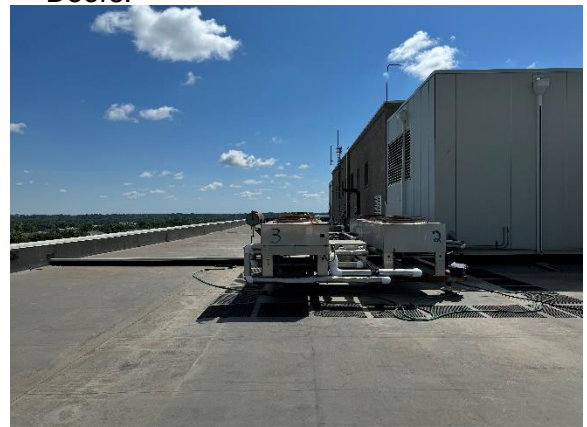
Photo #6 View of HVAC units to be removed.
