Addendum #02 for RFP #922600-02

Project Name: DCA MON Main House Site Work and Outbuilding Repairs

**Phase I Intensive Archaeological Survey for
Proposed Improvements at the
Montauk Historic Site and Preserve,
Fayette County, Iowa**

*Wapsi Valley Archaeology
Report No. 1266*

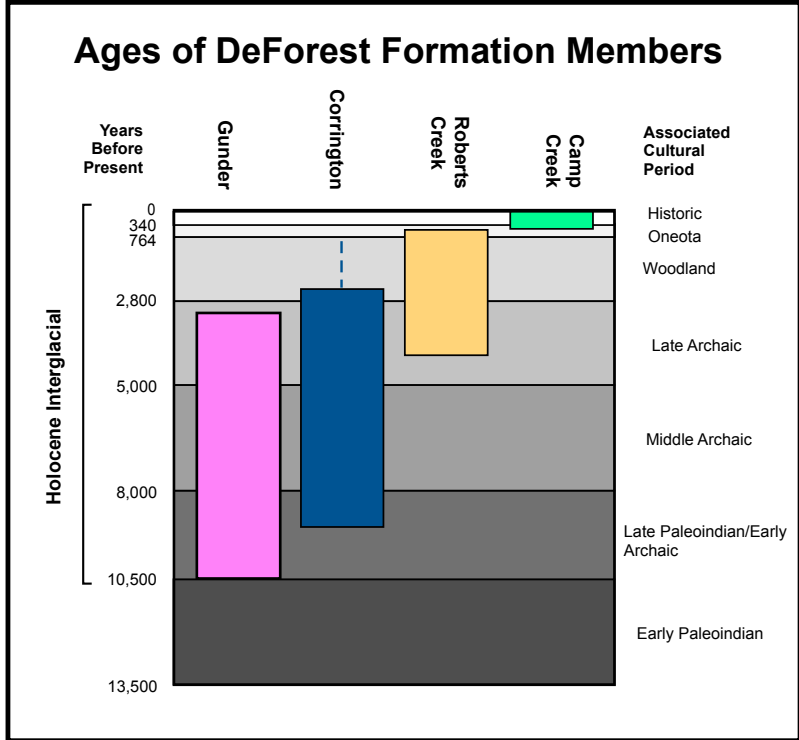
Figure 6. Chart showing DeForest Formation members and associated cultural periods. Source: Adapted from Bettis and Littke (1987).

present at a particular location (Figure 6), indicating that there is some potential for intact or buried archaeological sites *if* that area had been used by people in the past.

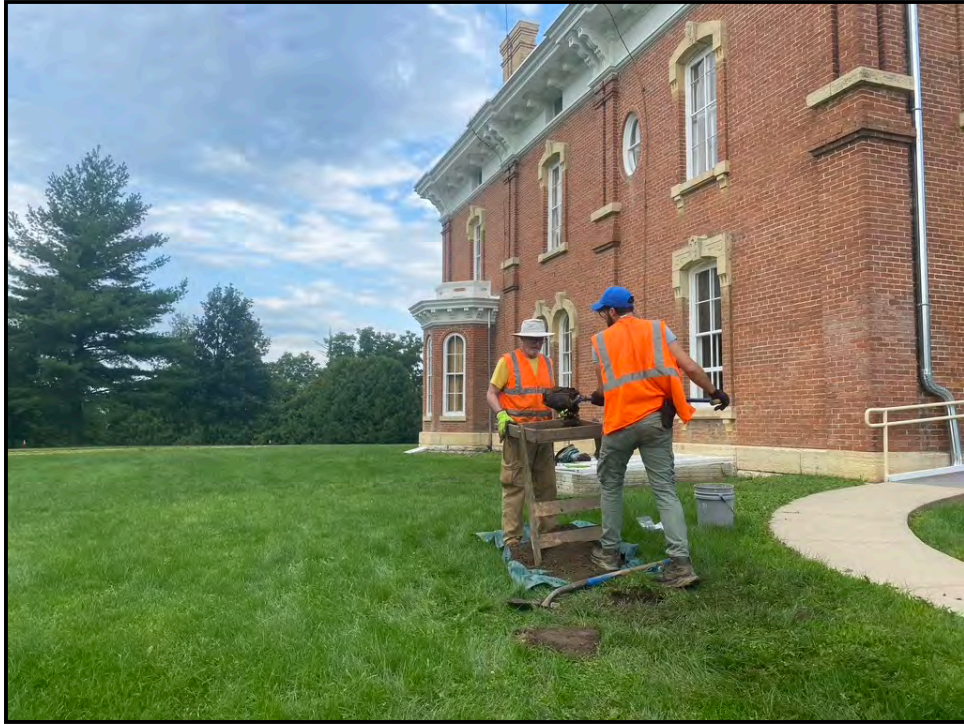
Figure 8. View of the East Yard and Auger Test T-17, view to the south.

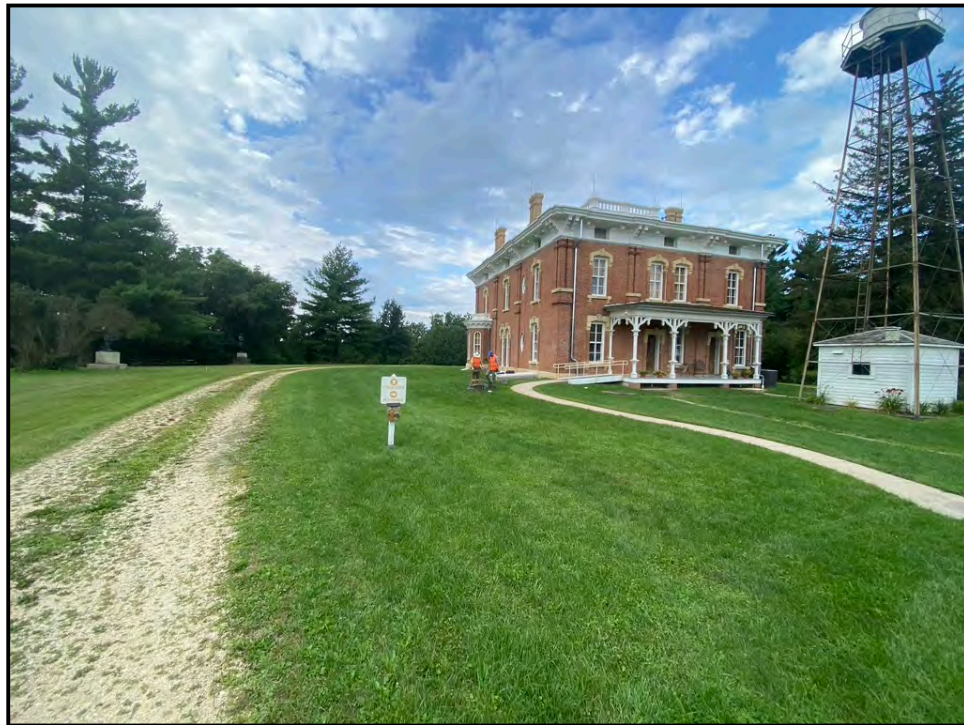
Figure 9. View of the Front Yard and East Yard, facing west.

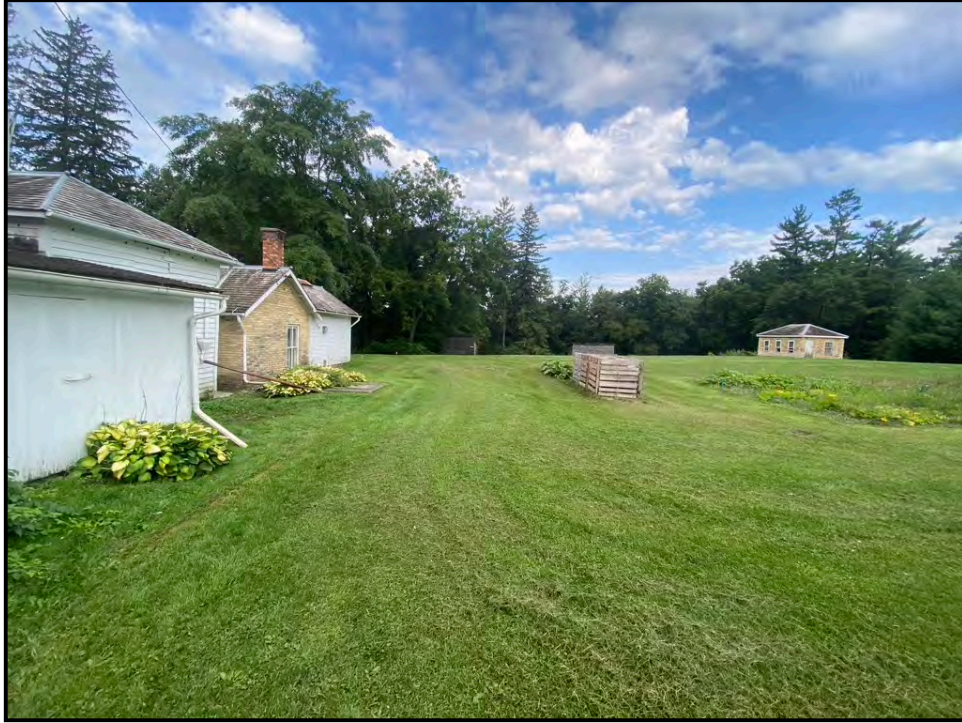
Figure 10. Overview of the North Outbuilding Yard, view to the west.

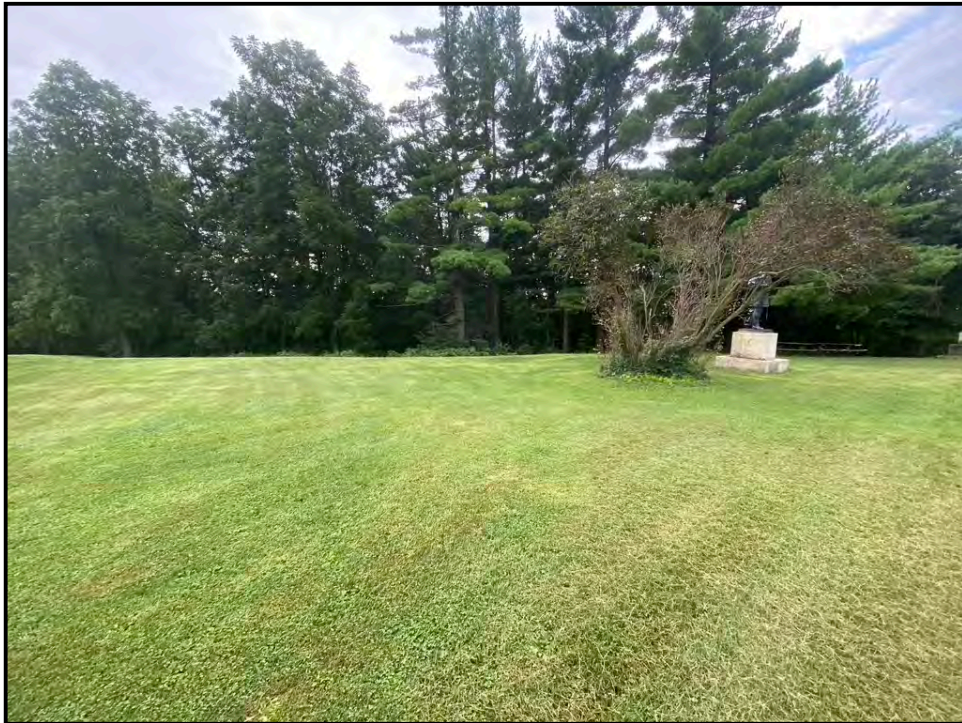
Figure 11. Utility Corridor, view to the east.

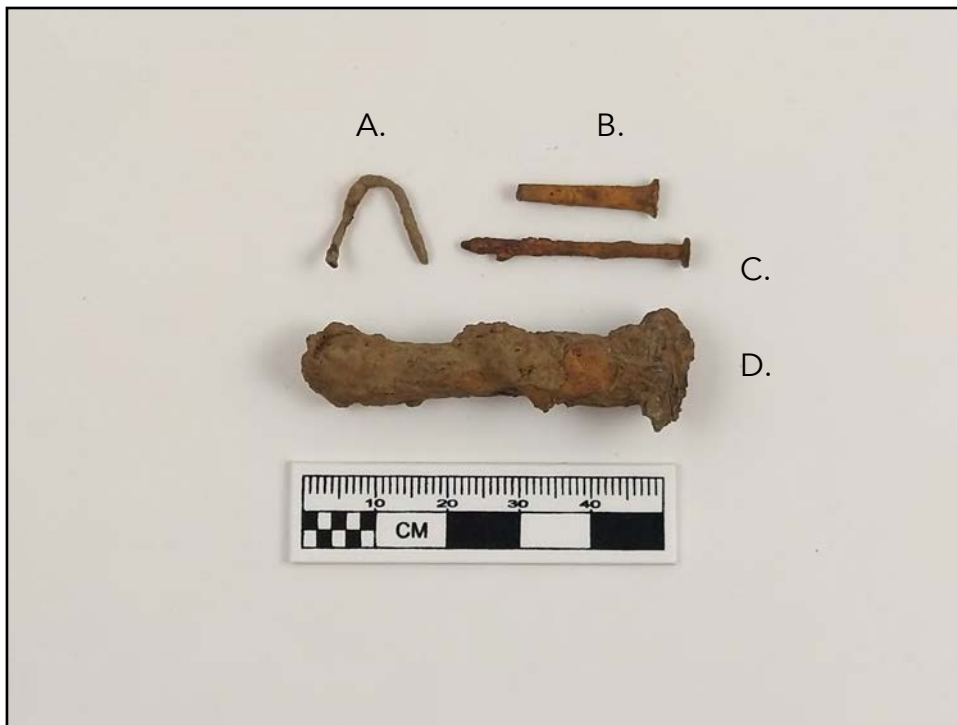
Figure 15. Metal artifacts recovered from the North Outbuilding Yard, including (A) a fencing staple; (B) a machine-cut B nail; (C) a wire nail; and (D) a screw.

Artifact types were distributed throughout the North Outbuilding Yard (see Table 7 on the next page). Out of the 127 artifacts recovered, metal was the most common material type in the North Outbuilding Yard, totaling 66 objects (52 percent of total), 45 of which are wire and machine-cut B nails (Figure 15). The three machine-cut B nails were recovered in Auger Test T-5 between 20 to 30 cm, Auger Test T-10 between 30 to 40 centimeters, and Auger Test T-11 between 0 to 10 centimeters in depth. Machine-cut B nails were created sometime between 1810 and 1900, while wire nails date to 1900 to the present (Visser 2020). Wire nails were recovered in Auger Tests T-1, T-2, T-9, T-8, T-10, T-11, and T-12 in depths ranging from 10 to 50 centimeters in depth. Other metal objects are primarily construction or farm-related objects, including a screw, strap, fencing staple, and other unidentifiable, corroded pieces.

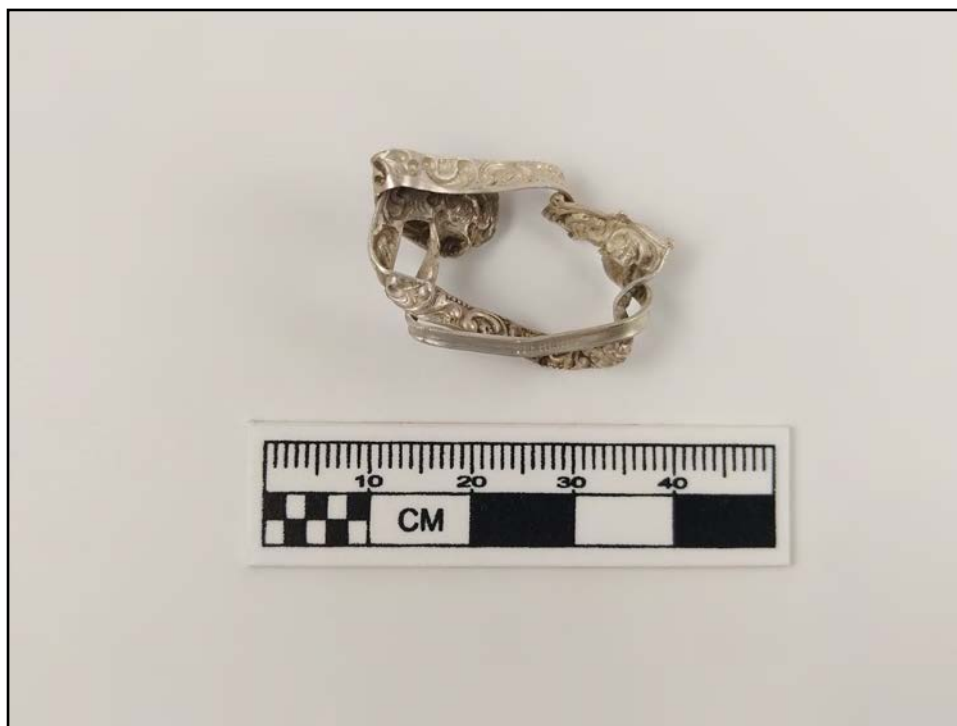
Figure 16. A piece of sterling silver jewelry recovered from Auger Test T-11 of the North Outbuilding Yard. The word "sterling" can be faintly seen on the lower band.

Notably, a sterling silver jewelry piece, possibly a scarf ring or hairpin, was recovered from Auger Test T-11 at a depth of 20 to 30 centimeters (Figure 16). The piece reads “sterling,” indicating its composition of sterling silver. Sterling silver is a silver alloy usually composed of 92.5 percent silver by weight alongside other metals such as copper or zinc. Sterling silver goods became abundant in the mid-1800s after an increase in domestic demand and foreign tariffs (Nova 2010).

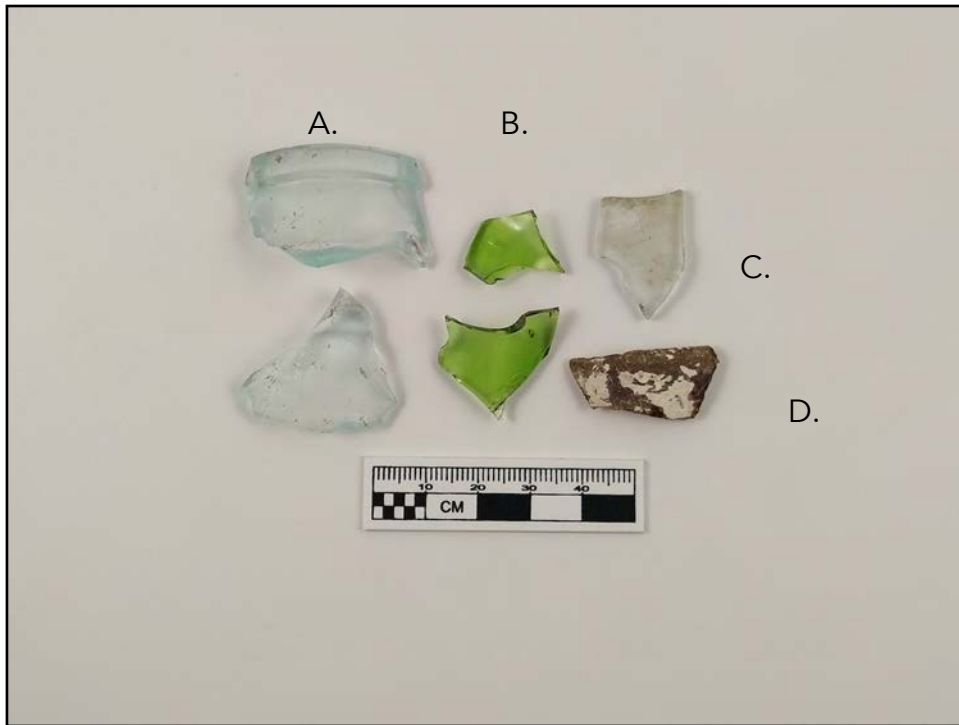
Figure 17. Glass artifacts recovered from the North Outbuilding Yard, including (A) aqua bottle shards; (B) green container shards; (C) clear glass shard; and (D) scorched brown container shard.

A total of 19 glass artifacts (15 percent of total) were found in the North Outbuilding Yard, including six shards of window glass, seven clear shards of a container, one aqua container shard, one shard of root beer-colored glass, and three green bottle shards (Figure 17). A small shard of lantern glass was recovered. Lantern glass dates between 1784 and 1930 was recovered from Auger Test T-9 between 20 to 30 centimeters in depth. No other diagnostic glass pieces were identified in the assemblage.

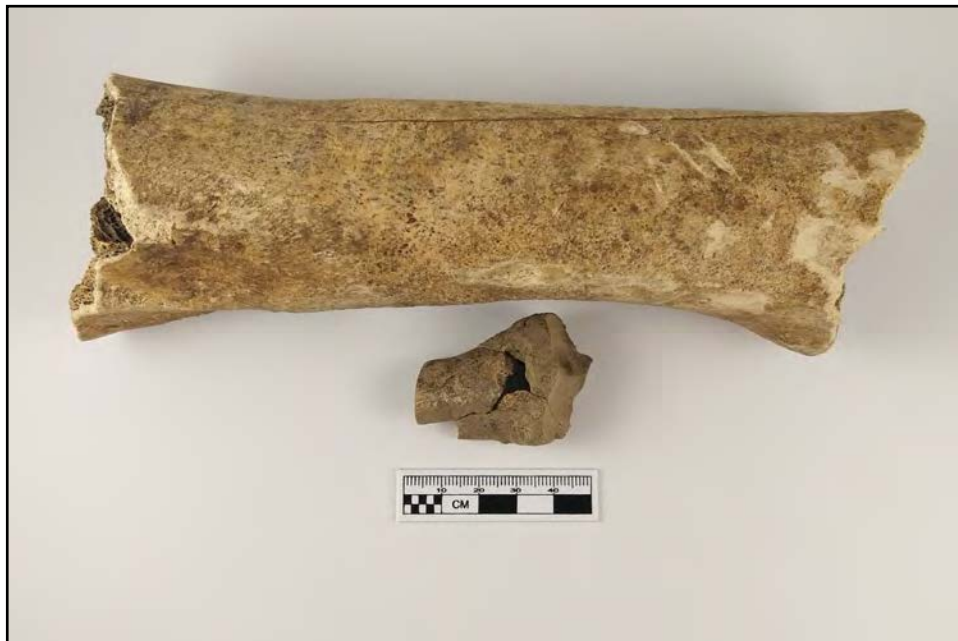
Figure 18. Faunal elements recovered from the North Outbuilding Yard.

The Montauk artifact assemblage also includes 11 faunal elements, nine of which belong to large mammals, one to a bird, and one that is unidentifiable (Figure 18). Out of the nine mammal bones, three refit to complete a portion of a large *Bos taurus* (domestic cow) tibia. Markings from chopping and sawing are present on three elements, while one element is burned.

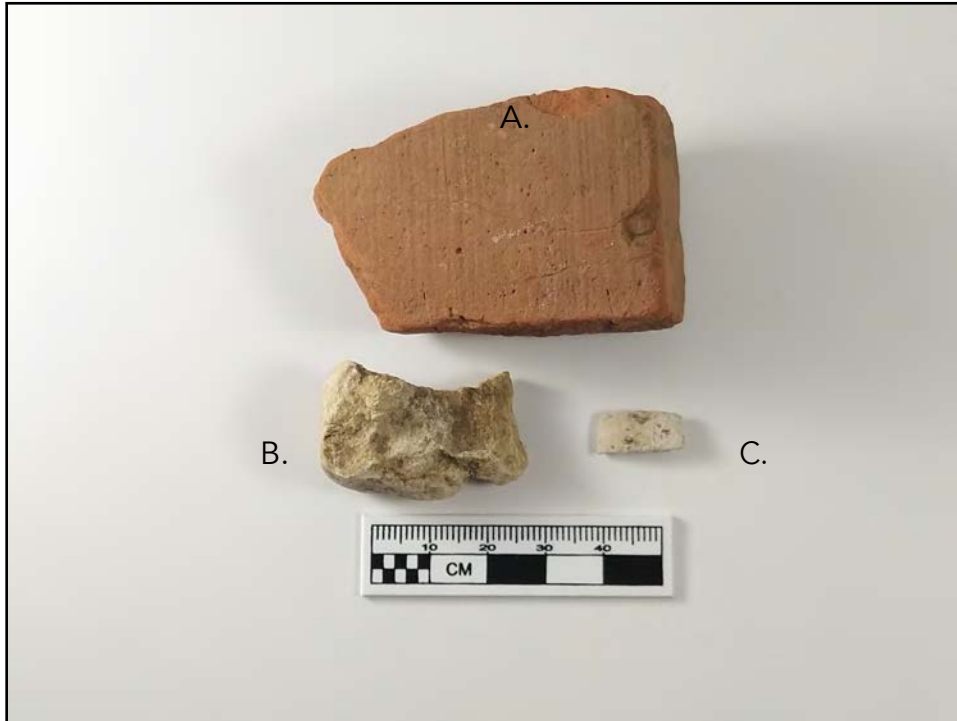
Figure 20. Masonry objects recovered from the North Outbuilding Yard, including (A) an orange brick; (B) limestone; and (C) mortar.

One red Bakelite button was recovered. Bakelite was invented during the early twentieth century and has been extensively used in manufacturing for the past 100 years. Seven mason objects were recovered including brick, limestone, and mortar fragments (Figure 20). Other recovered objects include two pieces of charcoal, 13 cinders or slag, and two pieces of unidentifiable plastic.

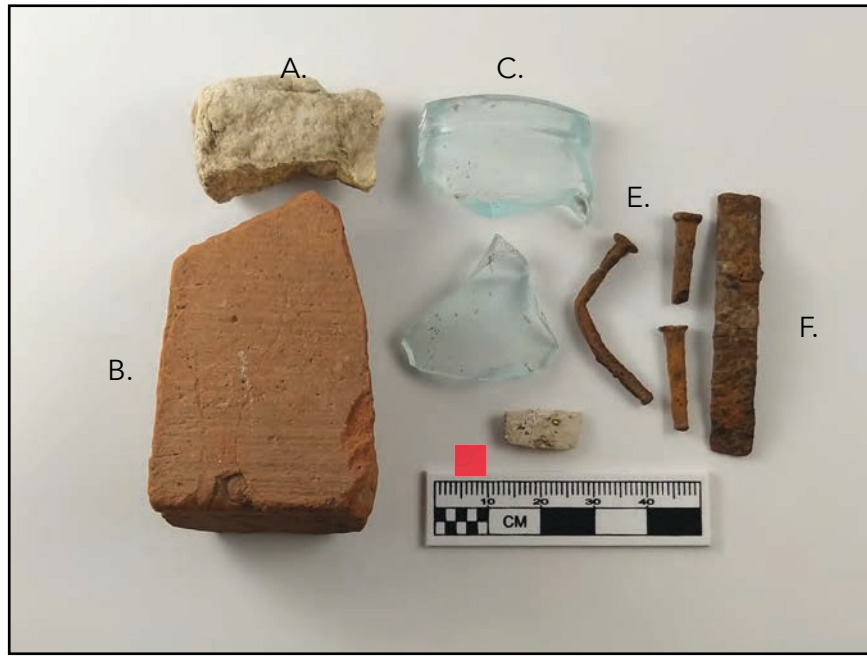
Figure 21. Representative artifacts from the East Yard, including (A) limestone; (B) orange brick; (C) two shards of aqua glass; (D) mortar; (E) machine-cut B nails; and (F) metal strap.

A total of 107 artifacts were collected from 10 subsurface tests placed in the East Yard (Figure 21). Seventy-five of these, or 70 percent of the total, are masonry objects consisting of limestone, brick, or mortar fragments. Masonry artifacts were collected at depths ranging between 10 to 60 centimeters, primarily in Auger Tests T-14, T-15, T-16, T-17, T-20, and T-20 (see Table 8 below). Two fill layers were identified in soil profiles, represented by Auger Tests T-14, T-18, and T-22. Fill 1 varied in depth, ranging from 0 to 27 centimeters in Auger Test T-14 but 0 to 12 and 0 to 10 centimeters in Auger Tests T-18 and T-22, respectively. An upper fill layer seen in the Phase II and Phase III excavations had been identified as an artificial topsoil placed across areas of the Montauk estate sometime around 1900. These dates are based on three coins recovered during excavations, manufactured in 1903, 1918, and 1919 (Finn et al. 2022:59).

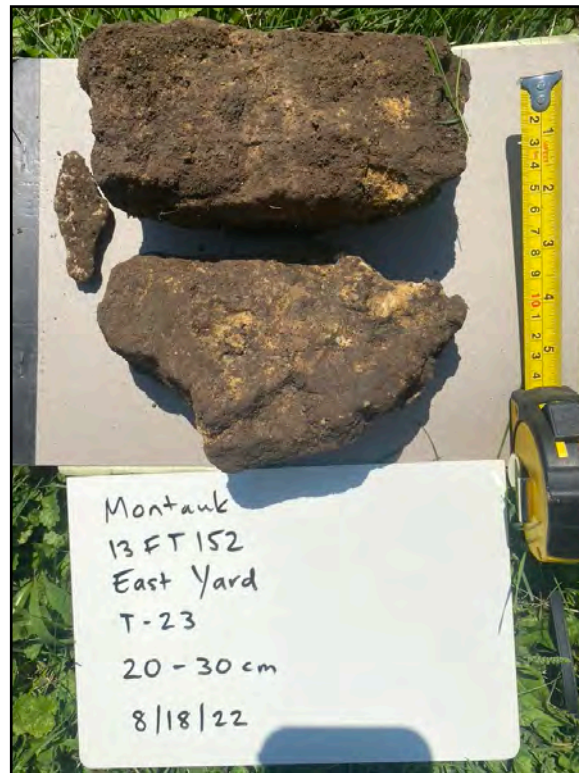
Figure 22. Field photograph of large limestone pieces recovered from Auger Test T-23 from depths ranging between 20 to 30 centimeters.

Test No.	Soil Horizon	Depth (cm)	Description	Artifacts?
23	Fill 2	13-31	Dark grayish brown (10YR 4/2) with dark yellowish brown (10YR 4/4) silt loam. Large limestone rocks and brick fragments at 22 cm.	Y
23	B	31-54	Dark yellowish brown (10YR 4/4) silt clay loam.	N
25		0-25	Dark grayish brown (10YR 4/2) silt clay loam.	N
25		25-38	Dark yellowish brown (10YR 4/6) silt clay loam.	N
