Existing Conditions Report and Treatment Recommendations

Abbie Gardner Sharp Cabin Historic Site

RDG Project Number: 3004.995.00

Report Date: September 15, 2022

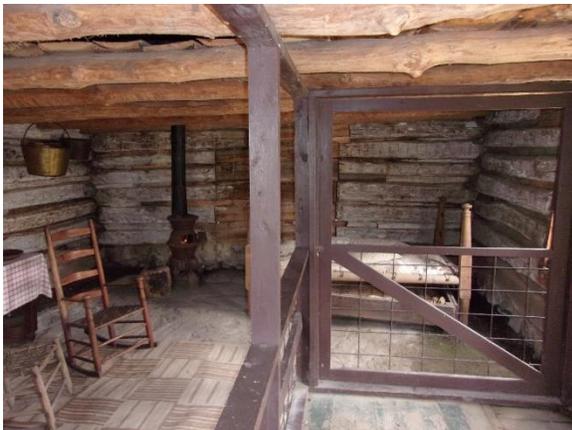
Figure 27 – cabin interior

The interior face of the log walls is exposed. Several show wood-working tool marks. There are also several wood pegs and pegs holes in the walls.

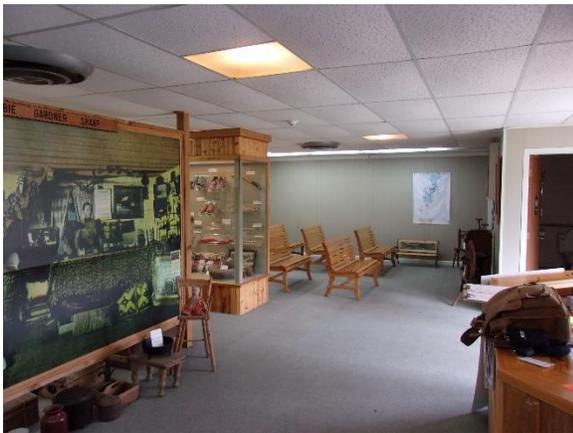
Figure 33 – museum interior

The interior consists generally of exhibit and orientation space. A small storage closet and a single user non-gender restroom is also present.

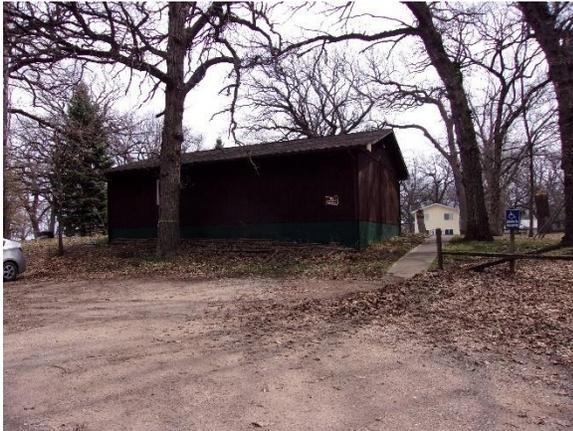
Figure 35 – museum exterior

A thin horizontal crack appears along the concrete footing, about 8" below the siding. This is likely near the point where the concrete floor transitions to the concrete footing.
