Ref : Law Enforcement Academy, Des Moines, IA

Based on our site visit made on the 10th of September 2024 we can inform you as follows.

There has been the problem of longitudinal cracks and deformations reported.

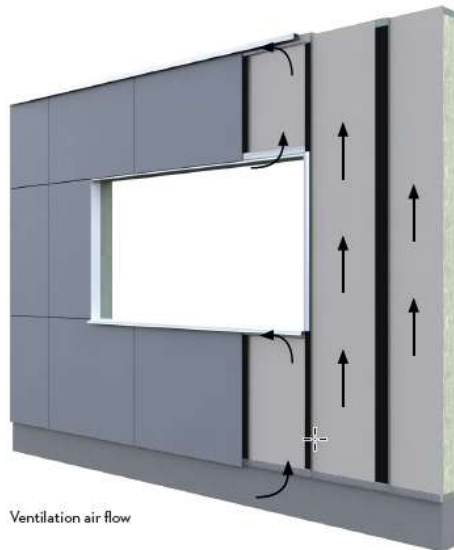
All facades must be designed and constructed as ventilated systems. This requires the provision of an air inlet at the bottom and an air outlet at the top, which applies equally to facade components such as windows and doors. A continuous ventilation gap must be maintained between the backside of the fiber cement boards and the underlying insulation, free from any obstructions.

Upon inspection, it was determined that the façade in question does not meet these ventilation requirements. For all facades incorporating fiber cement boards mounted on a subframe, adequate ventilation is essential. The ventilation principles specific to Swisspearl Patina boards are detailed in the installation manuals provided by our partner, AFCC, which are available on their official website.

To meet the general ventilation requirements, a continuous and unobstructed gap must be present behind the boards. The minimum dimensions for the air inlet and outlet should be at least 3/4 inch.

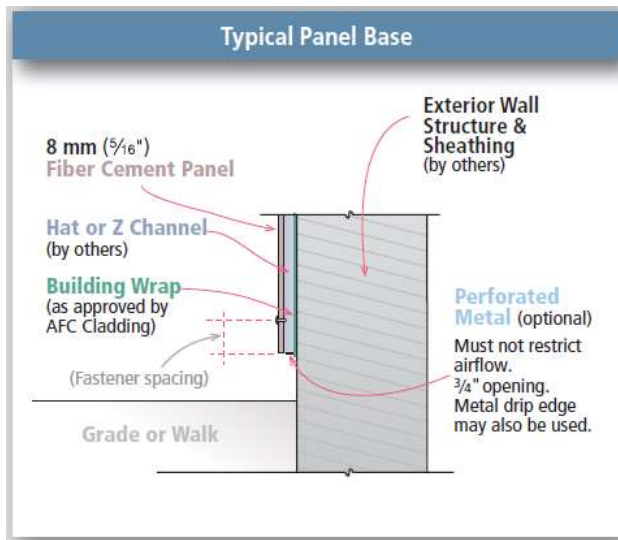
Air inlet, Installation guide page 6

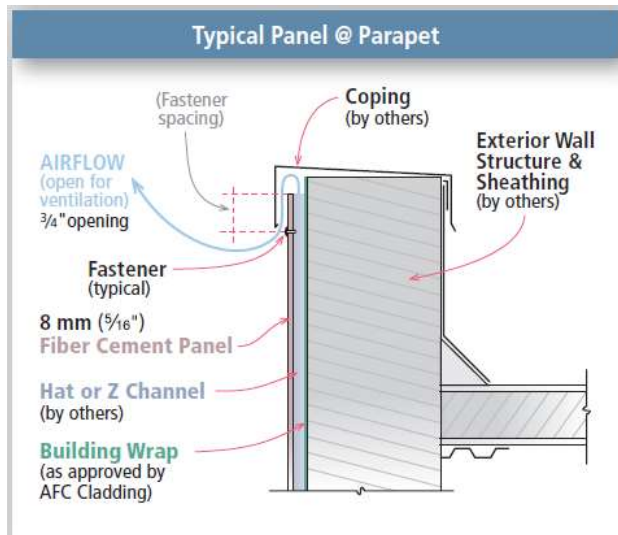
Air outlet, Installation guide page 7

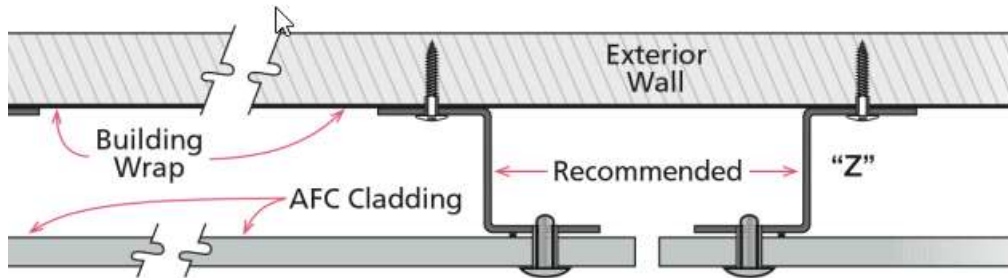
Picture taken from Installation manual, page 5 showing the board installed on the "Z" profiles

"Z" profile are visibly installed in an improper way, these are fixed askew and deformed

We recommend to check whether the profiles meet the basic requirements.
