ADDENDUM #3

Project Name: ISD Elem. School & Outreach Bld. Fire Alarm Replacement DAS# 9381.00 RFB 938100-01 Addendum #3 Dated: March 04, 2024

Hazardous Building Materials Survey Report

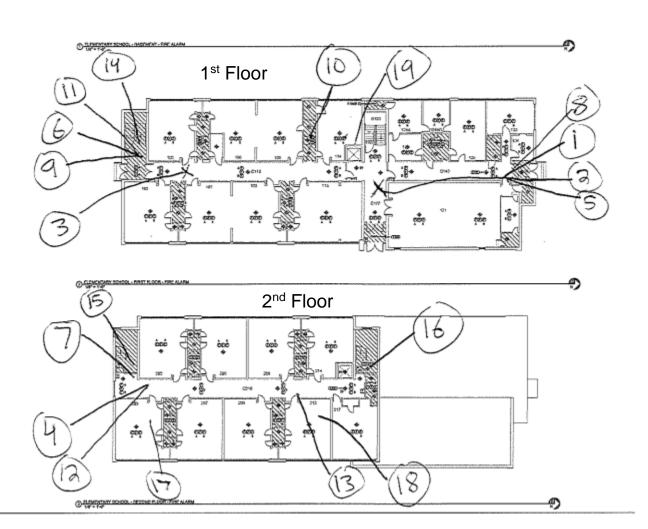
Impacted Material Locations

Iowa School for the Deaf -Elementary School Building 3501 Harry Langdon Boulevard Council Bluffs, Iowa
